PTTEP International Limited (Yangon Branch)

Monitoring Report 2019

3D Seismic Survey in Block M9, Offshore Myanmar

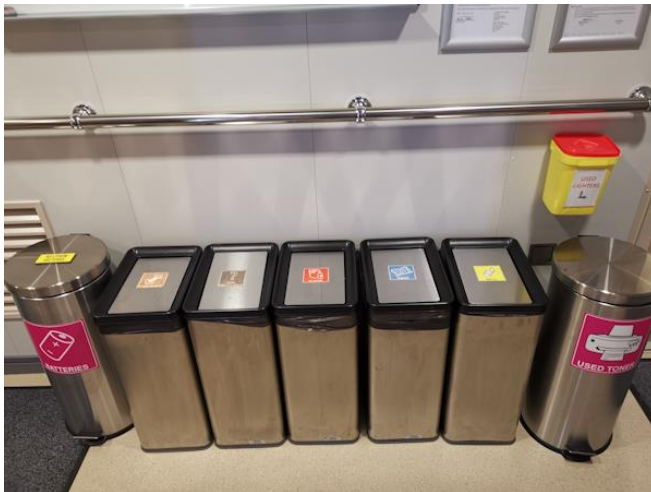
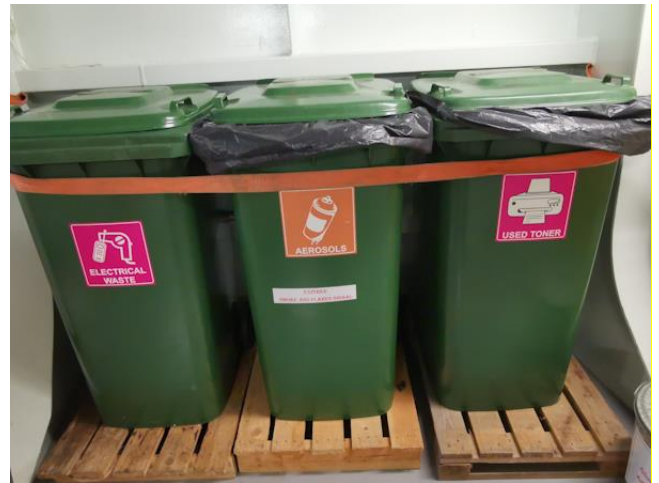
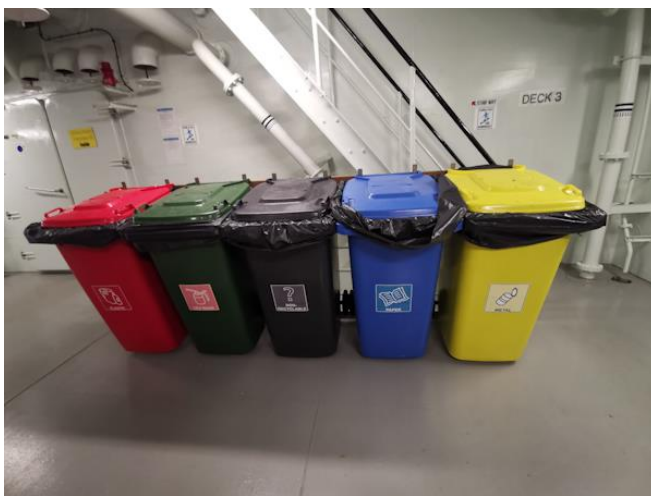
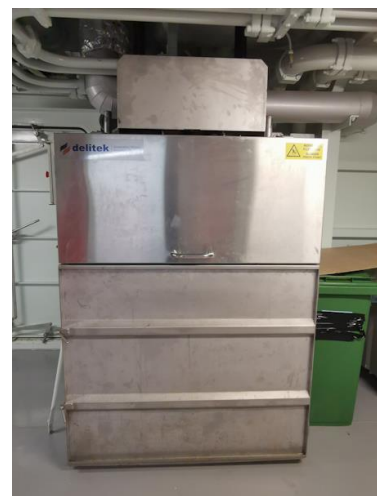
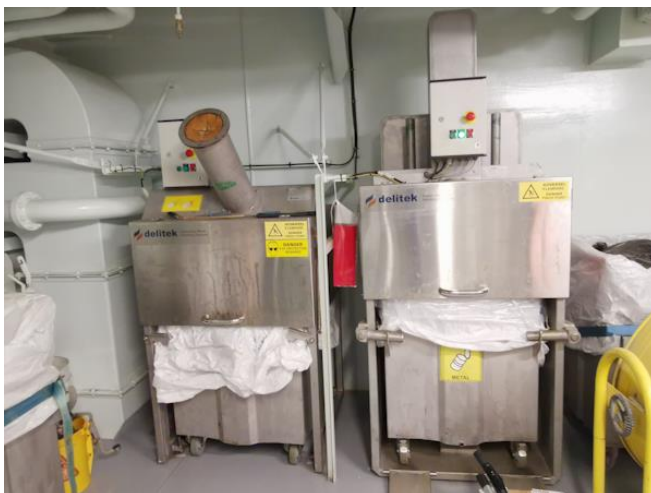
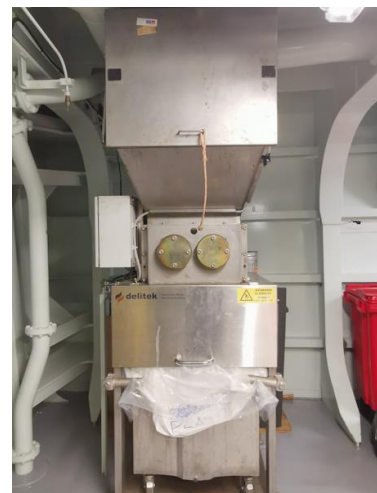
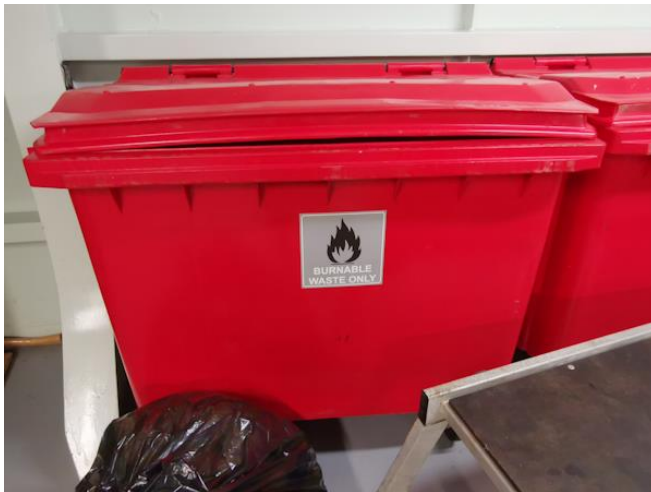
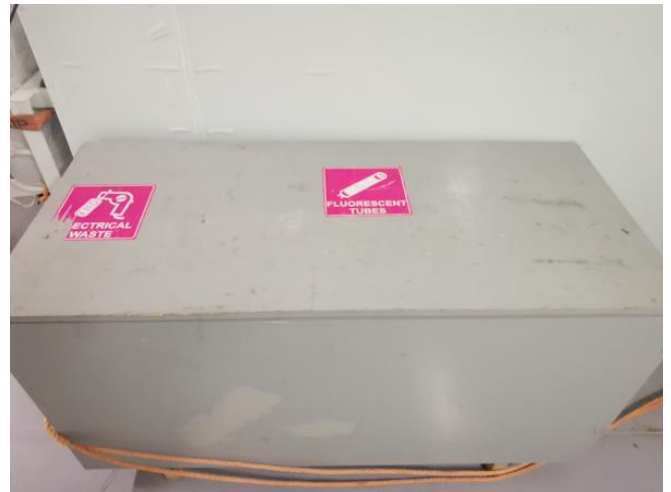
Figure 3-1 Waste Reception and Storage Facilities on
M/V Ramform Hyperion

2.1.2 Separate and store each type of waste (non-hazardous waste and hazardous waste) into appropriate containers having clear labels.	All project vessels.	✓	Waste is separated into non-hazardous (plastic, paper, metal, glass, wood, food waste, and non-recyclable) and hazardous waste (oil-contaminated waste, batteries, and infirmity waste) complying with project's waste management plan. Separated reception and storage containers with clear labels are provided for each type of waste in designated places.	-	Figure 3-1 – Waste Reception and Storage Facilities on M/V Ramform Hyperion

2.1.10 Segregate non-hazardous waste including food waste, paper, aluminium can, glass, rag and other wastes in separate containers or proper areas.	All project vessels.	✓	Non-hazardous waste is segregated into plastic, paper, metal, glass, wood, food waste, and non-recyclable complying with project's waste management plan. Separated containers are provided for each type of waste.	-	Figure 3-1 –Waste Reception and Storage Facilities on M/V Ramform Hyperion

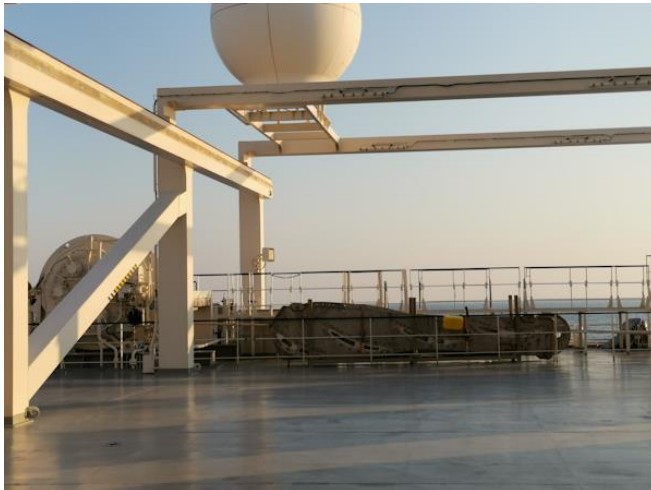
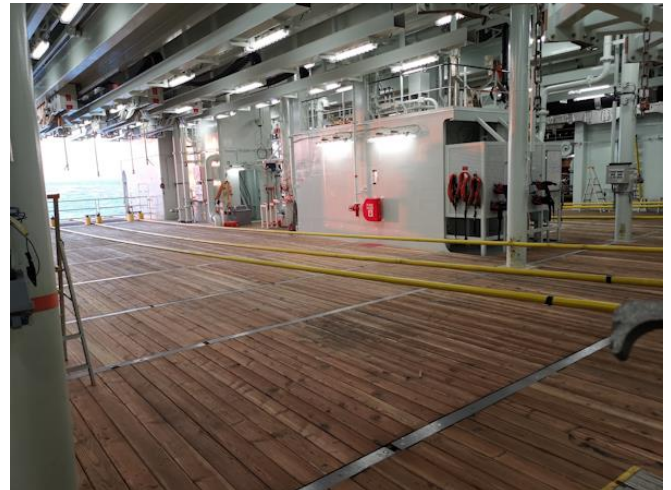
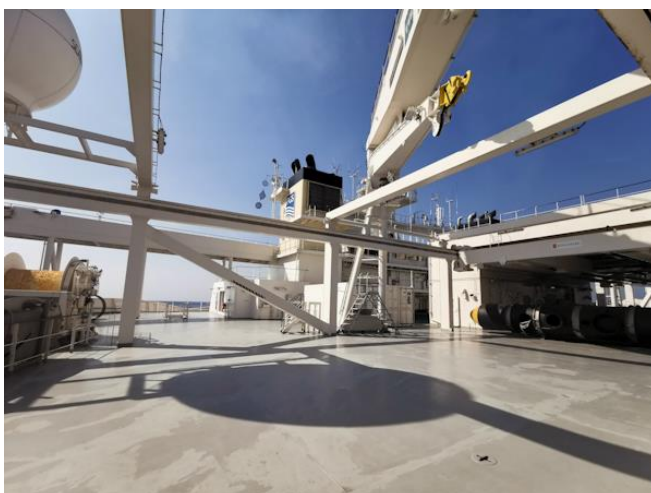
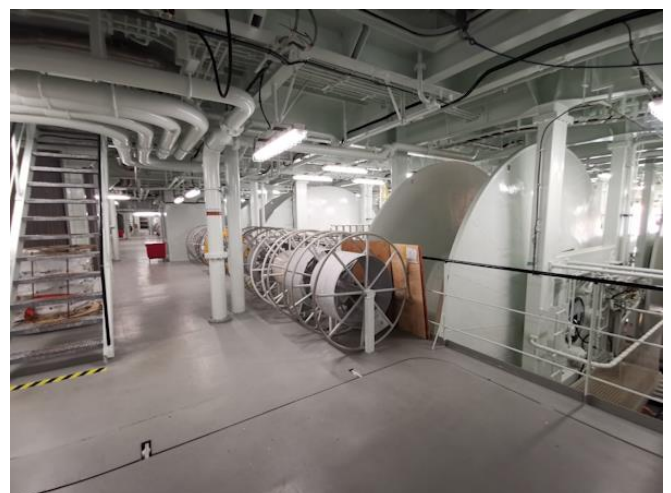
Figure 3-2 Deck Area of M/V Ramform Hyperion

2.1.6 The vessel deck shall be cleaned to minimise the impact from oil and chemical contamination into the sea during periods of rain.	All project vessels.	✓	Vessel deck and work areas are kept clean. Housekeeping conditions of the deck areas of the survey vessel are routinely inspected by the Chief Officer.	-	<p>Appendix 2-7 – Routine Housekeeping Inspection Checklist</p> <p>Figure 3-2 – Deck Area of M/V Ramform Hyperion</p>

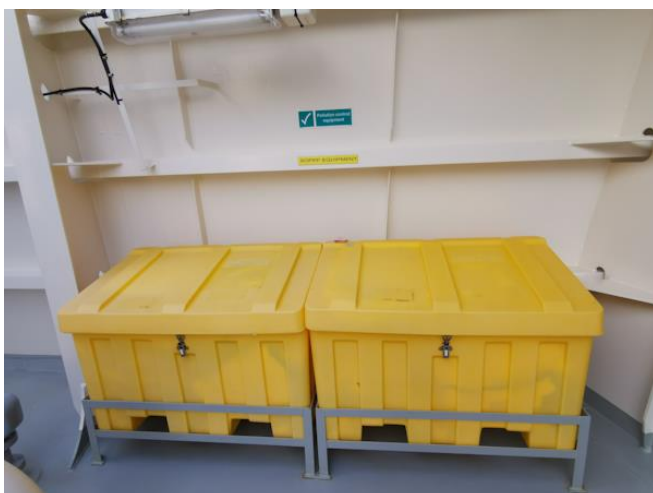
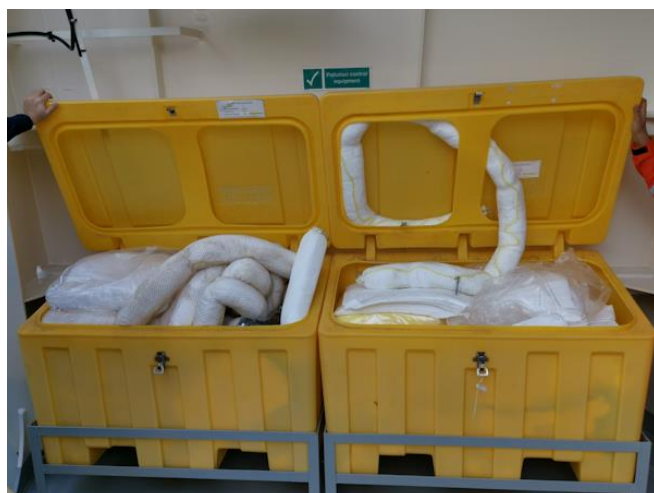
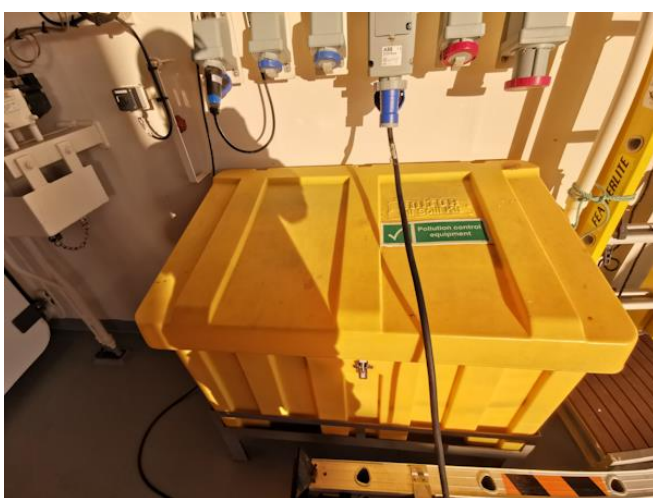
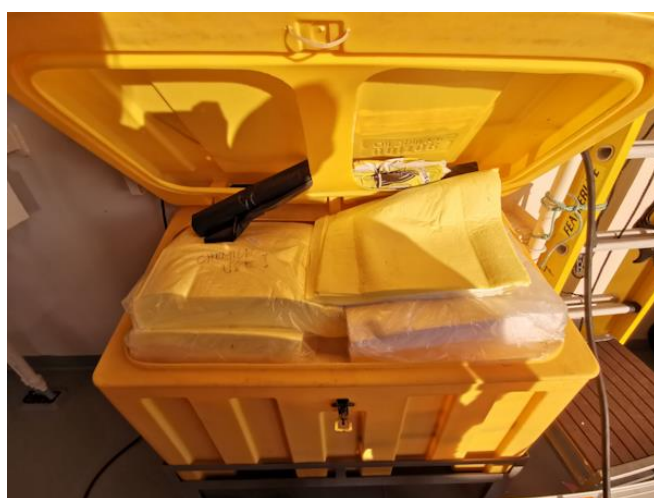
Figure 3-3 SOPEP Equipment on M/V Ramform Hyperion

Aspects	Potential Impacts	Mitigation Measure	Implementation Area	Compliance Status*	Compliance Summary	Issue/ Approach/ Corrective Action	Reference
2. Seawater Quality (cont.)	2.1 Impact on seawater quality due to improper management of non-hazardous and hazardous waste (cont.)	2.1.7 Oil absorbents are required in the case of a small spill and the used absorbent shall be stored in containers onboard and disposed of onshore.	All project vessels.	✓	Absorbents are provided according to Shipboard Oil Pollution Emergency Plan (SOPEP). The Chief Officer maintains inventory and conduct monthly inspection of SOPEP equipment. SOPEP equipment are provided at SOPEP station and areas where there are risk of oil and chemical spills. Used absorbents are collected in oil-contaminated waste container for onshore disposal.	-	Appendix 2-3 – PTTEPI Relevant Plans and Procedures Appendix 2-8 – SOPEP Equipment Inventory Figure 3-3 – SOPEP Equipment on M/V Ramform Hyperion

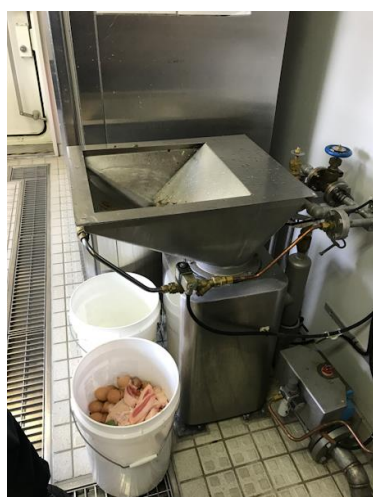
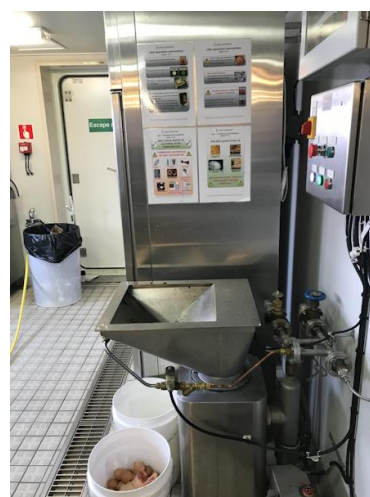
Figure 3-4 Food Grinder on M/V Ramform Hyperion

Aspects	Potential Impacts	Mitigation Measure	Implementation Area	Compliance Status*	Compliance Summary	Issue/ Approach/ Corrective Action	Reference
2. Seawater Quality (cont.)	2.1 Impact on seawater quality due to improper management of non-hazardous and hazardous waste (cont.)	2.1.11 Grind food waste to a size less than 25 mm before discharge into the sea at a distance of 12 nautical miles from shore, in a location that is not located in coral reef area, according to the requirements under MARPOL 73/78.	All project vessels.	✓	Food waste are managed according to MARPOL 73/78 Annex V requirement. Discharge of food waste is recorded in Garbage Record Book consistent with MARPOL Annex V requirements and in garbage record according to the PGS waste management system.	-	Appendix 2-5 – Waste Management Procedure and Garbage Record Book Figure 3-4 – Food Grinder on M/V Ramform Hyperion

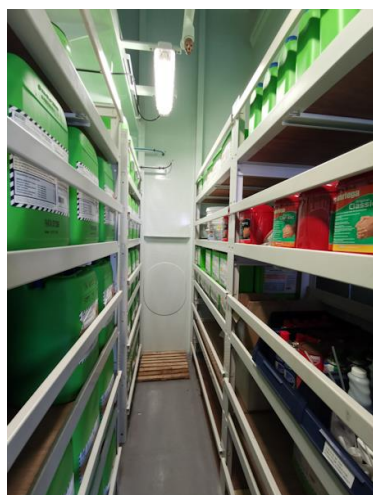
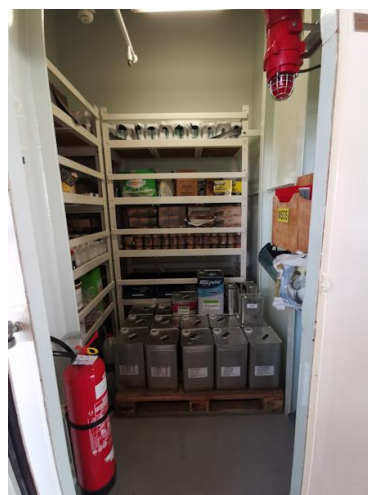
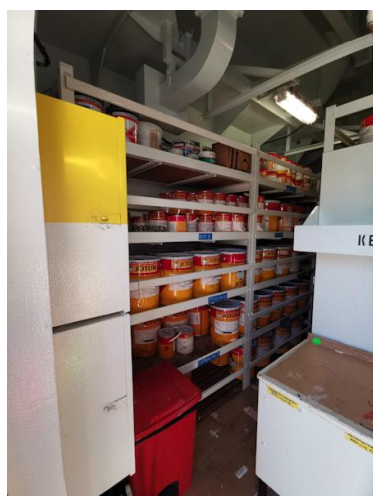
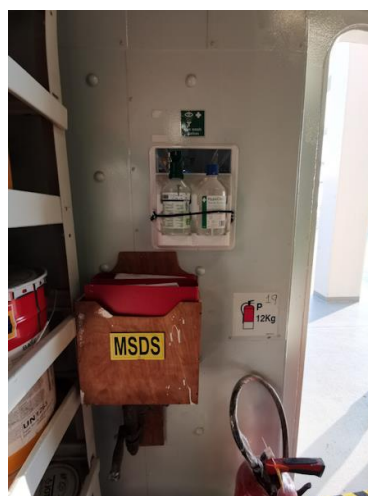
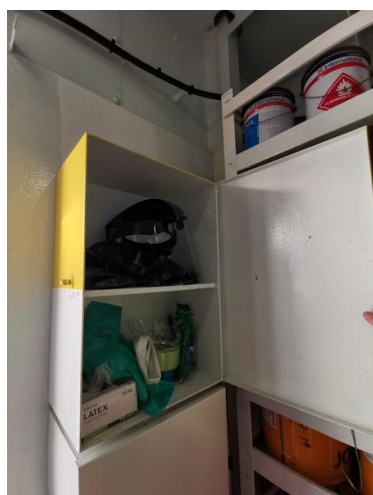
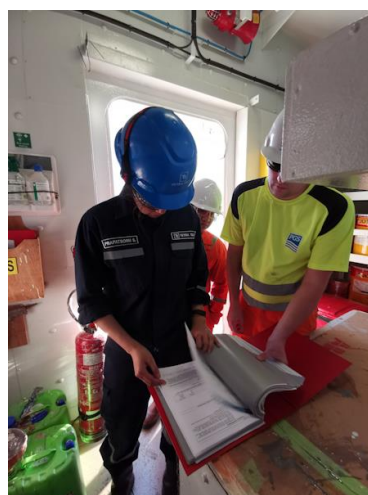
Figure 3-8 Chemical and Paint Storage Areas and Associated PPEs and SDS Files

Aspects	Potential Impacts	Mitigation Measure	Implementation Area	Compliance Status*	Compliance Summary	Issue/ Approach/ Corrective Action	Reference
7. Occupational Health and Safety of the Project Employees (cont.)	7.1 Potential impacts on health and safety of employees on the seismic vessel from potential exposure of workers to unsafe noise levels during survey operation, accidents during operation and improper sanitary system (cont.)	7.1.5 Implement steps of operation for occupational, health, and safety; and the protection and controlling of accidents: <ul style="list-style-type: none"> • Safety method for working with machines/equipment • Procedure for safety operation • Procedure for work permission • Provide SDS for all chemicals • Regulations for fuel storage and waste management • Compliance monitoring system and manifest system for hazardous wastes 	All project vessels.	✓	<p>PTTEPI and the seismic survey contractor (PGS) prepared a Project Plan and Bridging Document that align the project operation procedures to ensure that the Project's operations comply with PTTEPI's SSHE Management System including use of PPEs, Emergency and Crisis Management Plan, and Tropical Revolving Storm Procedure.</p> <p>PGS implements Occupational Health Manual and Risk Management Procedure which outlines safety methods and operations. Risk assessment is conducted prior to commencement of the Project. Work Permit and Job Safety Assessment (JSA) is implemented.</p> <p>Chemical inventory is maintained by Safety Officer. PPEs and SDSs are available and provided at the paint and chemical storage areas.</p> <p>Chief Officer maintains logs of waste onboard in Garbage Record Book consistent with MARPOL Annex V requirements and in garbage record according to the PGS waste management system.</p>	-	<p>Appendix 2-3 – PTTEPI Relevant Plans and Procedures</p> <p>Appendix 2-5 – Waste Management Procedure and Garbage Record Book</p> <p>Appendix 2-16 – Occupational Health Management and Example of JSA and Work Permit</p> <p>Appendix 2-19 – Chemical Management and Training Materials</p> <p>Figure 3-8 Chemical and Paint Storage Areas and Associated PPEs and SDS Files</p>
