PTTEP International Limited (Yangon Branch)

Monitoring Report

3D Seismic Survey in Block M9, Offshore Myanmar

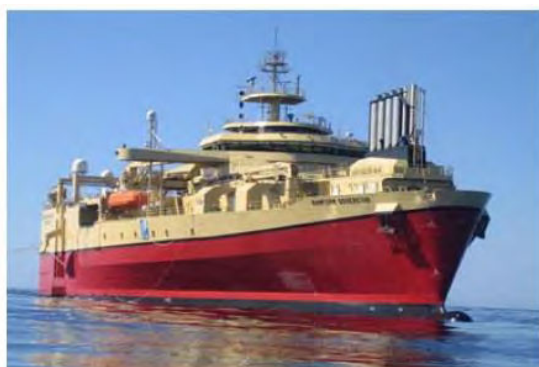
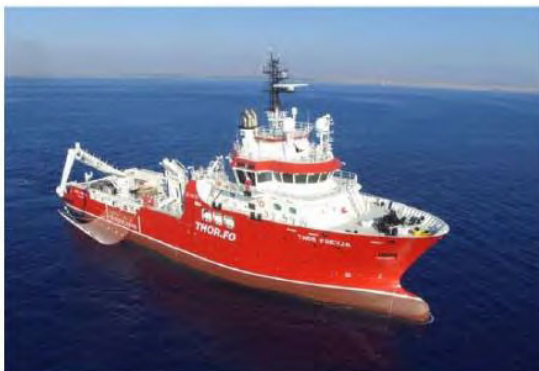
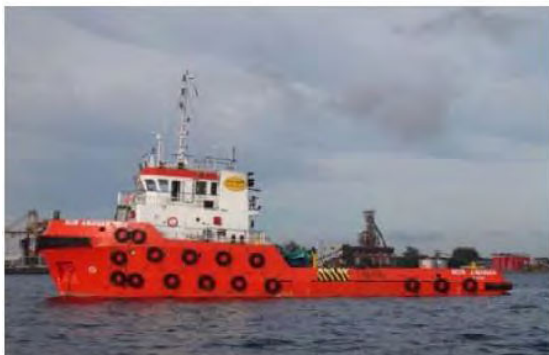
Figure 1-2 Brief Technical Details of Vessels in the Project

| Vessel | Ramform Sovereign |

| Vessel | Thor Freyja |

| Vessel | Nur Amanah |

are *M/V Thor Freyja*, *M/V Ultra Jaya*, *M/V Nur Amanah*, and *M/V Winjaya*. Details of each vessel are shown in Figure 1-2.

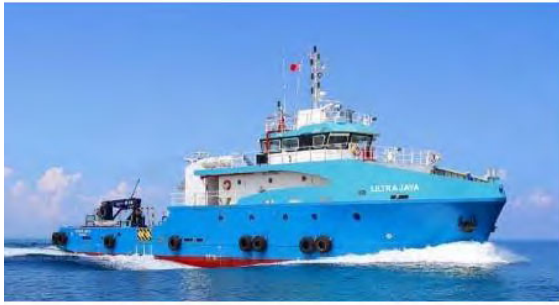
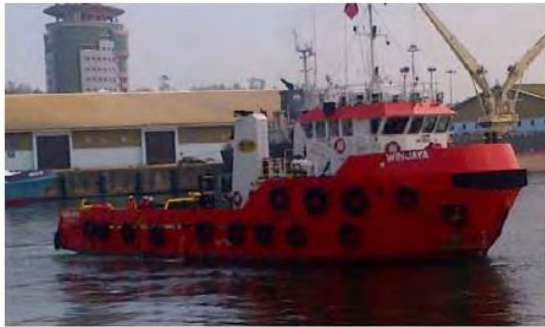
Figure 1-2 Brief Technical Details of Vessels in the Project (Cont.)

| Vessel | Ultra Jaya |

| Vessel | Winjaya |

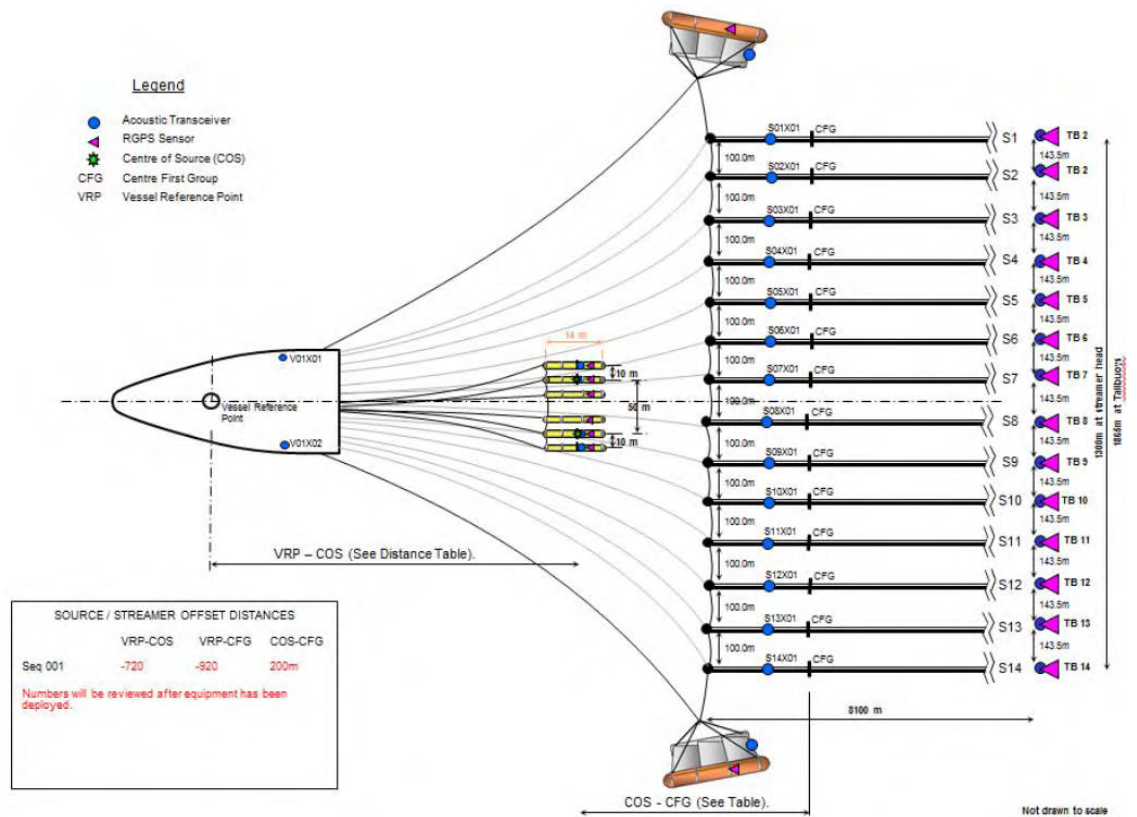
Figure 1-3 Towing Configuration

The survey was three-dimensional (3D) seismic survey. The seismic data acquisition was done by 14 streamers and dual seismic sources. Each streamer was 8,100 m long and approximately 100 m apart. The total width of the tow was approximately 1,300 m at the beginning of the streamers and over 1,800 m at the end of the streamers (Figure 1-3). Sail lines were in north-south direction spreading throughout the area.

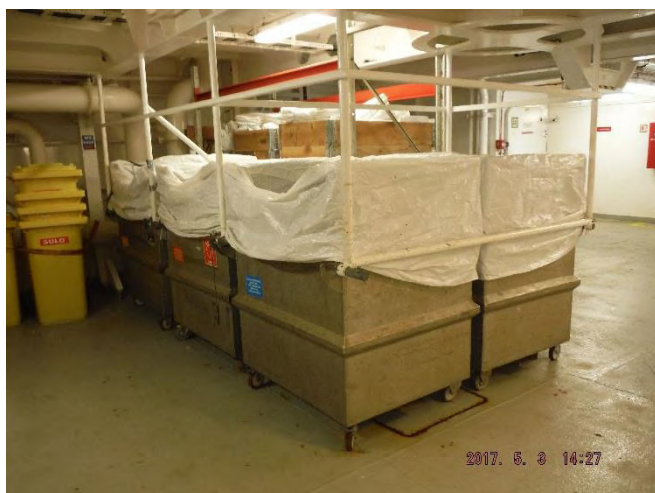
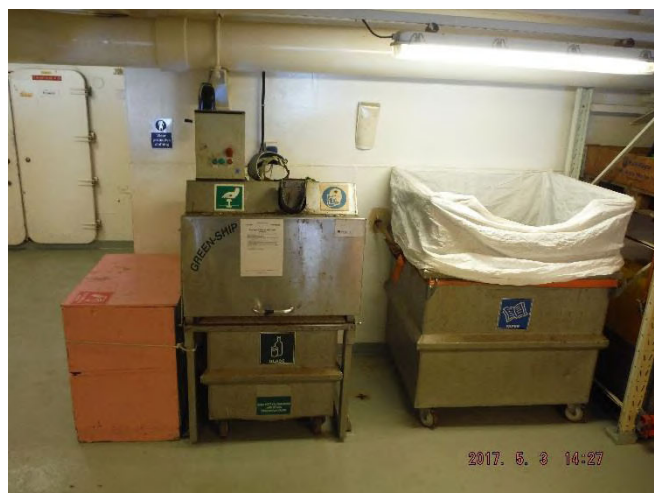
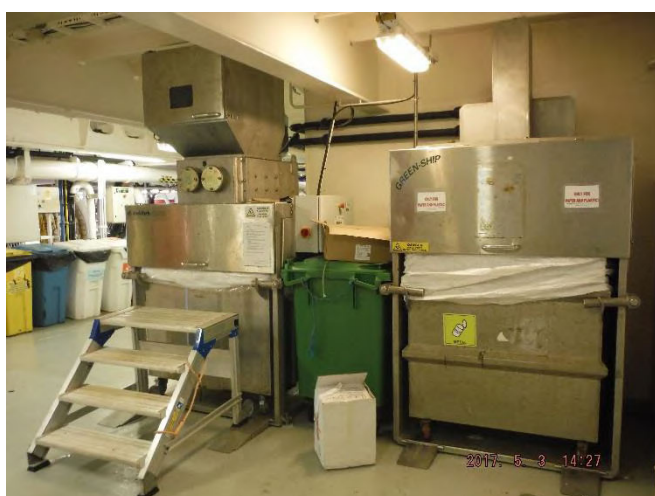
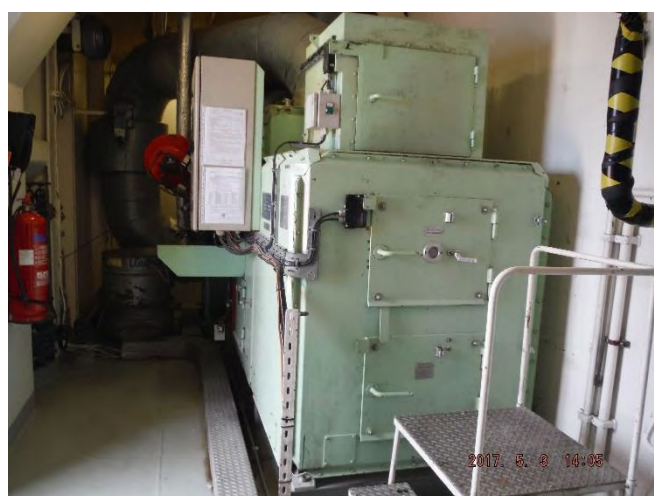
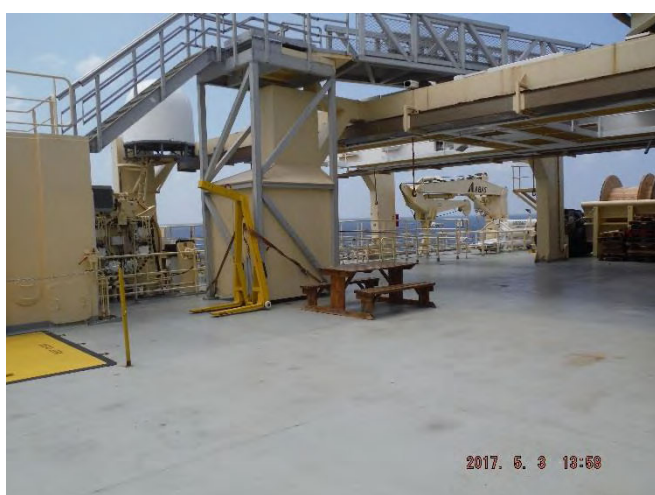
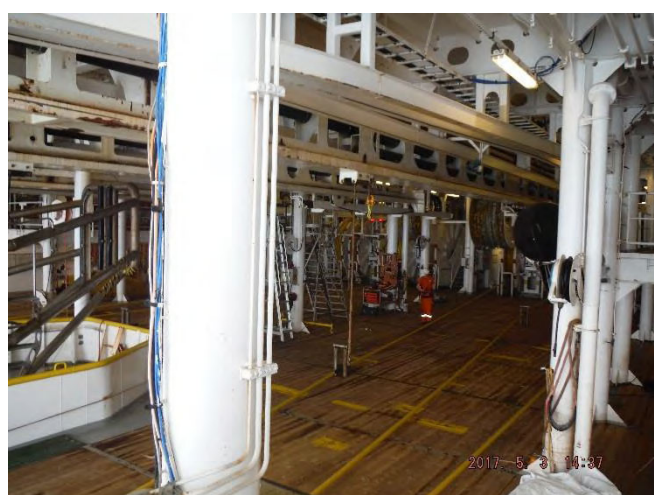
Figure 2-2 Waste Management Plan and Waste Reception and Storage Facilities on M/V Ramform Sovereign

| Aspects | Potential Impacts | Mitigation Measure | Implementation Area | Compliance Status* | Compliance Summary | Issue/ Approach/ Corrective Action | Reference |
|---|--|--|---|---|---|---|--|
| | | 2.1.2 Separate and store each type of waste (non-hazardous waste and hazardous waste) into appropriate containers having clear labels. | All project vessels. | ✓ | Waste is separated into non-hazardous (plastic, paper, metal, glass, wood, food waste, and non-recyclable) and hazardous waste (oil-contaminated waste, batteries, and infirmity waste) complying with project's waste management plan. Separated reception and storage containers with clear labels are provided for each type of waste in designated places. | - | Figure 2-2 – Waste Management Plan and Waste Reception and Storage Facilities on M/V Ramform Sovereign |

| Aspects | Potential Impacts | Mitigation Measure | Implementation Area | Compliance Status* | Compliance Summary | Issue/ Approach/ Corrective Action | Reference |
|---|--|--|---|---|--|---|---|
| 2. Seawater Quality (cont.) | 2.1 Impact on seawater quality due to improper management of non-hazardous and hazardous waste (cont.) | 2.1.3 Store hazardous waste in sealed container and keep such container away from sparkling area until disposal/treatment. The container shall be durable, safe and proper for transporting, transferring, treatment and disposal. | All project vessels. | ✓ | Separated reception and storage containers with clear labels are provided hazardous waste in designated places. Disposal of hazardous waste at sea is prohibited according to project's waste management plan and MARPOL 73/78 Annex V. Hazardous waste is stored in durable sags in enclosed garbage rooms and under helideck protected from weather. | - | Figure 2-2 – Waste Management Plan and Waste Reception and Storage Facilities on M/V Ramform Sovereign |

| Aspects | Potential Impacts | Mitigation Measure | Implementation Area | Compliance Status* | Compliance Summary | Issue/ Approach/ Corrective Action | Reference |
|---|--|--|---|---|--|--|---|
| | | 2.1.10 Segregate non-hazardous waste including food waste, paper, aluminium can, glass, rag and other wastes in separate containers or proper areas. | All project vessels. | ✓ | Non-hazardous waste is segregated into plastic, paper, metal, glass, wood, food waste, and non-recyclable complying with project's waste management plan. Separated containers are provided for each type of waste. | - | Figure 2-2 – Waste Management Plan and Waste Reception and Storage Facilities on M/V Ramform Sovereign |

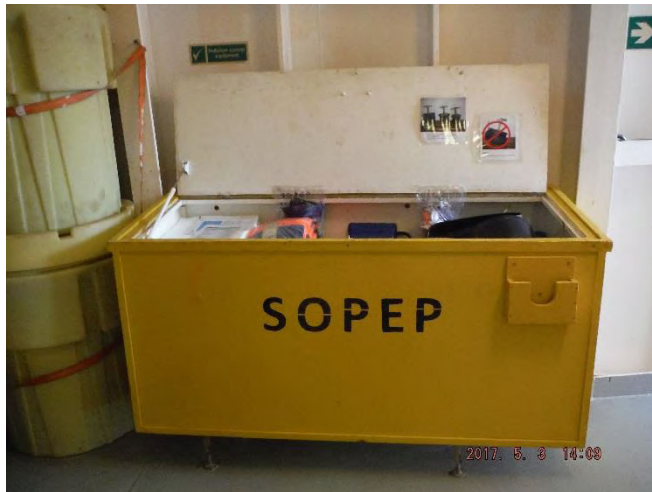
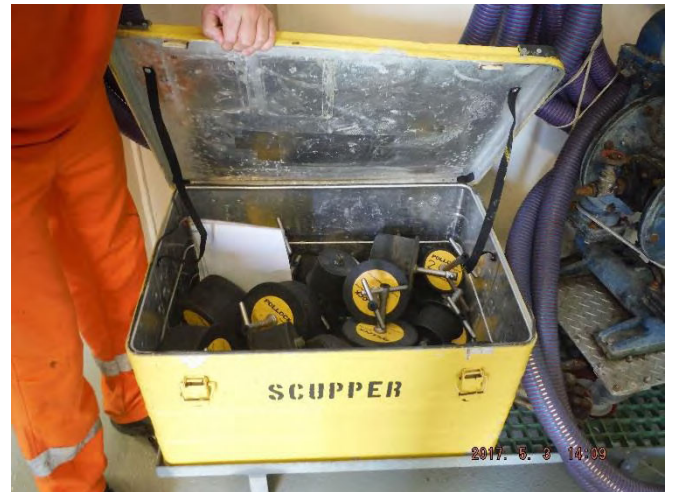
Figure 2-3 Deck Area of M/V Ramform Sovereign

| Aspects | Potential Impacts | Mitigation Measure | Implementation Area | Compliance Status* | Compliance Summary | Issue/ Approach/ Corrective Action | Reference |
|---|--|--|---|---|---|--|--|
| | | 2.1.6 The vessel deck shall be cleaned to minimise the impact from oil and chemical contamination into the sea during periods of rain. | All project vessels. | ✓ | Vessel deck and work areas are kept clean. Housekeeping conditions of the deck areas of the survey vessel are routinely inspected by the Chief Officer. | - | <p>Appendix 2-5 – Routine Housekeeping Inspection Checklist</p> <p>Figure 2-3 – Deck Area of M/V Ramform Sovereign</p> |

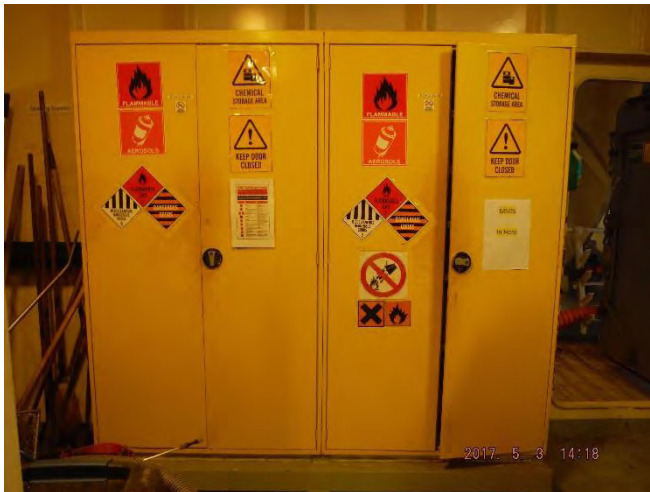
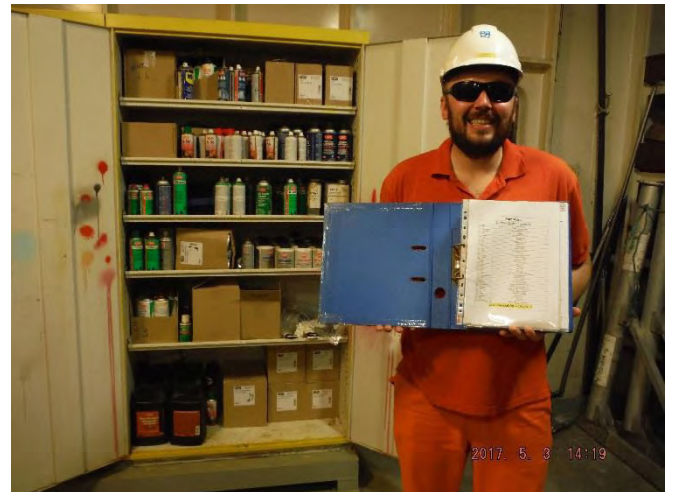
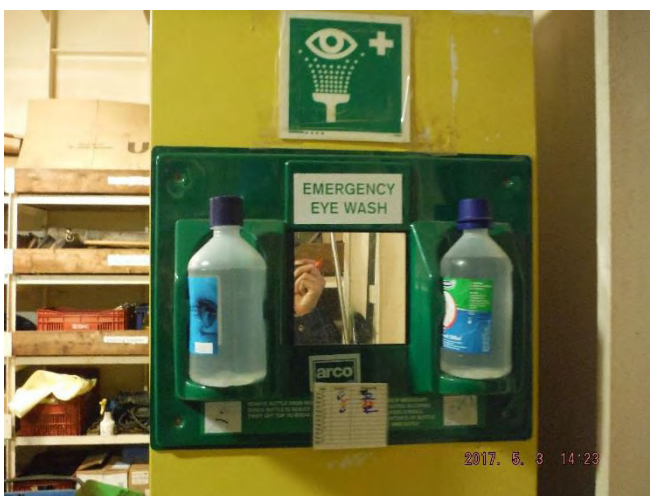
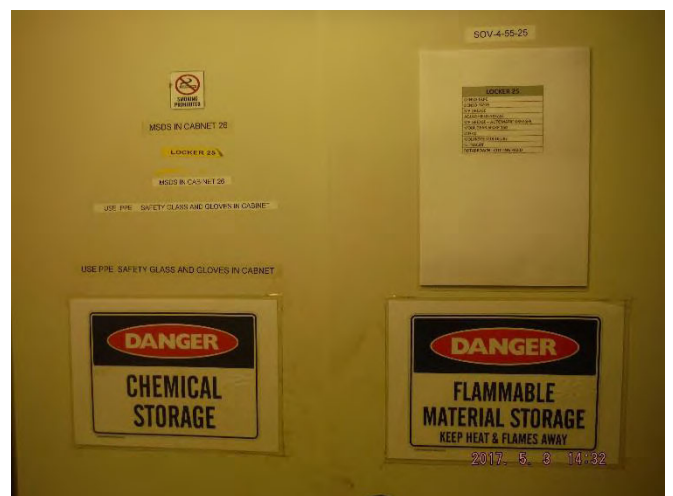
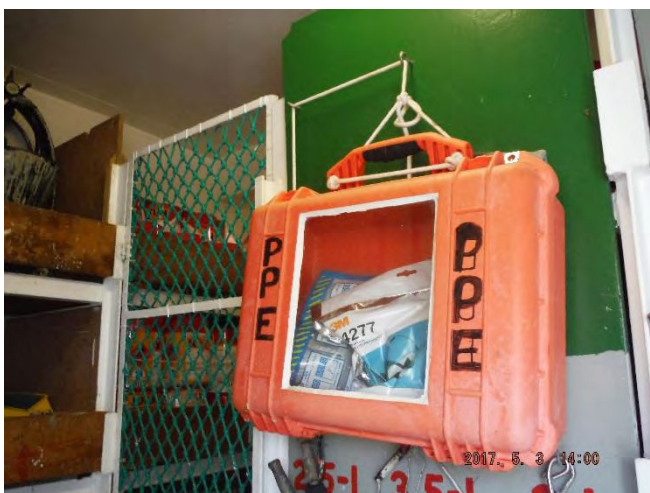
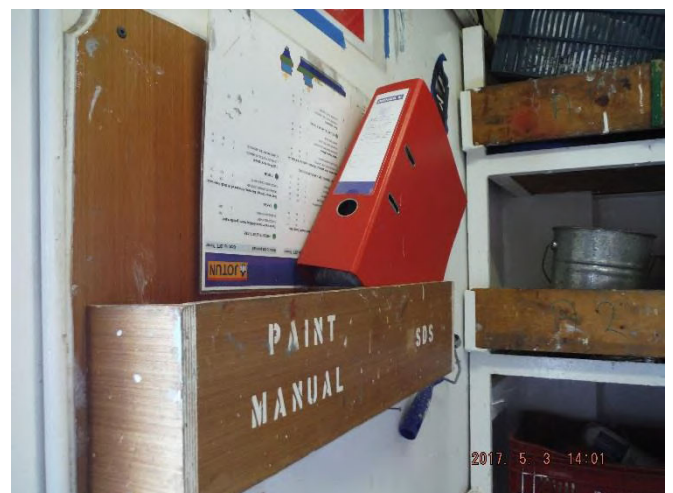
Figure 2-7 Chemical and Paint Storage Areas and Associated PPEs and SDS Files

| Aspects | Potential Impacts | Mitigation Measure | Implementation Area | Compliance Status* | Compliance Summary | Issue/ Approach/ Corrective Action | Reference |
|---|--|--|---|---|---|---|--|
| 7. Occupational Health and Safety of the Project Employees (cont.) | 7.1 Potential impacts on health and safety of employees on the seismic vessel from potential exposure of workers to unsafe noise levels during survey operation, accidents during operation and improper sanitary system (cont.) | 7.1.5 Implement steps of operation for occupational, health, and safety; and the protection and controlling of accidents: <ul style="list-style-type: none"> • Safety method for working with machines/equipment • Procedure for safety operation • Procedure for work permission • Provide SDS for all chemicals • Regulations for fuel storage and waste management • Compliance monitoring system and manifest system for hazardous wastes | All project vessels. | ✓ | <p>PTTEPI and the seismic survey contractor (PGS) prepared a Project Plan and Bridging Document that align the project operation procedures to ensure that the Project's operations comply with PTTEPI's SSHE Management System including use of PPEs, Emergency and Crisis Management Plan, and Tropical Revolving Storm Procedure.</p> <p>PGS implements Occupational Health Manual and Risk Management Procedure which outlines safety methods and operations. Risk assessment is conducted prior to commencement of the Project. Work Permit and Job Safety Assessment (JSA) is implemented.</p> <p>Chemical inventory is maintained by Safety Officer. PPEs and SDSs are available and provided at the paint and chemical storage areas.</p> <p>Chief Officer maintains logs of waste onboard in Garbage Record Book consistent with MARPOL Annex V requirements and in garbage record according to the PGS waste management system.</p> | - | <p>Appendix 2-2 – PTTEPI Relevant Plans and Procedures</p> <p>Appendix 2-7 – Garbage Record Book and Garbage Log</p> <p>Appendix 2-17 – Occupational Health Management</p> <p>Appendix 2-18 – Chemical Management and Training Materials</p> <p>Figure 2-7 Chemical and Paint Storage Areas and Associated PPEs and SDS Files</p> |
