**Monitoring Report of Myanmar Onshore Block MOGE-3  
Exploration Drilling Campaign  
(Drilling Phase of Monatkan Well Site) during January-June 2019**

**PTTEP South Asia Limited (PTTEP SA)**

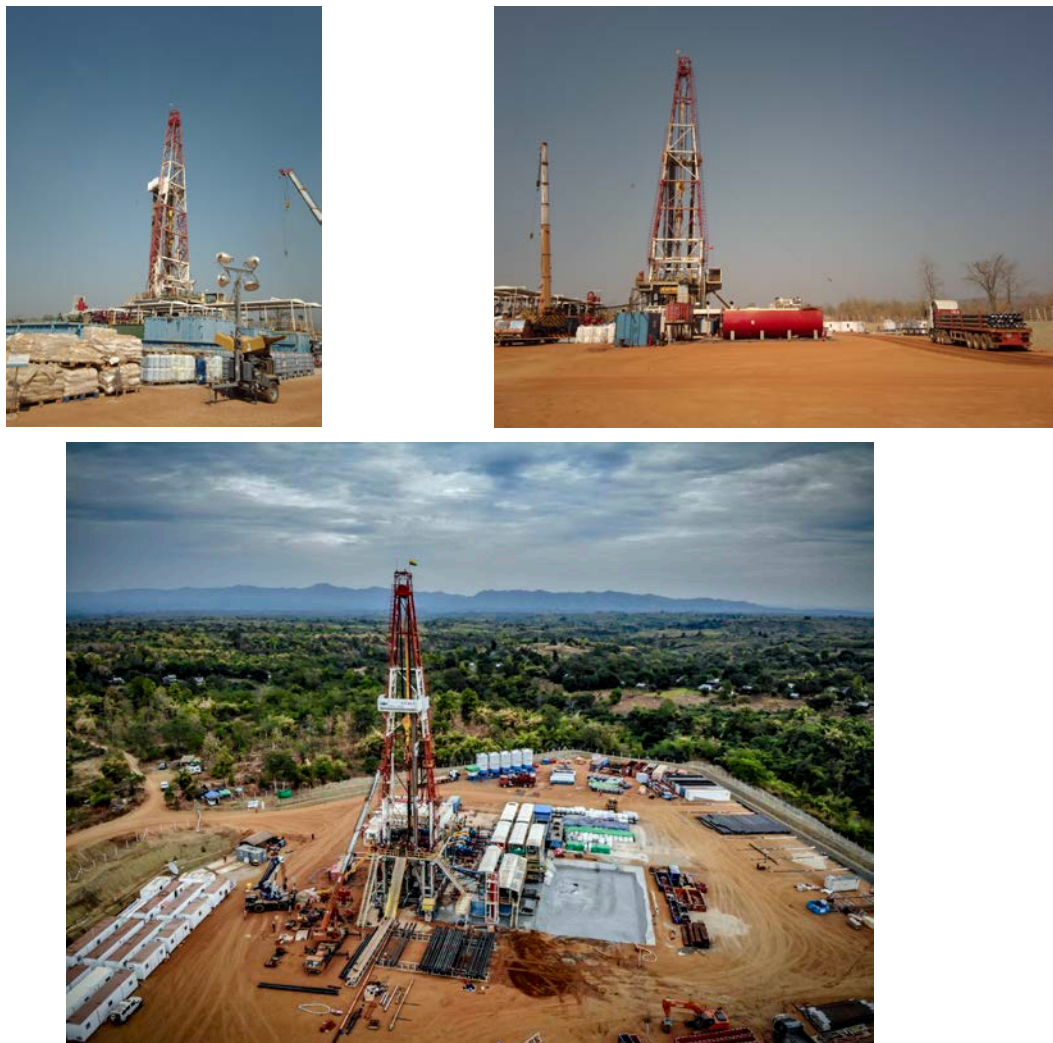
**Figure 1-2 Moenatkone (MNK) Wellsite in Drilling Phase**

The example for current condition of Moenatkone wellsite as shown in Figure 1-2.

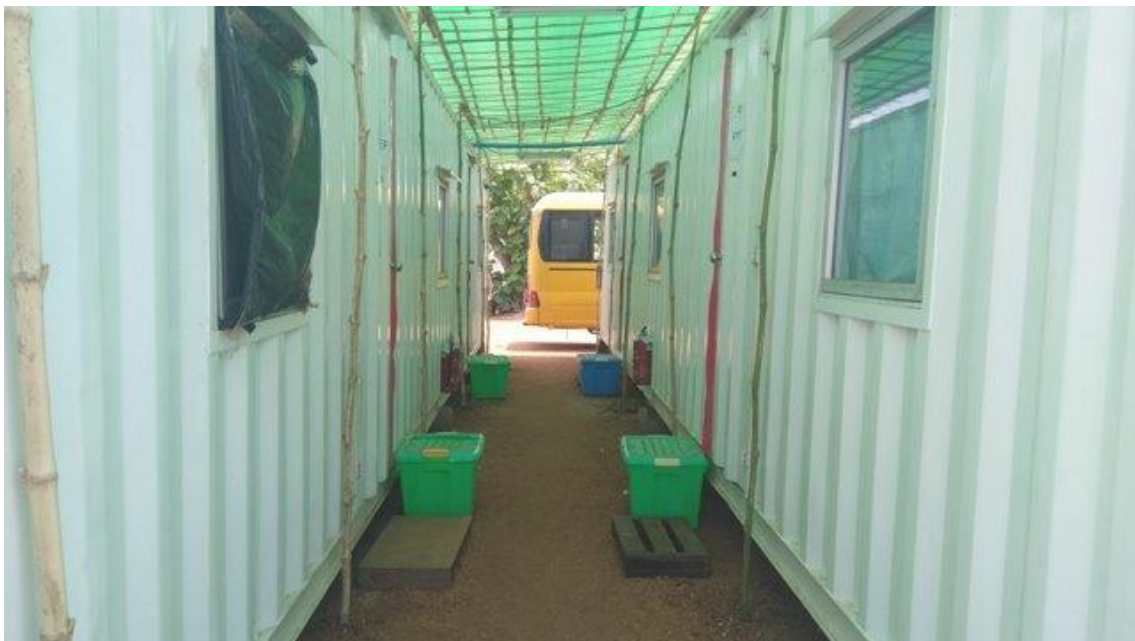
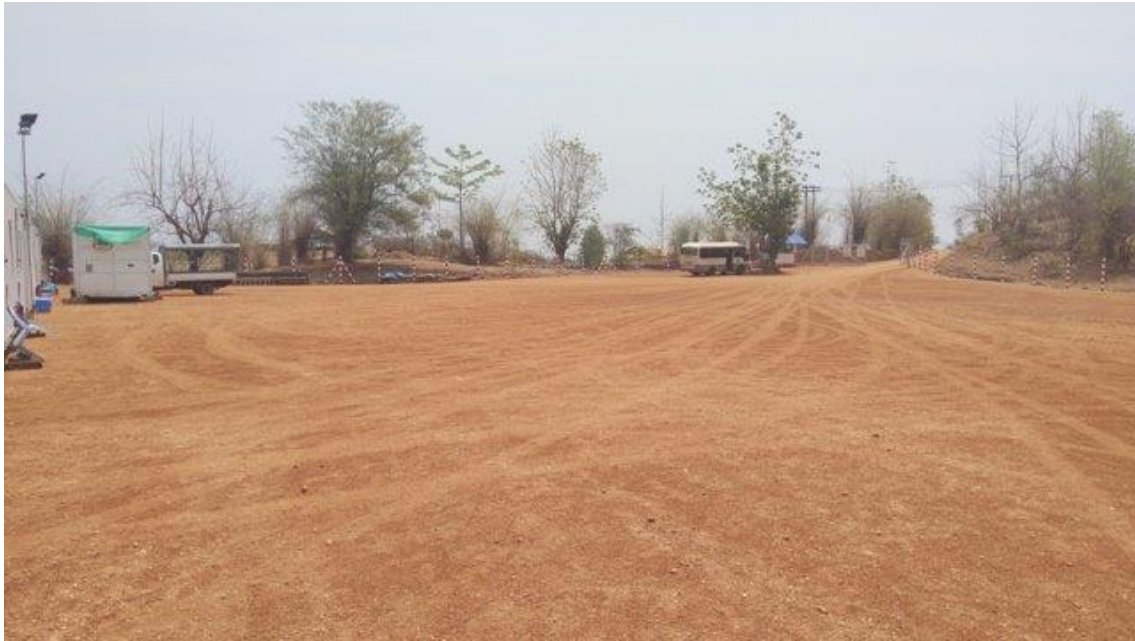
**Figure 1-7 Central Campsite for drilling phase**

Currently, Central Campsite for drilling phase as shown in Figure 1-7.

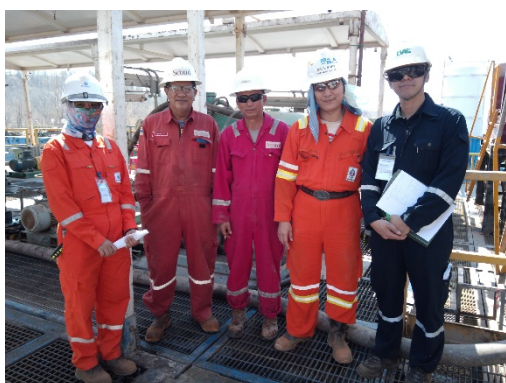
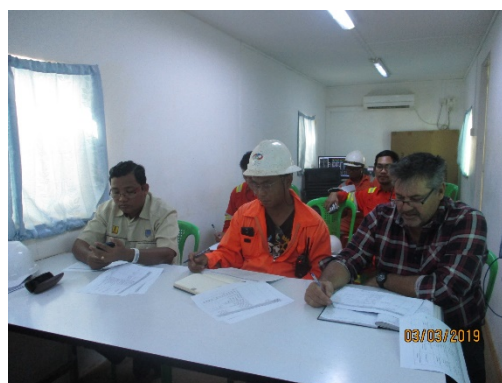
**Figure 2-1 Mitigation Measures Compliance Audit in March 3, 2019**

Audit was performed at Moenatkone, on March 3, 2019 during drilling phase (Figure 2-1) and document checking by setting 4 levels of evaluation as follows;

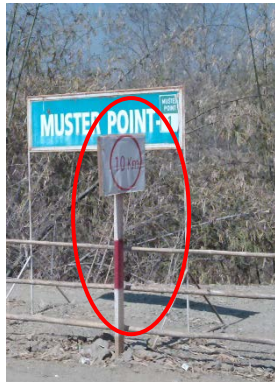
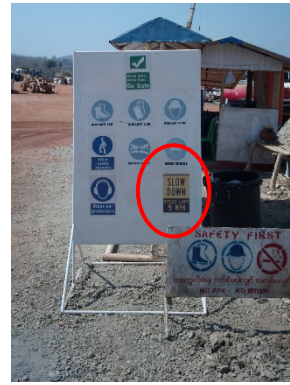
Figure 2-2 Speed limit sign

Access road

Project area

8.1.1.2 Strictly follow speed limits	✓	PTTEP SA prepared safety land transport procedure and enjoined the contractor to follow regulation of speed limitation 5 km/hr within wellsite and 10 km/hr along the access road. The speed limitation signs have provided along access road. Furthermore, speed limitation was communicated to all worker in daily tool box talk before working by the header of contractor/safety officer.	Figure 2-2 Figure 2-3 and Appendix D-1

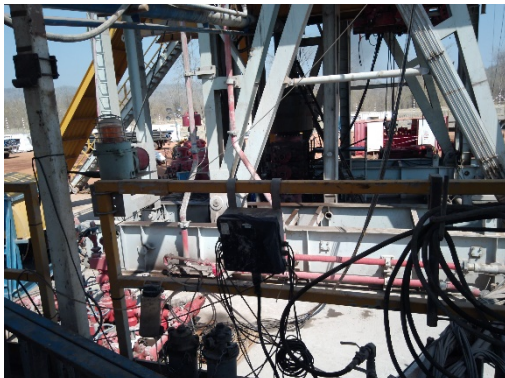
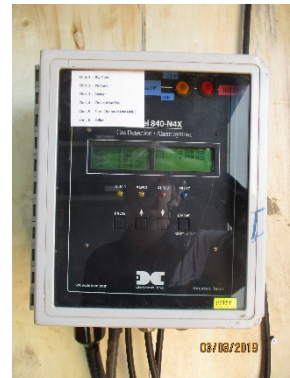
Figure 2-7 H<sub>2</sub>S Alarm System

H<sub>2</sub>S Alarm and H<sub>2</sub>S Sensor

H<sub>2</sub>S Monitor

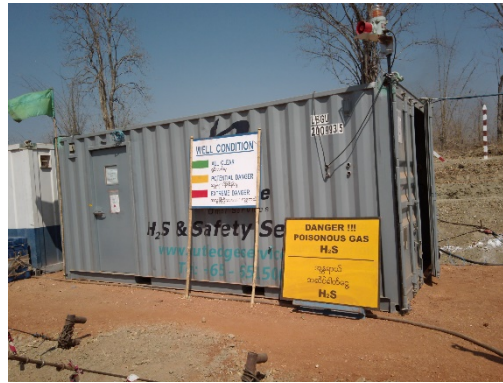
**Figure 2-7 (Cont.) H<sub>2</sub>S Alarm System**

**H<sub>2</sub>S Station**

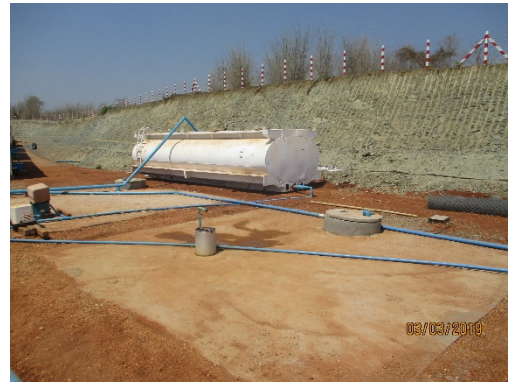
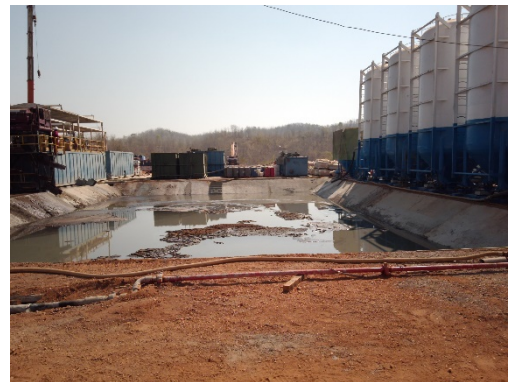
**Figure 2-15 Cutting pit and Mud pit**

**Cutting pit**

**Mud pit**

Drilled Cutting was temporary stored in cutting pit with HDPE liner in order to prevent contamination to groundwater before bioremediation onsite or sent for disposal at approved waste management facility after the rig move out from location. When drilling activity complete, the project will dispose of waste kept in waste pit by approved waste management facility. The project has prepared on health screening to all workers before employment. Emergency respond procedure, ambulance, medical personnel and training were provided in case of emergency. Moreover, the contractor cooperated with nearby hospital to support if need for serious injuries or emergencies case. The contractor hired qualified local workers, according to the job description. PTTEP SA has provided training program to contractors on regulation and prohibition including control the performed as defined requirements.

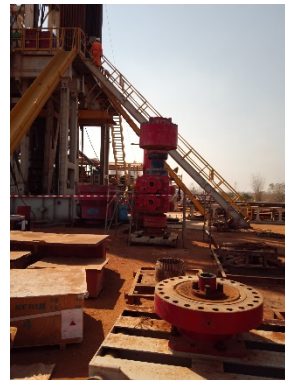
**Figure 2-30 BOP (Blow Out Preventer)**

A complex series of valves, known as the “blowout preventer” (BOP), is attached to the top of the conductor below the derrick floor. All further casing strings are also attached into this blowout preventer. These are powerful hydraulically-activated valves and rams that can be closed around the drill pipe to isolate the well bore should unexpectedly high formation pressure be encountered. If formation pressure exceeds the hydrostatic head of the drilling mud, it may cause the well to flow strongly, referred to as a “kick”. A kick can also occur if a highly permeable formation, such as a naturally fractured limestone, is encountered and a large volume of mud is suddenly lost into the formation. The blowout preventer is the primary safety mechanism for well control. The series of valves act independently and when closed in an emergency form a series of increasingly secure barriers that isolate the well so that a plan of action can be developed to bring it back under control.

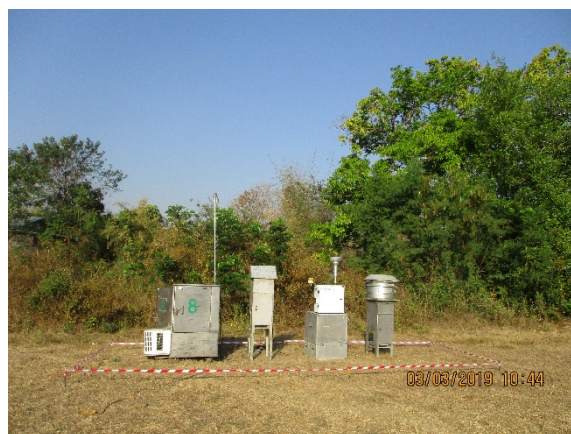
**Figure 3-2 Air Quality Monitoring in drilling phase phase of Moenatkone (MNK) well site**

Air quality monitoring during January – June 2019, in drilling phase phase of Moenatkone (MNK) well site was conducted during March 3-4, 2019 as shown in Figure 3-2.

**Moenatkone station (A2)**

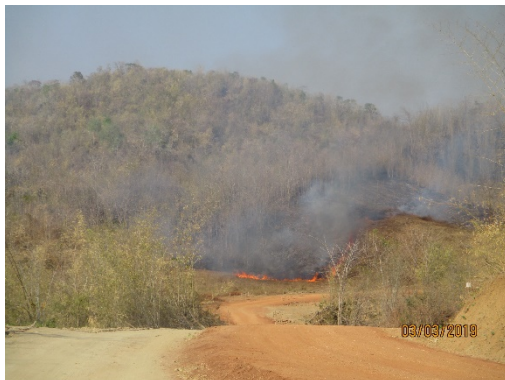
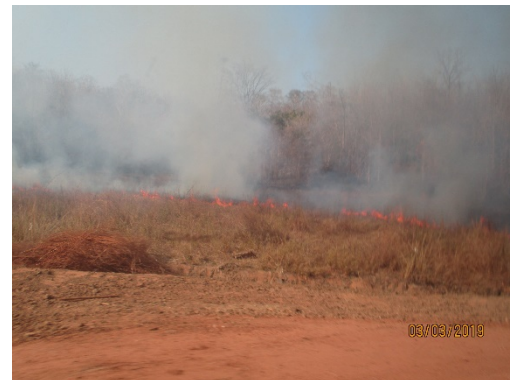
**Figure 3-4 Wildfire around project area during air quality monitoring.**

Accordingly, the results of average 24 hours  $\text{PM}_{10}$ , average 24 hours  $\text{PM}_{2.5}$  and average 8 hrs Ozone ( $\text{O}_3$ ) which not complied with the standards may be the result from wildfire around project area during monitoring period. The nearest wildfire was occurred approximately 500 meters from Moenatkone main gate in the same day of air quality monitoring. Wildfire around project area as shown in Figure 3-4 and Filter of air quality monitoring as shown in Figure 3-5.

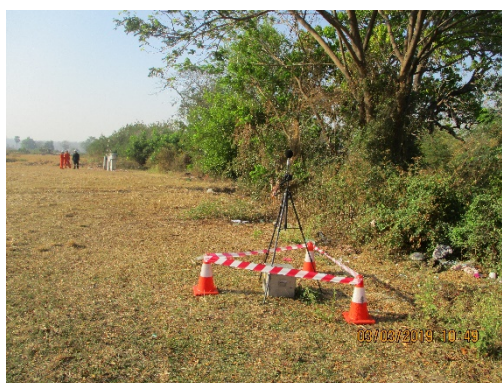
**Figure 3-7 Noise Level Monitoring in drilling phase of Moenatkone well site**

Noise level was conducted for drilling phase of Moenatkone (MNK) wellsite during March 3-4, 2019 by REM-UAE Laboratory and Consultant Company Limited at 1 station; Moenatkone station (N2). The result 2019 found that  $L_{Aeq\ 24\ hours}$ ,  $L_{Amax}$  and  $L_{Adn}$  were 52.5 dB(A), 52.8-87.8 dB(A) and 58.4 dB(A), respectively. The Myanmar National Environmental Quality (Emission) Guidelines (2015) and WHO guideline for community noise (1999) were not specify the standard for  $L_{Aeq\ 24\ hours}$ ,  $L_{Amax}$  and  $L_{Adn}$ .

Noise level monitoring in drilling phase of Moenatkone well site during January – June 2019 was conducted during March 3-4, 2019 as shown in Figure 3-7.

**Moenatkone station (N2)**

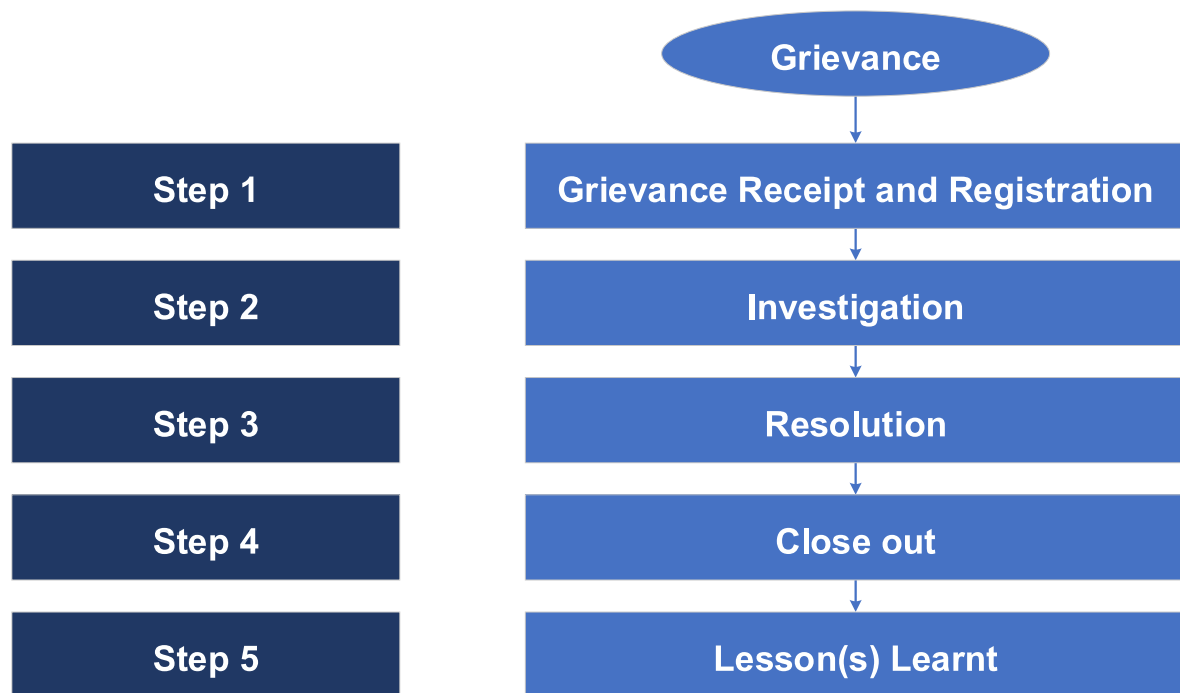
Figure 3-8 Grievance Handling Process

Social monitoring is the investigation of complaints from the community. PTTEP SA provided grievance handling guideline to receive any complaints from the stakeholder and resolve the complaint in the immediate (Appendix F-1). If any damage occurs, PTTEP SA will be responsible to solve and track them. In addition, problem's cause will be analyzed to prevent same problem occurring again. The Grievance Handling Process of PTTEP SA as shown in Figure 3-8.
