**Monitoring Report of PTTEPI's Yangon Office Building  
(Construction Phase) during January - June 2019**

**PTTEP International Limited (PTTEPI)**

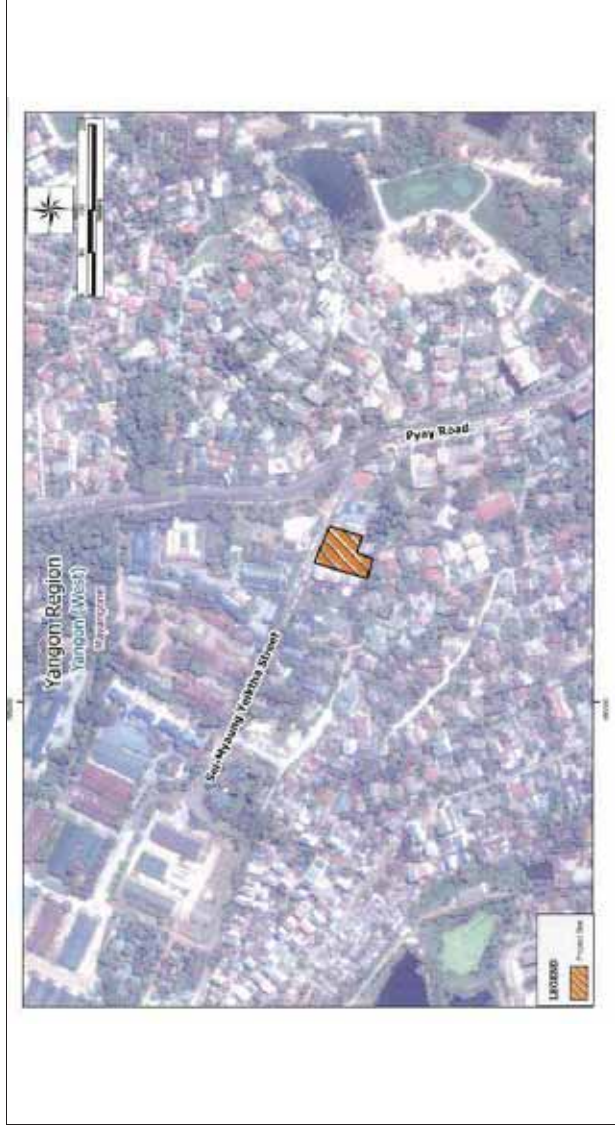
**Figure 1-1 Project Location**

The PTTEPI's Yangon Office Building will replace the existing building of PTTEP International Limited (Yangon Branch) which is located at No. 2, Sei-Myaung Yeiktha Street, 8 ½ Mile, Mayangone Township, Yangon. The project site is located on the south of the Sei-Myaung Yeiktha Street and the west of the Pyay Road, Mayangon Township, Yangon. An Aerial view of project location is presented in Figure 1-1.

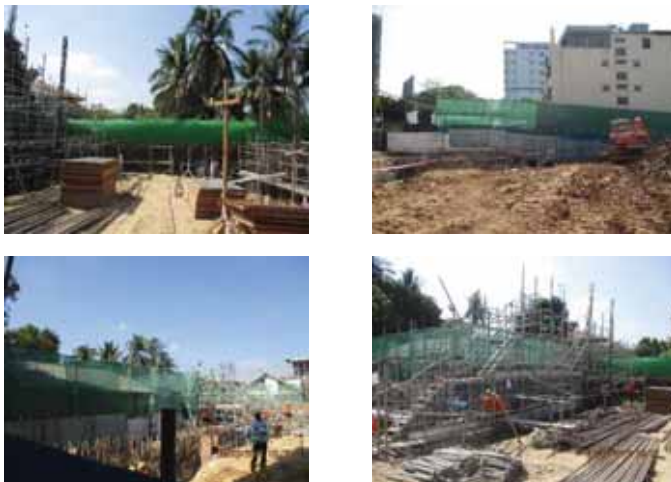
Figure 1-3 PTTEPI's Yangon Office Building in construction phase during January – June 2019

Once the demolition of old building finished, PTTEPI started the construction of new office building since January 2018 and expected to complete in 2020. The example for construction activity as shown in Figure 1-3.

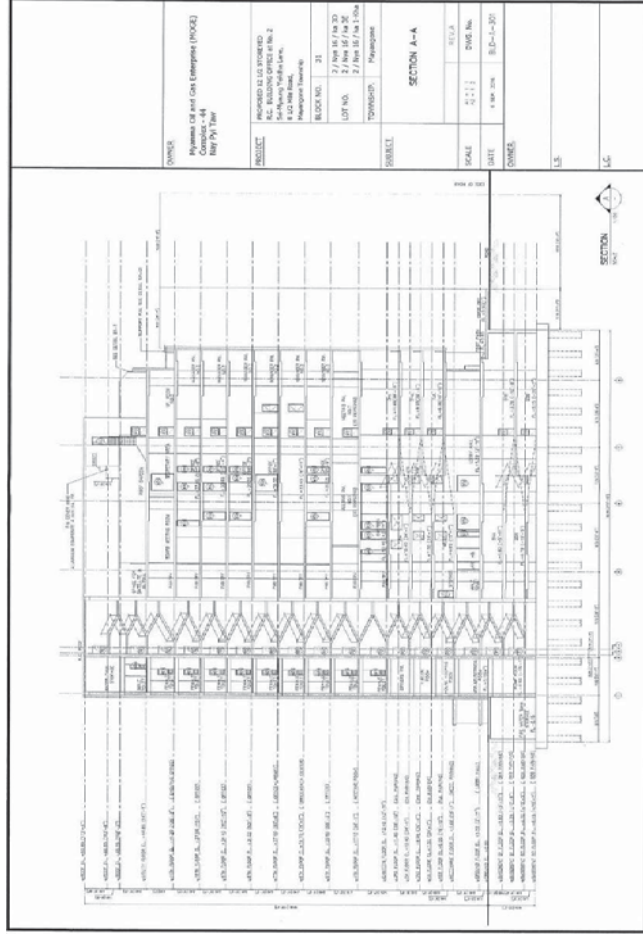
Figure 1-4 Height of PTTEPI's Yangon Office Building

- The 11<sup>th</sup> floor consists of stair, lift, corridor, lobby, mechanical room, executive office space area, pantry & maid room, toilet, roof garden, etc. with total function area of 1,161.00 sq.m.

- The 12<sup>th</sup> and 12 ½ floor consists of stair, lift, corridor, lobby, mechanical room, pantry, toilet, roof slab etc. with total function area of 1,417.00 sq.m.

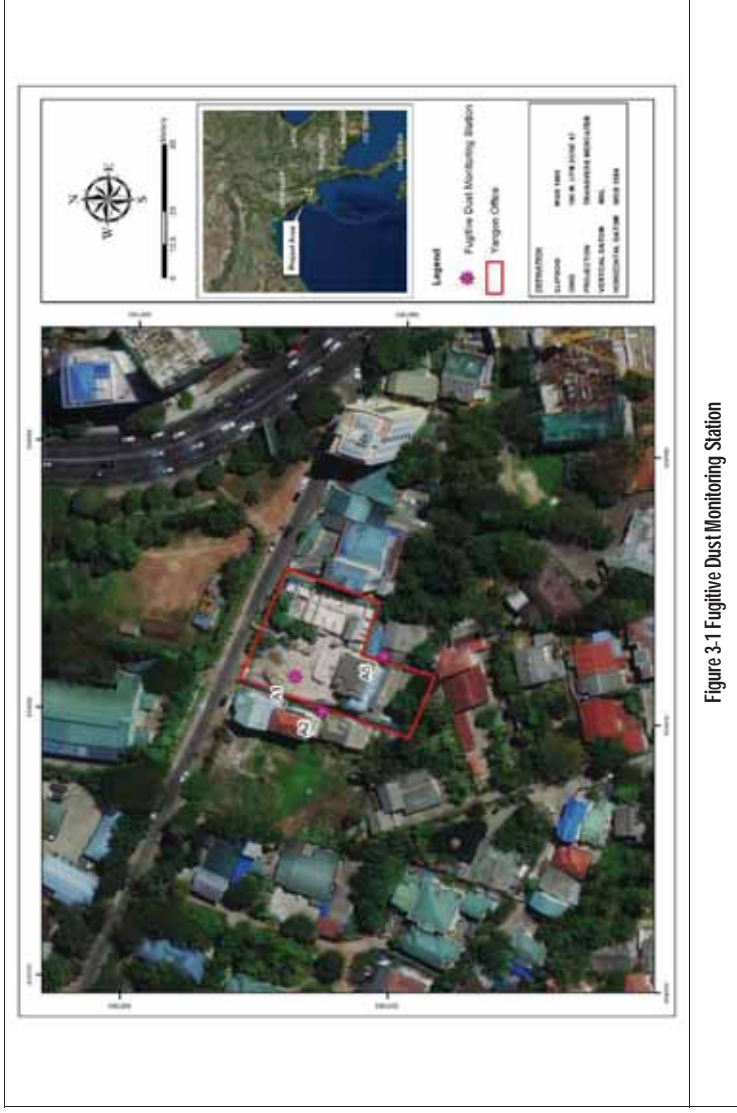
Figure 3-1 Fugitive Dust Monitoring Station

Monitoring Station	Coordinate (UTM Datum WGS 84)		
	Zone	East (X)	North (Y)
1. Construction site : North of construction fence (A1)	47Q	195164.54	1867478.46
2. PTTEPI Building 7 : West of construction fence (A2)	47Q	195154.37	1867467.01
3. House behind PTTEPI Office : South-east of construction fence (A5)	47Q	195173.26	1867446.36

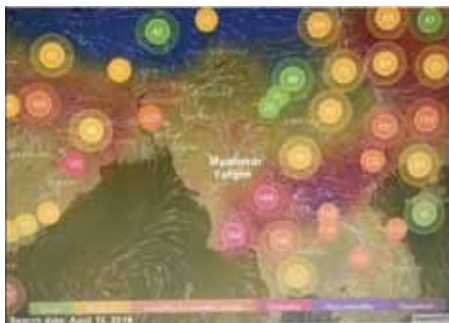
**Figure 3-3 Live AQI on April 10, 2019**

From Wind statistics data for Yangon Airport based on observations taken between 01/2012 - 03/2019 daily from 7am to 7pm local time indicated that during March in Yangon the wind blew from Southwest (SW). From local wind direction during March in Yangon suggested that PTTEPI Building 7 : West of construction fence (A2) and House behind PTTEPI Office : South-east of construction fence (A5) were upwind. Thus, Total Suspended Particulate (TSP) and particulate matter less than 10 Micron (PM-10) which not complied to the standard probability from both internal and external factor including traffic on the public road nearby project area, during sampling period was dry season can cause higher concentration of particulate matter in ambient air. In addition, air quality index data source (<https://www.airvisual.com/world-air-quality>) shown that the risk of air pollution was high and the air quality index was red during dry season in Myanmar (Figure 3-3) .

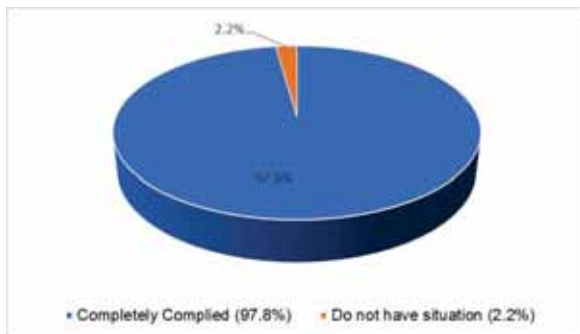
**Figure 4-1 The Results of Environmental Mitigation Measures Compliance in Construction Phase during January – June 2019**

The results determined that the project completely complied on the Mitigation Measures during January – June 2019 in construction phase with 97.8% and do not have situation with 2.2%. The results are shown in Figure 4-1.

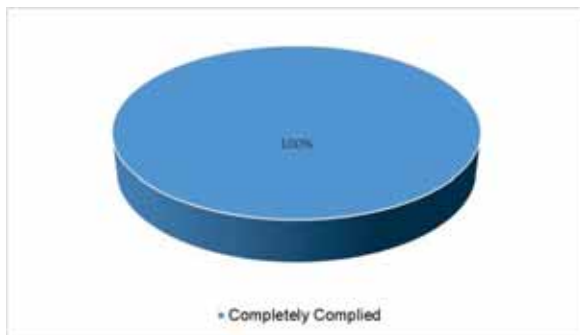
Figure 4-2 The Results of Environmental Monitoring in Construction Phase during January – June 2019

The project was completely complied the environmental impact monitoring as specified in IEE, including Fugitive dust monitoring, Noise level monitoring, Grievance mechanism monitoring, Public and occupational health and safety monitoring as shown in Figure 4-2.
