PTTEP INTERNATIONAL LIMITED (YANGON BRANCH)

ENVIRONMENTAL MONITORING REPORT FOR IEE'S OF YANGON OFFICE BUILDING CONSTRUCTION (DEMOLITION PHASE)

JUNE 2018

Environmental Monitoring Report PTTEPI's New Office Building Construction (Demolition Phase)

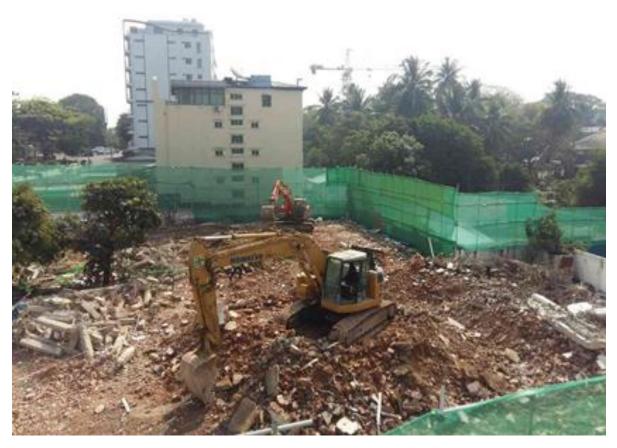
Figure 1-2 Demolition Activities

In order to proceed with new construction, existing 4 building were demolished. Demolition started in February 2018 and completed in March 2018. During the demolition phase, various monitoring were conducted based on recommendations from Initial Environmental Examination (IEE) for PTTEPI's Yangon office building construction (Table 3-1). Demolition activities photo is shown in Figure 1-2.

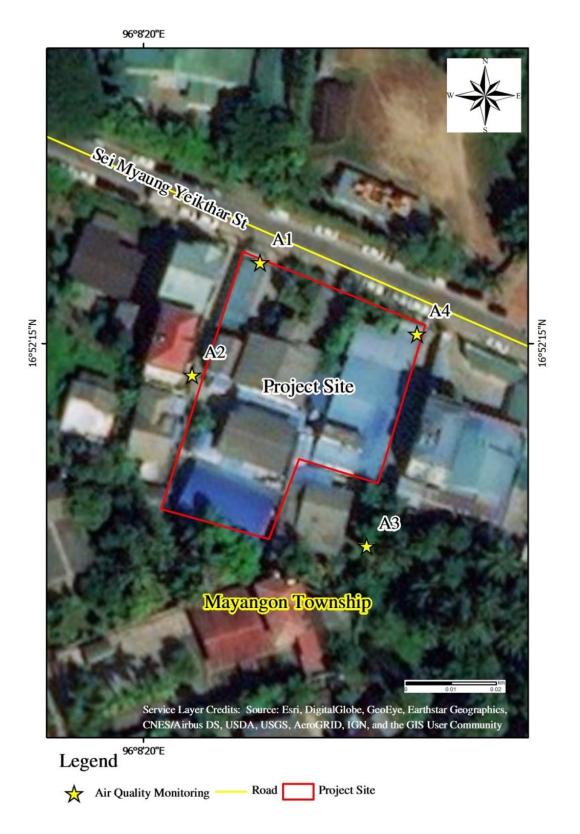
Figure 3-1 Location map of ambient air quality monitoring station

PTTEPI new office building construction site is located on the 8.5 miles, Mayangone Township, Yangon. Ambient air monitoring was conducted at 4 stations during February 4-11, 2018 which comprising of 2 stations within the demolition site, at station A1 and A4. Other 2 stations which expected to be affected by the demolish activities, are A2 and A3 (PTTEPI Building 7(now ATT office building is A2 and House behind the site is A3). The location map is shown in Figure 3-1, and sampling information is summarized in Table 3-2.

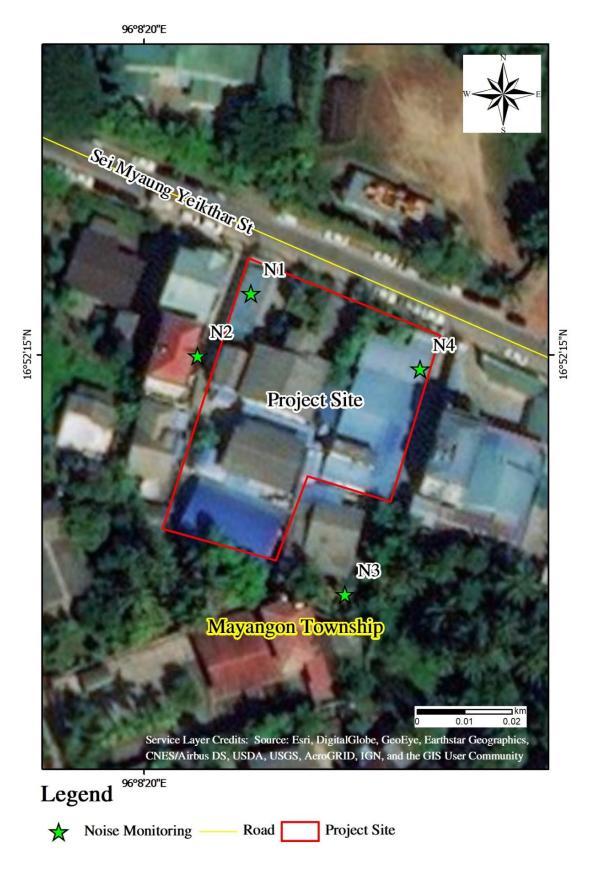
Figure 3-2 Location of noise measurement point

Station	Location	Date		Frequency	Reference	Photo	Sampling	Equipment
		Holidays	Weekdays	Timing	Coordinate		Period	
N1	Demolition Site(S1)	4-5/ 2/ 2018	5-6/ 2/ 2018	24 hours	16°52'15.42"N 96° 8'20.73"E		48 hours	Sound level meter
N3	House behind the site	4-5/ 2/ 2018	5-6/ 2/ 2018	24 hours	16°52'13.36"N 96° 8'21.38"E		48 hours	Sound level meter
N2	PTTEPI	Weekdays	Holidays	24 hours	16°52'14.99"N	_	48 hours	Sound level
	building 7 (now ATT office building)	9-10/ 2/ 2018	10-11/2/ 2018		96° 8'20.37"E			meter

Station	Location	Г	Date	Frequency Reference		Photo	Sampling	Equipment
		Holidays	Weekdays	Timing	Coordinate		Period	
N4	Demolition Site (S2)	9-10/ 2/ 2018	10-11/ 2/ 2018	24 hours	16°52'14.90"N 96° 8'21.89"E		48 hours	Sound level meter
