Monitoring Report of PTTEPI's Yangon Office Building (Construction Phase) during July - December 2020

PTTEP International Limited (PTTEPI)

Project Title	PTTEPI's Yangon New Office Building
Project Location (Address)	No. (2), Sei-Myaung Yeiktha Street, 8 ½ Mile, Mayangone Township, Yangon.
ECC number	Letter No. Forest 3(2)/ 6(D) (3423/2017) dated on 25 th October 2017

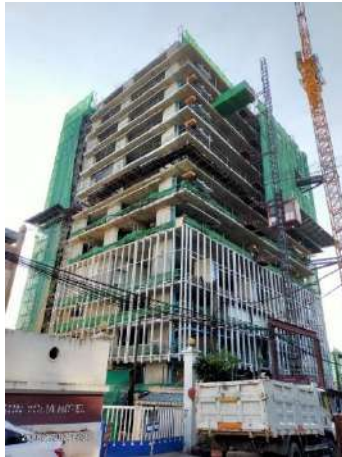
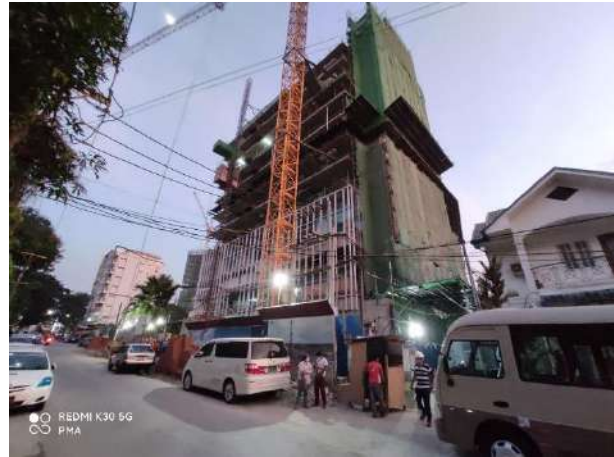
Figure 1-3 PTTEPI's Yangon Office Building in construction phase during July - December 2020

Once the demolition of old building finished, PTTEPI started the construction of new office building since January 2018 and expected to complete in April 2021. The main activity during July - December 2020 was structural work and infrastructure work (M&E activities and Finishing work). The example for construction activity as shown in Figure 1-3.

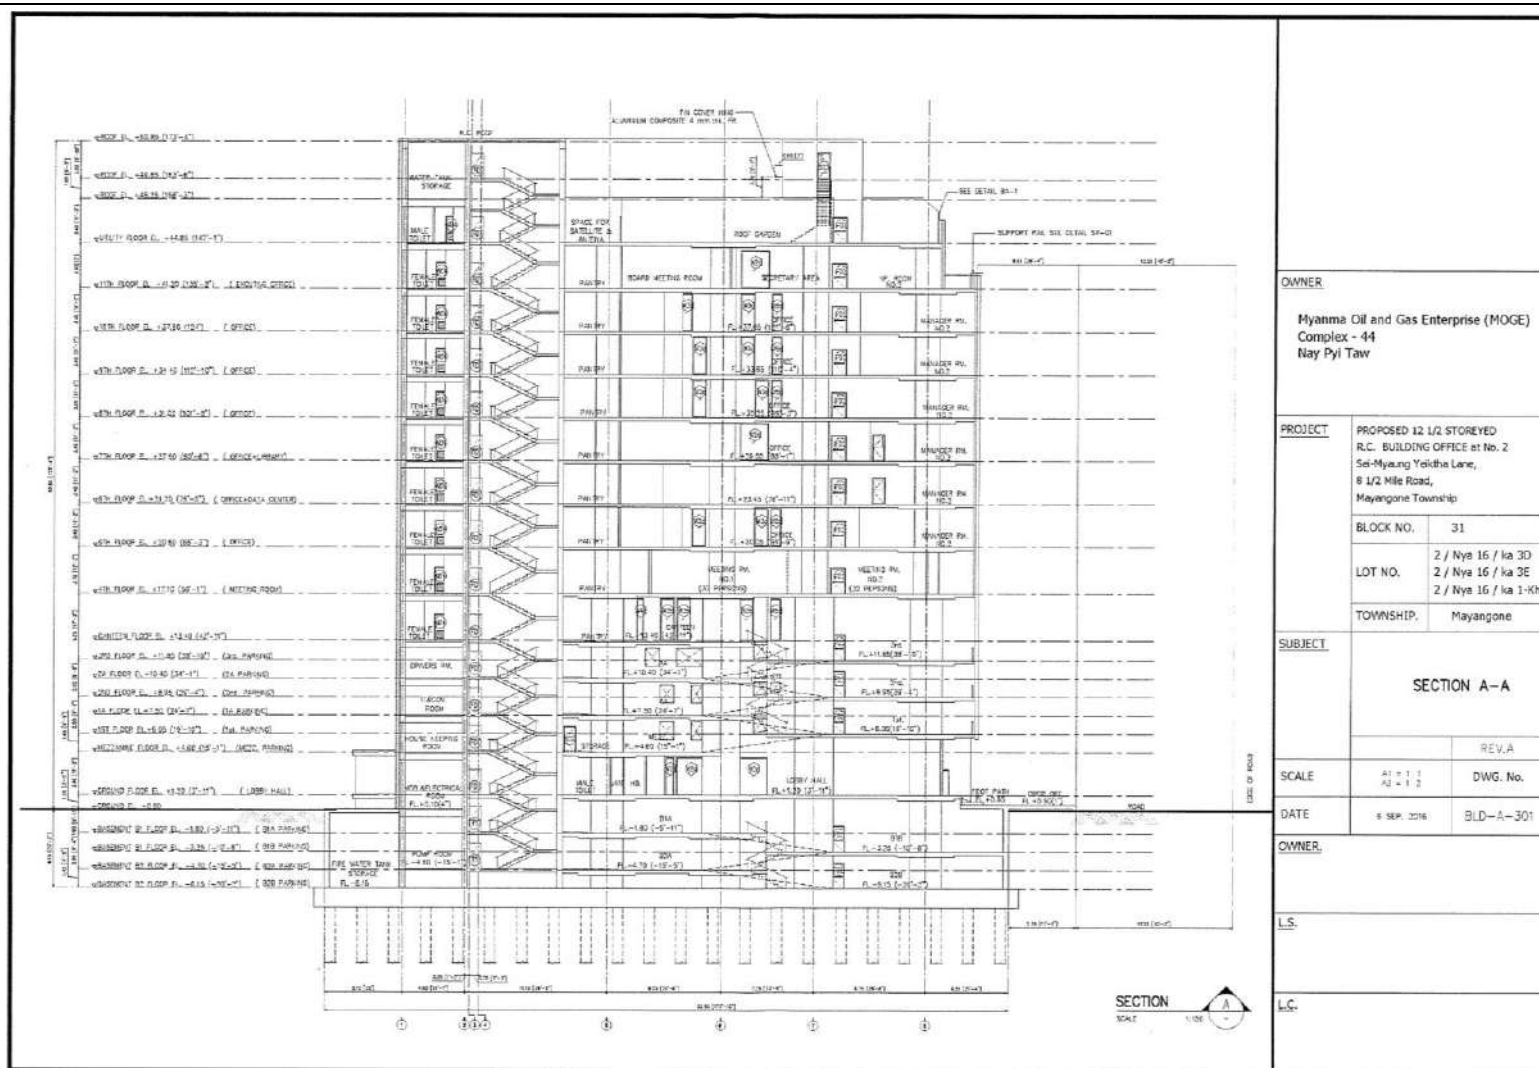
Figure 1-4 Height of PTTEPI's Yangon Office Building

- The 11th floor consists of stair, lift, corridor, lobby, mechanical room, executive office space are, pantry & maid room, toilet, roof garden, etc. with total function area of 1,161.00 sq.m.

- The 12th and 12 ½ floor consists of stair, lift, corridor, lobby, mechanical room, pantry, toilet, roof slab etc. with total function area of 1,417.00 sq.m.

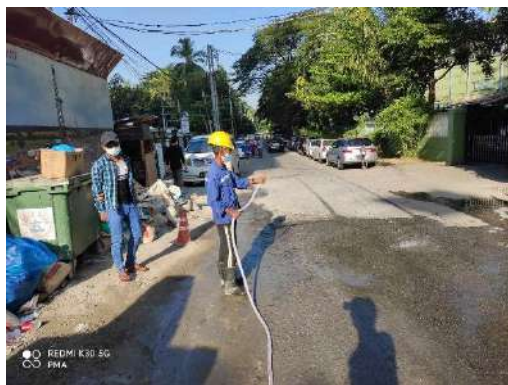
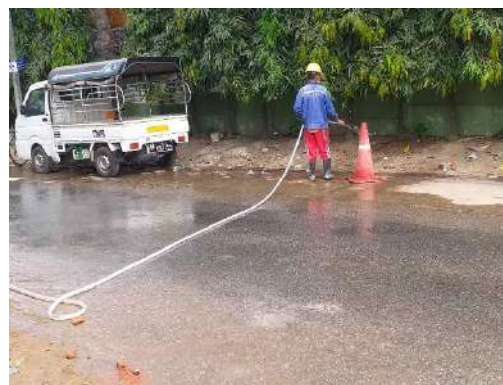
Figure 2-2 Water Spray

- **Air Pollution** - The project complied with the environmental mitigation measures strictly such as assigned staff to spray water around construction area at least twice a day or more in dry season or depending on the atmospheric conditions and the existing road was in a good condition. The project provided PVC mesh sheets around the construction areas in order to prevent dust dispersion and reduced effected to the communities nearby the construction site and along the transportation route. The main activity during July - December 2020 was structural work and infrastructure work (M&E activities and Finishing work) which mostly used finished material. However, in case of the project has activity about construction materials transportation, the truck was covered during transport material to the construction area as specified in measure. Moreover, the contractor provided dust masks for workers and controlled all worker wear dust mask during working.

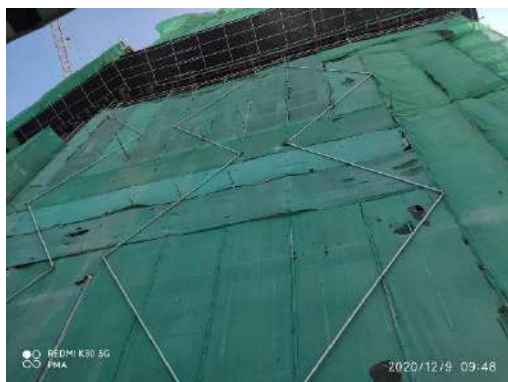
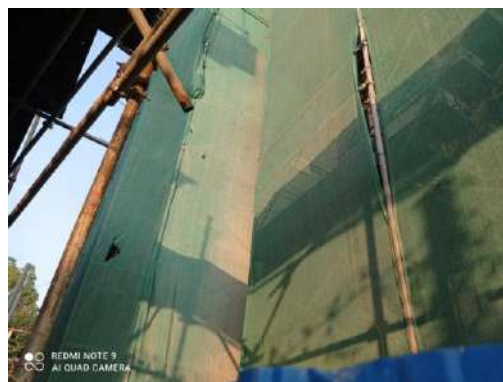
Figure 2-3 PVC Mesh Sheet

Aspects	Potential Impacts	Mitigation Measures	Location	Period/ Frequency	Status	Details	Remarks/ Reference
Environmental Mitigation Measures							
Air Pollution	<ul style="list-style-type: none"> Impacts on air quality from dust dispersion resulting from foundation and structural work cause adverse effected to the communities nearby the construction site and along the transportation route. 	<ul style="list-style-type: none"> Water spraying twice a day at and around the construction areas 	Project Site	Construction Phase	✓	The project has assigned staff to spray water around construction area at least twice a day or more in dry season or depending on the atmospheric conditions.	Figure 2-2 and Appendix J
		<ul style="list-style-type: none"> Polyester/ PVC mesh sheet should be covered around the construction areas 			✓	The project provided PVC mesh sheets around the construction areas in order to prevent dust dispersion and reduced effected to the communities nearby the construction site and along the transportation route.	Figure 2-3

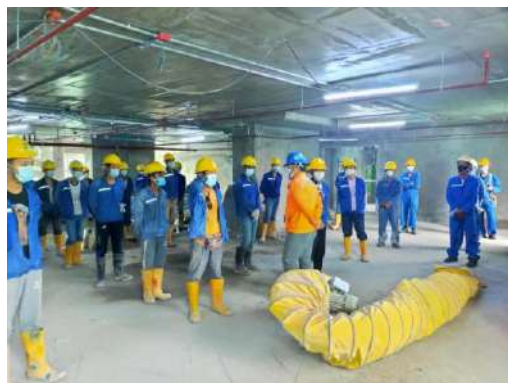
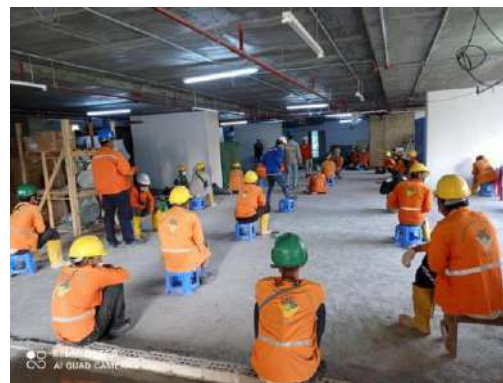
Figure 2-5 Example of Tool Box Talk

Aspects	Potential Impacts	Mitigation Measures	Location	Period/ Frequency	Status	Details	Remarks/ Reference
		<ul style="list-style-type: none"> Dust masks should be provided (where applicable) to specified construction workers. 			✓	The contractor provided dust masks for workers and controlled all worker wear dust mask during working.	Figure 2-4
Excessive Noise and Vibration	<ul style="list-style-type: none"> Impacts on excessive noise and vibration from foundation and structural work to disturb the nearby communities. 	<ul style="list-style-type: none"> Provide noise protection equipment such as ear muff, ear plugs to the construction workers working in the area 	Project Site	Construction Phase	✓	The contractor provided ear muffs for workers and controlled to use during working in high noise area.	Figure 2-4
		<ul style="list-style-type: none"> Try to carry out construction activities with high noise and vibration level at day time, some activities need to be carried out in the nighttime. 			✓	The main activity during July - December 2020 was structural work and infrastructure work (M&E activities and Finishing work). The contractor emphasized all workers in daily toolbox talk before working to carried out the construction activities with high noise and vibration level at daytime (9 a.m. – 5 p.m.) in order to reduce noise and vibration impact to nearby communities. However, there was no any complaints during July - December 2020.	Figure 2-5 Appendix J

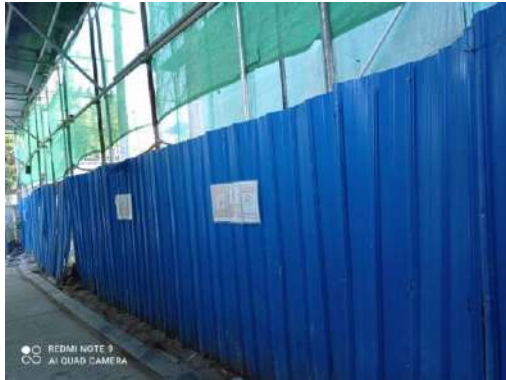
Figure 2-6 Noise Barrier

<ul style="list-style-type: none"> Install metal sheet as temporary noise barrier at construction site to reduce noise impact nearby communities 			✓	Noise barrier (metal sheet) was installed around the construction site to reduce noise impact to nearby communities.	Figure 2-6

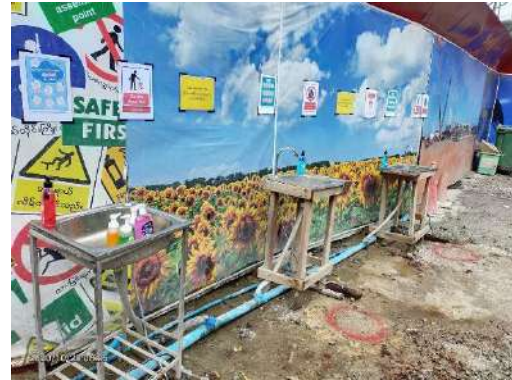
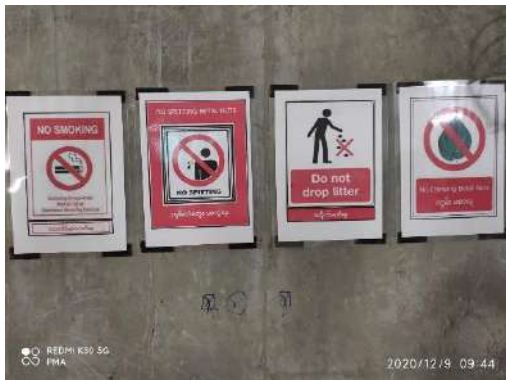
Figure 2-7 Warning Sign

Aspects	Potential Impacts	Mitigation Measures	Location	Period/ Frequency	Status	Details	Remarks/ Reference
		<ul style="list-style-type: none"> Install warning signs that can be clearly seen to show the access road and construction area. 			✓	Warning signs were installed and can be clearly seen at the public road (in front of the construction area) and within construction area.	Figure 2-7
		<ul style="list-style-type: none"> Avoiding/ lessening mobilization of material and equipment at day time. 			✓	The contractor informed about construction plan and transportation route for construction materials and heavy vehicles to local people. Moreover, avoiding transportation of materials and equipment at day time.	Appendix D-2
		<ul style="list-style-type: none"> Prepare security guard and signal man at guard house close to access road to give the sign in and out of vehicle from project area. 			✓	Security guard are stationed at guardhouse in front of construction area for 24 hr. (2 shift) and the project also provided signal man while transportation of construction materials to give the sign in and out of vehicle/truck from project area.	Figure 2-8 Figure 2-9 and Appendix J

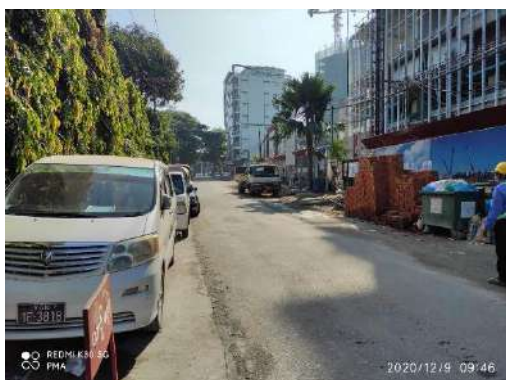
**Figure 2-10 Public Road
(In front of the construction area)**

construction area. Routine inspection and preventive maintenance for all vehicles conducted as per the inspection plan. The contractor has strictly controlled of overloaded heavy vehicles to prevent road deterioration. Moreover, the public road (in front of the construction area) was in good condition and there was no complaint from nearby communities.

<ul style="list-style-type: none"> Carry out regular, routine check and maintenance of vehicles following safety instruction. 			✓	Routine inspection and preventive maintenance for all vehicles as per inspection plan.	Appendix E-4
		<ul style="list-style-type: none"> Strictly control on over loading of heavy truck to prevent damage on road surface. 			✓	The contractor has strictly controlled of overloaded heavy vehicles to prevent road deterioration. Moreover, the public road (in front of the construction area) was in good condition and there was no complaint from nearby communities.	Figure 2-10

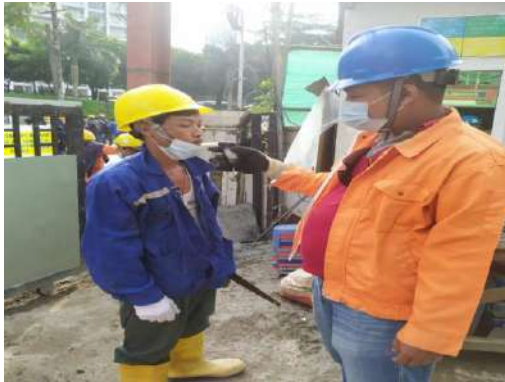
Figure 2-12 Alcohol Test

- The contractor provided journey management and transportation safety procedure and enjoined workers to follow regulation. The emergency response procedure was set up including incident, fire action, first aid action. The contractor prepared drug and alcohol abuse policy and enforced all workers to follow. Alcohol testing was conducted before working every day. The worker will immediately stop working if alcohol is found more than 0%. For drug testing, all staffs including workers, engineers and safety staffs were random tested (1time/week maximum 8 samples), the staff who found to be positive in drug testing shall be required to undergo rehabilitation and counseling in government accredited center. However, during July - December 2020 there were no staff found positive in drug test.

<ul style="list-style-type: none"> Test alcohol and drug on drivers before transportation. 			✓	The contractor prepared drug and alcohol abuse policy and enforced all workers to follow. Alcohol testing was conducted before working every day. The worker will immediately stop working if alcohol is found more than 0%. For drug testing, all staffs including workers, engineers and safety staffs were random tested (1 time/week maximum 8 samples), the staff who found to be positive in drug testing shall be required to undergo rehabilitation and counseling in government accredited center. However, during July - December 2020 there were no staff found positive in drug test.	Figure 2-12 Appendix H-1 and Appendix H-2

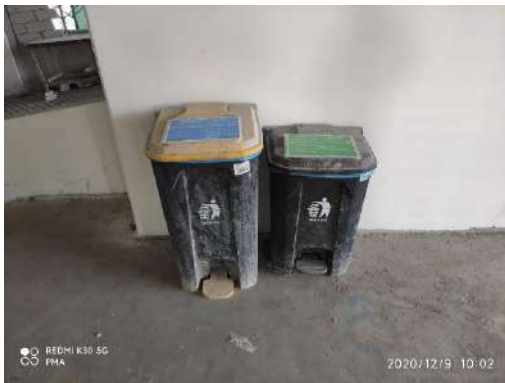
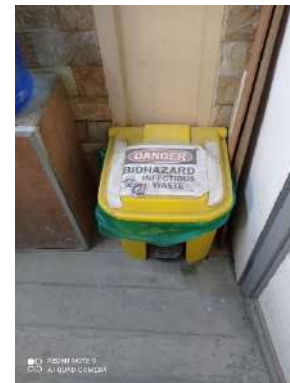
Figure 2-14 Waste Containers

- **Solid Waste**
 - Non- Hazardous Waste - The contractor provided temporary storage area for construction materials. separate waste containers with cover are provided for 5 types; general waste (blue), recycle waste (yellow), hazardous waste (red), organic waste (green) and biohazard infectious waste. The quantity of waste was recorded by contractor. The contractor cooperated with YCDC to collect and dispose of waste in order to prevent residual waste in construction area. Moreover, the constructor enforced all workers not to burn any wastes in the construction area.

- Hazardous Waste - Hazardous waste container (red) was provided at the construction area. However, there are no hazardous waste during construction phase in July - December 2020. If there are occurred, the contractor will cooperate with licensed contractor or authorities to collect and dispose.

Aspects	Potential Impacts	Mitigation Measures	Location	Period/ Frequency	Status	Details	Remarks/ Reference
Solid waste	<ul style="list-style-type: none"> Improper management of construction waste will cause the adverse effect to the environmental. 	Non-Hazardous Waste <ul style="list-style-type: none"> Provide storage area for construction materials. 	Project Site	Construction Phase	✓	The contractor has provided temporary storage area for construction materials.	Figure 2-13
		<ul style="list-style-type: none"> Prepare proper waste bins or containers covered with garbage bag for waste collection at the construction site. 			✓	Waste containers with cover are provided at the construction area for 5 types; general waste (blue) , recycle waste (yellow) , hazardous waste (red) , organic waste (green) and biohazard infectious waste. Moreover, the quantity of waste was recorded by contractor.	Figure 2-14 and Appendix G-2

Aspects	Potential Impacts	Mitigation Measures	Location	Period/ Frequency	Status	Details	Remarks/ Reference
		Hazardous Waste • Separate hazardous waste from solid waste and store the specific containers with clear label.			✓	The contractor has provided separate waste containers with cover for waste collection at the construction area. However, there are no hazardous waste during construction phase in July - December 2020.	Figure 2-14

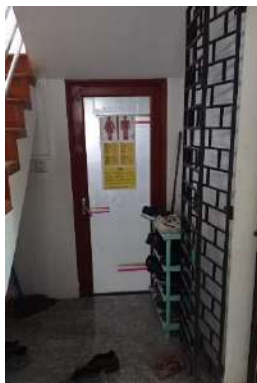
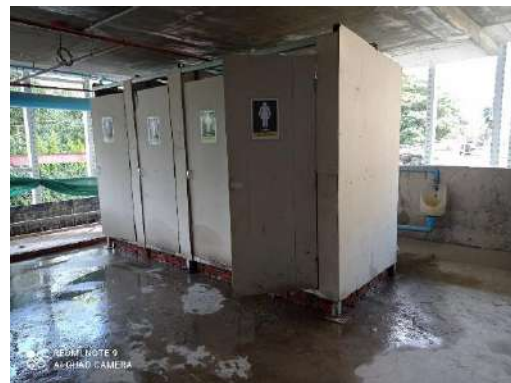
Figure 2-15 Toilets

• Hazardous waste will be disposed by licensed contractor or authorities			✓	Hazardous waste container (red) was provided at the construction area. However, there are no hazardous waste during construction phase in July - December 2020. In case of hazardous waste generated, the project will strictly implement as specified in the measure.	Appendix G-1
Wastewater	• Improper management of sanitary system within the site will caused the adverse effect to the environmental	1) Wastewater from workers • Provide appropriate sanitary facilities in construction site and properly maintained for construction workers.	Project Site	Construction Phase	✓	The contractor has provided 9 temporary toilets within construction area (1 st and 2 nd floor), 2-3 toilets at the back of construction area and 9 toilets within PTTEPI Office for 420 workers.	Figure 2-15

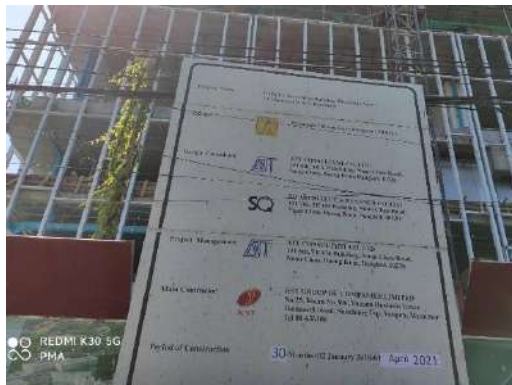
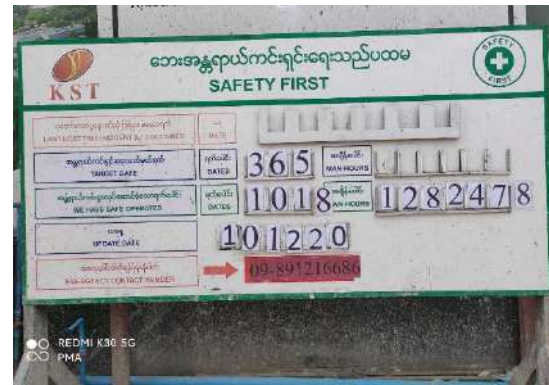
Figure 2-18 Signboard in front of the Construction Area

Aspects	Potential Impacts	Mitigation Measures	Location	Period/ Frequency	Status	Details	Remarks/ Reference
		<ul style="list-style-type: none"> Assign project staff with 24/ 7 available telephone number to handle any complaint/ issue from surrounding. In case of any damage by project activities PTTEPI will investigate and solve the problem. 			✓	PTTEPI provided grievance handling guideline to receive any complaints from the stakeholder and resolve the complaint in the immediate. Moreover, project' s signboard was installed in front of the construction area to inform the project details such as project name, owner, consultant, contractor, period of construction and emergency contact number. However, there was no any complaints during July - December 2020.	Figure 2-18 and Appendix D-1
		<ul style="list-style-type: none"> Install signboard in front of the Project site in order to inform about construction area with the name of the Project, Contractor company, permission license, PTTEP representative name and telephone number etc. 			✓	Project' s signboard was installed in front of the construction area to inform the project details such as project name, owner, consultant, contractor, period of construction and emergency contact number.	Figure 2-18

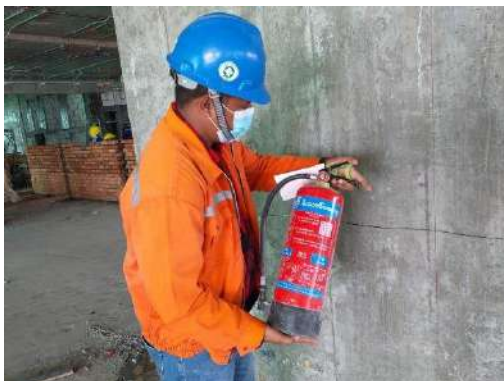
Figure 2-20 Firefighting Equipment Inspection

Aspects	Potential Impacts	Mitigation Measures	Location	Period/ Frequency	Status	Details	Remarks/ Reference
	<ul style="list-style-type: none"> Carelessness of workers may cause fire, injuries and death. 	<ul style="list-style-type: none"> Install appropriate warning signs, markings and safety signs. 			✓	The contractor has installed warning signs and safety sign in construction area to warns workers from dangers. Moreover, the contractor has provided Stop Work Policy to maintain a safe and secure work environment.	Figure 2-7 and Appendix E-2
		<ul style="list-style-type: none"> Regular checking all equipment to ensure it can be used without defect. 			✓	Routine inspection and preventive maintenance for all equipment were conducted as per inspection plan.	Appendix E-4
		<ul style="list-style-type: none"> Firefighting equipment and portable fire extinguishers shall be properly provided in construction area. 			✓	The contractor has provided firefighting equipment in the construction area and inspected monthly.	Figure 2-20

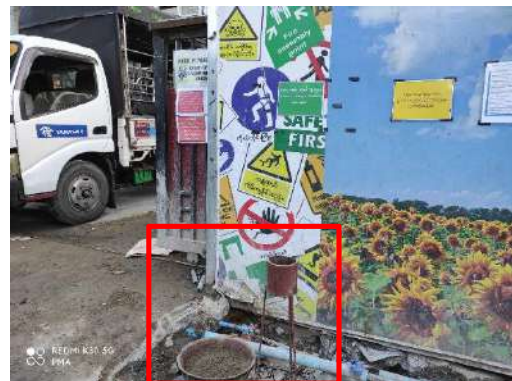
Figure 2-21 Smoking area

<ul style="list-style-type: none"> Provide smoking area in the construction zone. 			✓	The contractor has provided smoking areas in the west and in front of construction area.	Figure 2-21

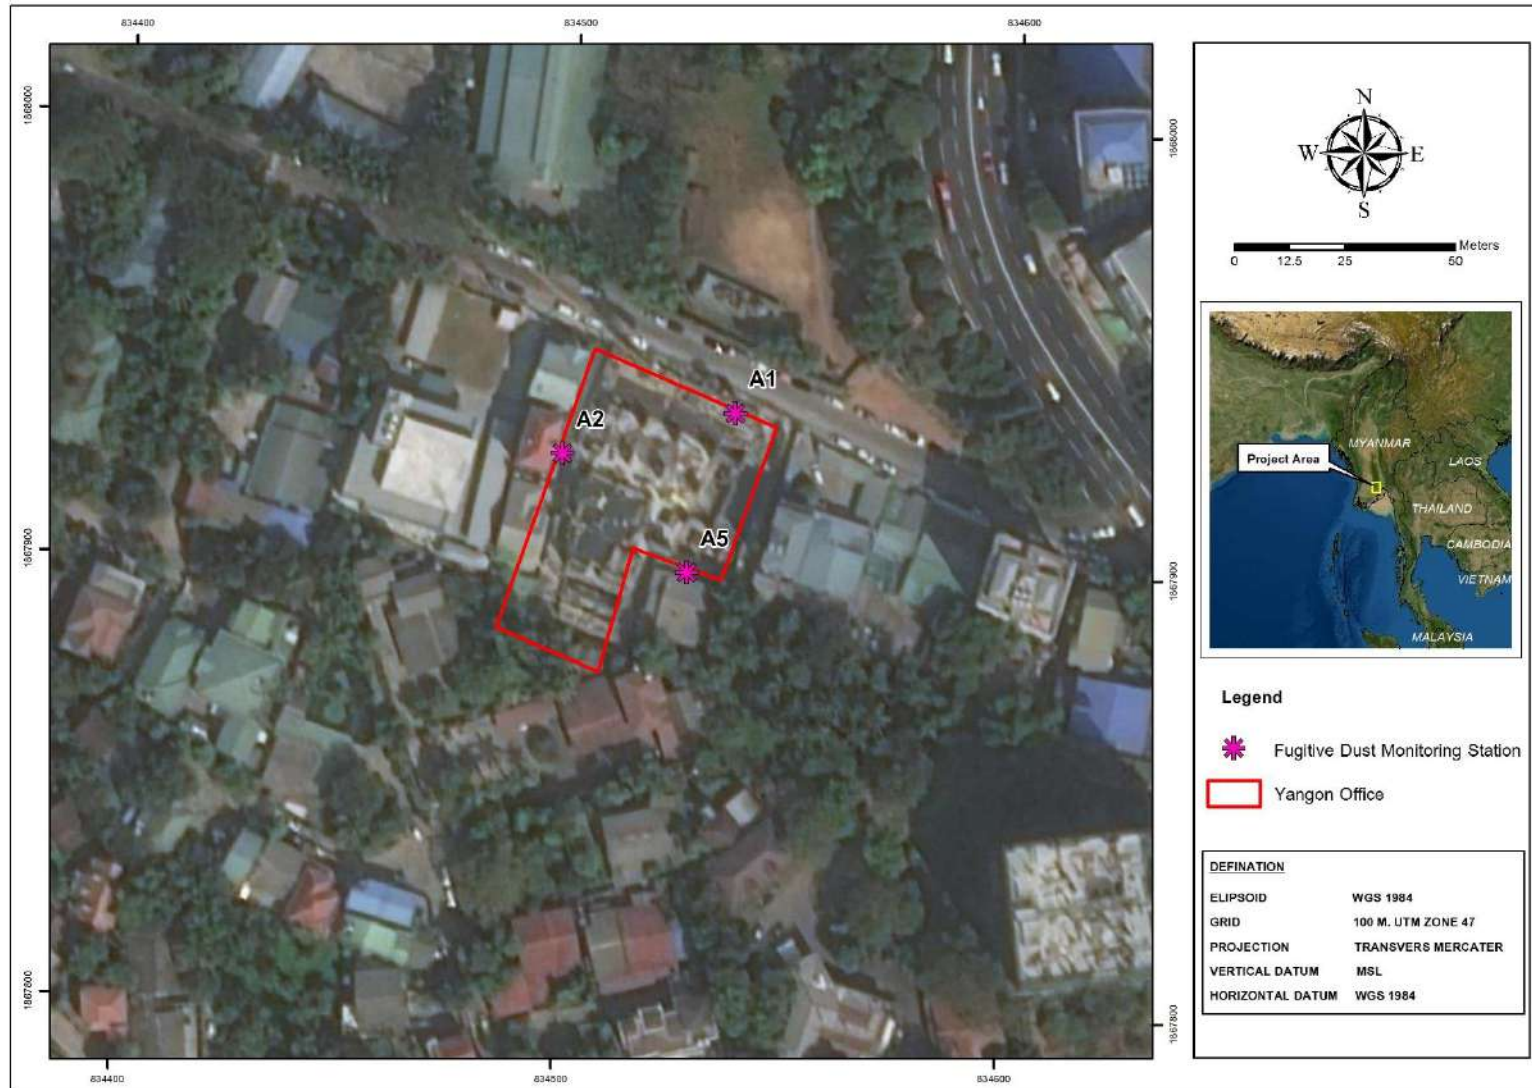
Figure 3-1 Fugitive Dust Monitoring Station

Monitoring Station	Coordinate (UTM Datum WGS 84)		
	Zone	East (X)	North (Y)
1. Construction site : North of construction fence (A1)	47Q	195196	1867483
2. PTTEPI Building 7 : West of construction fence (A2)	47Q	195157	1867474
3. House behind PTTEPI Office : South-east of construction fence (A5)	47Q	195185	1867447

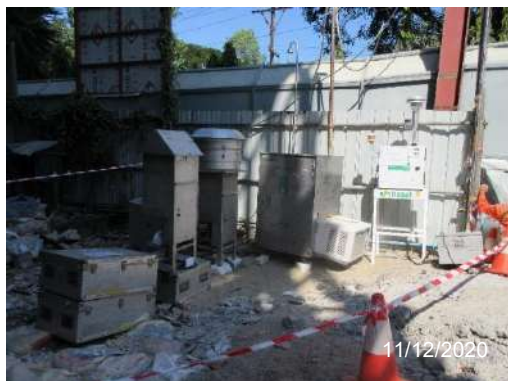
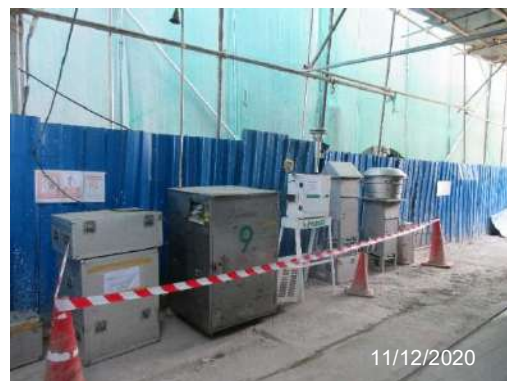
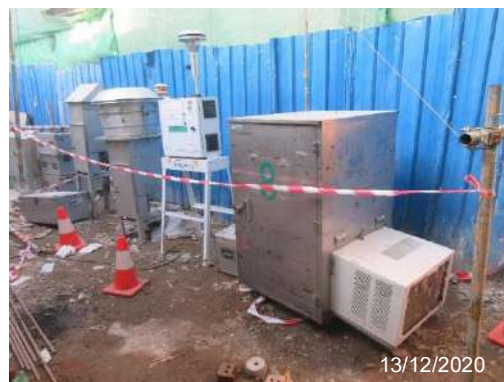
Figure 3-2 Fugitive Dust Monitoring

Fugitive dust samples were monitored at PTTEPI Building 7 and House behind PTTEPI Office during December 11-13, 2020. Construction site was monitored during December 13-15, 2020 as shown in Figure 3-2.

Fugitive dust monitoring results found that Total Suspended Particulate (TSP) of Construction site : North of construction fence (A1) during December 12-13, 2020 and PTTEPI Building 7 : West of construction fence (A2) have complied with Ambient Air Quality of WORLD BANK GROUP, whereas TSP of House behind PTTEPI Office: South-east of construction fence (A5) haven't complied with Ambient Air Quality of WORLD BANK GROUP which determined that Average 24 hours TSP should not exceed 230 $\mu\text{g}/\text{m}^3$. For the results of Particulate matter less than 10 Micron (PM-10) found that all stations exceeded the National Environmental Quality (Emission) Guideline (EQEG) which determined that PM10 should not exceed 50 $\mu\text{g}/\text{m}^3$. However, when comparison the results of Particulate matter less than 10 Micron (PM-10) with the Ambient Air Quality Standard of WHO and IFC found that all results have complied the standard which determined that PM10 should not exceed 150 $\mu\text{g}/\text{m}^3$.

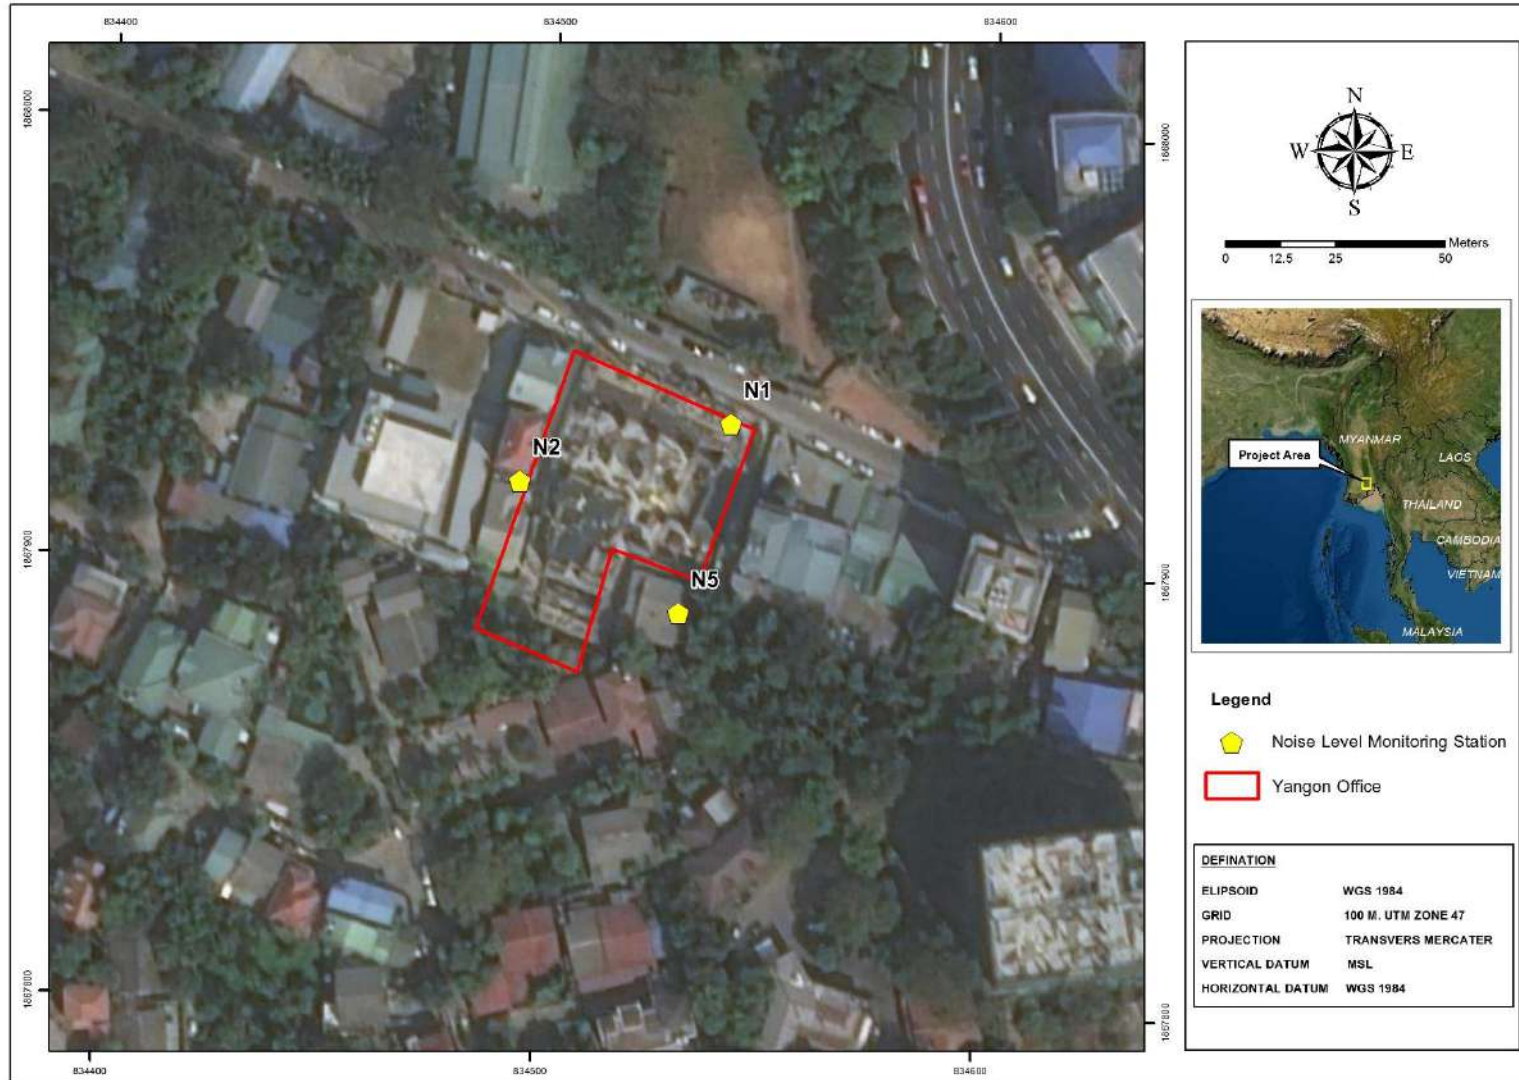
Figure 3-3 Noise Level Monitoring Station

Monitoring Station	Coordinate (UTM Datum WGS 84)		
	Zone	East (X)	North (Y)
1. Construction site : North of construction fence (N1)	47Q	195200	1867481
2. PTTEPI Building 7 : West of construction fence (N2)	47Q	195152	1867468
3. House behind PTTEPI Office : South-east of construction fence (N5)	47Q	195188	1867438

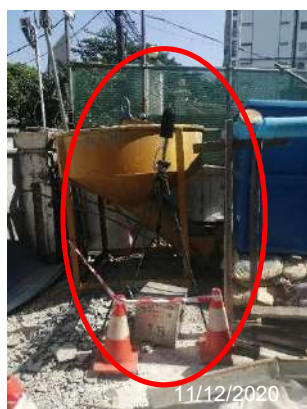
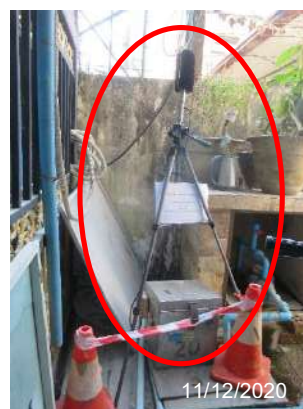
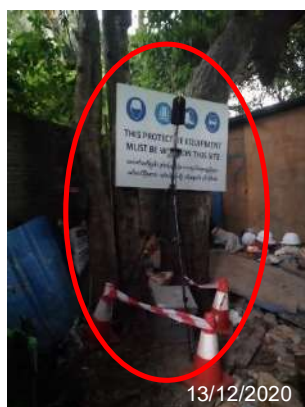
Figure 3-4 Noise Level Monitoring

Noise level monitoring of PTTEPI's Yangon Office Building were monitored at Construction site and PTTEPI Building 7 during December 11-13, 2020. House behind PTTEPI Office was monitored during December 13-15, 2020 as shown in Figure 3-4.

Noise level monitoring results found that The L_{Aeq} -1 hr daytime of Construction site : North of construction fence (N1), PTTEPI Building 7 : West of construction fence (N2) and House behind PTTEPI Office : South-east of construction fence (N5) were in ranged of 55.5-68.5, 53.9-67.8 and 51.8-62.4 dB(A), respectively. While The L_{Aeq} -1 hr night-time of N1, N2 and N5 were ranged from 57.3-65.3, 56.8-69.1 and 52.7-62.3 dB(A), respectively. All of the result of L_{Aeq} -1 hr daytime and L_{Aeq} -1 hr night-time has complied with EQEG, 2015 for Industrial/ Commercial Area which determined L_{Aeq} -1 hr daytime and night-time not more than 70 dB(A).

The comparison of noise level monitoring results in construction phase December 2020 and baseline data found that the result of L_{Aeq} -1 hr daytime and L_{Aeq} -1 hr night-time of 3 stations were higher than baseline data. However, all of the result of L_{Aeq} -1 hr daytime and night-time in construction phase in December 2020 has complied with EQEG, 2015 for Industrial/ Commercial Area which determined L_{Aeq} -1 hr daytime and night-time not more than 70 dB(A). In addition, the project has continually monitoring, as specified in the measure for surveillance of environmental impact from the project construction activity.
