Monitoring Report of Myanmar Onshore Block MOGE-3 Exploration Drilling Campaign (Construction and Installation Phase) in 2018

PTTEP South Asia Limited (PTTEP SA)

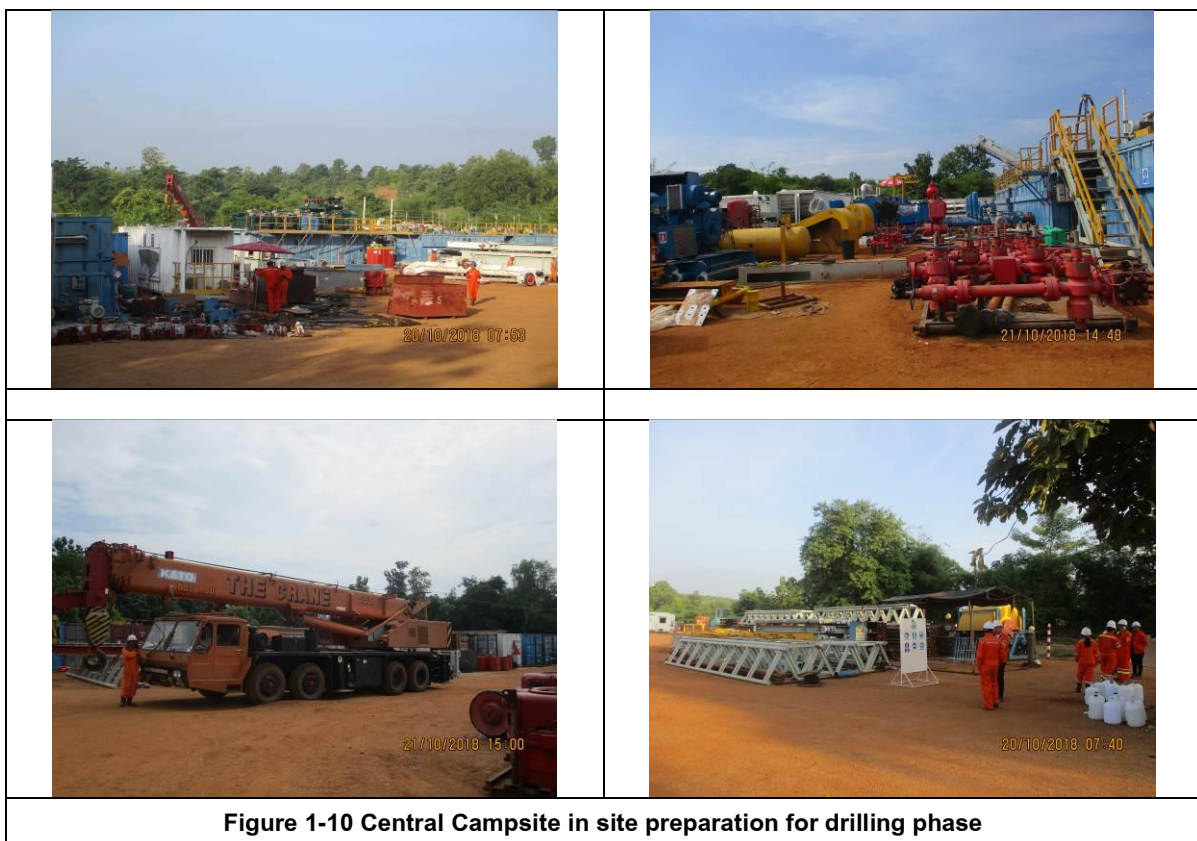
Currently, Central Campsite is in site preparation for drilling phase as shown in Figure 1-10.

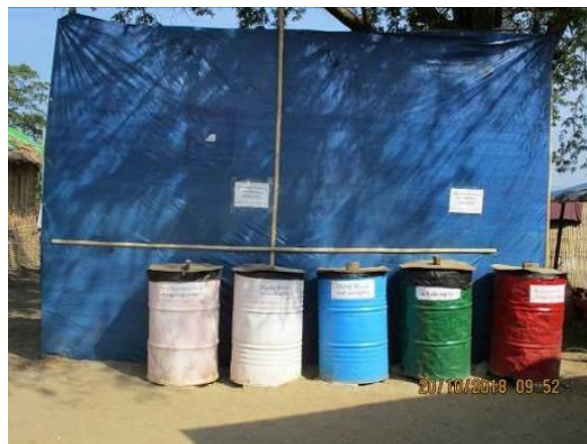
Figure 1-11 Separate waste container

PTTEP SA has handled waste according to PTTEP SA Standards. All wastes were classified and segregated before sending to disposal. All wastes were collected, stored, and segregated in arranged containers such as non-hazardous waste, plastic waste, metal waste and hazardous waste as shown in Figure 1-11.

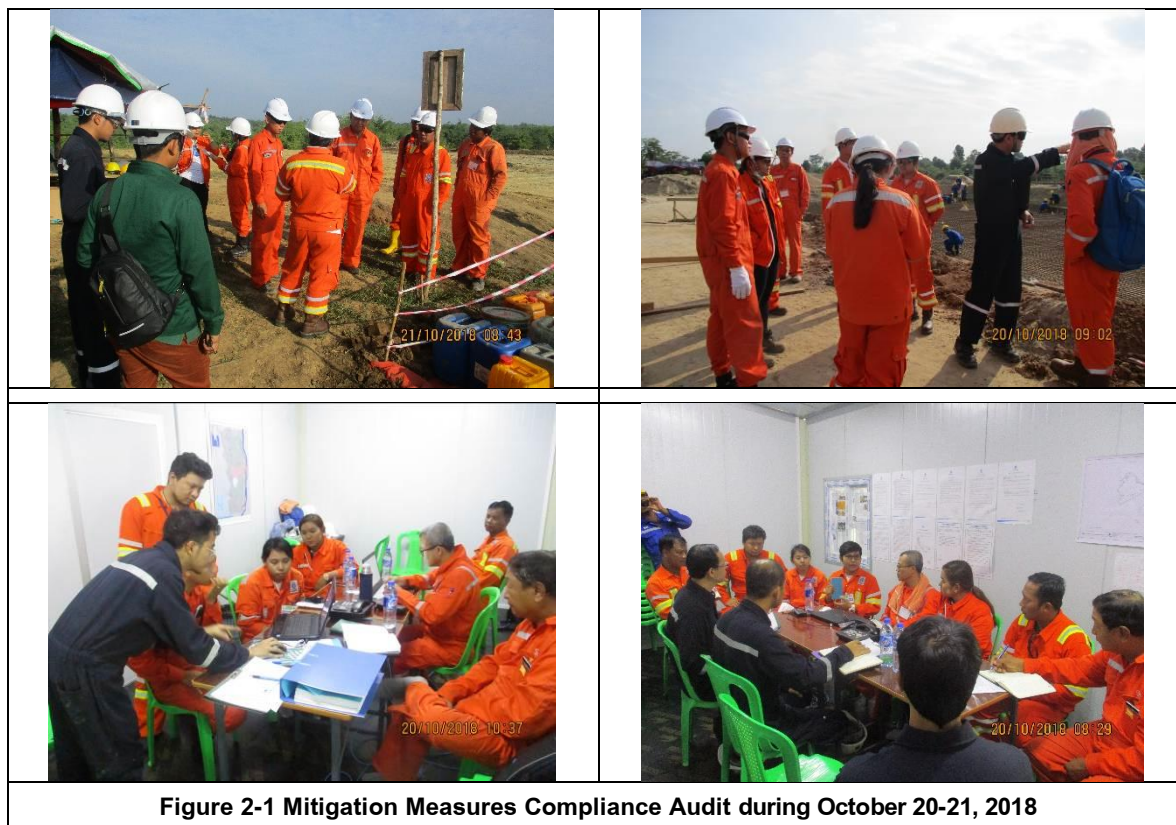
Audit was performed at Moenatkone, Ngabatkya, Padaukpin and Sakangyi during October 20- 21, 2018 in construction and installation phase (Figure 2-1) and document checking by setting 4 levels of evaluation as follows;

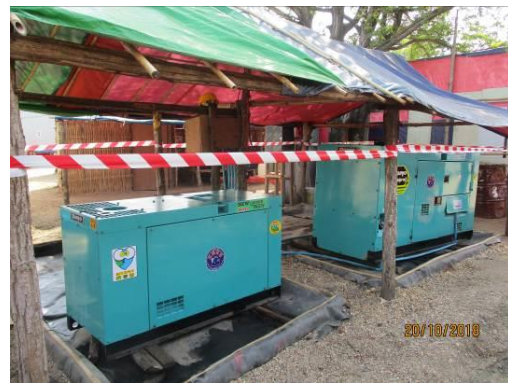
Figure 2-5 Soundproof Generator

No need to use noise barrier due to construction area far away from sensitive area. Moreover, the soundproof generator was used to minimize noise disturbance. And PTTEP SA specified the contractor to regularly check and maintain the machines and vehicles in good condition.

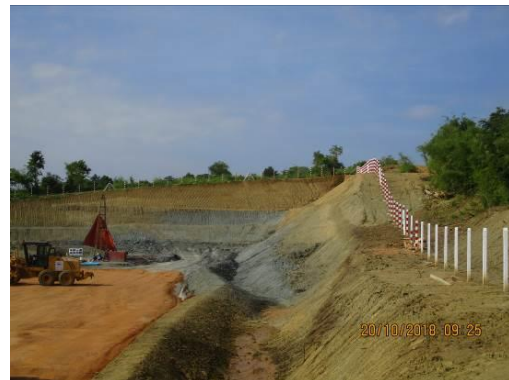
Figure 2-10 Fence around Project area

Environmental Factors/Events	Activity	Potential Impacts	Mitigation Measures	Status	Details	Remarks
	7.2 Construction of roads and well / camp sites	7.2.1 Habitat degradation from construction	7.1.1.3 Mark well sites clearly and prohibit vehicles from moving off site onto surrounding land.	✓	Fence was installed around the well site to separate the project area and nearby area. The security guard was assigned 24 hr. to check unauthorized people and vehicles coming into wellsites.	Figure 2-10, Figure 2-11 and Figure 2-12

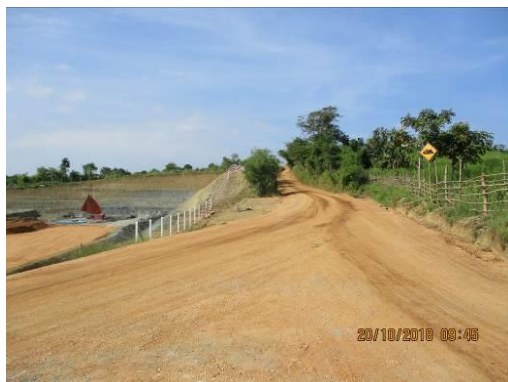
Figure 2-13 Access road was in good condition.

The access road was in good condition and ready for use. In case of the road was damaged from project activity, the contractor will repair to prevent unsafe condition to user.

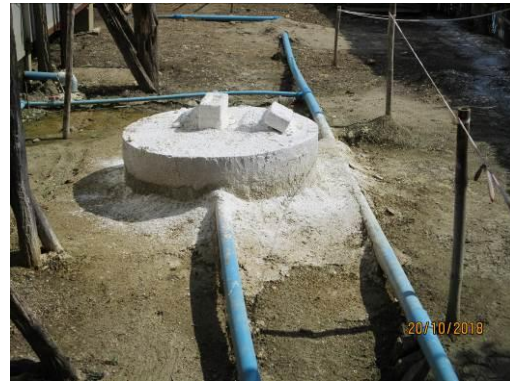
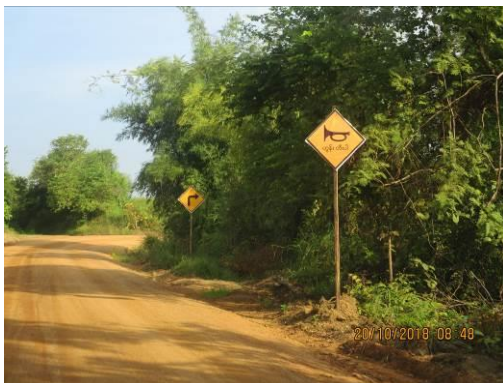
Figure 2-16 Example of Warning signs at the access road

PTTEP SA prepared land transport safety procedure and enjoined the contractor to follow regulation such as speed limit, loading of truck and transportation's time. The contractor installed warning sign along the access road and provided staffs for facilitate the traffic during transportation. The access road was in good condition and ready for use. In case of the road was damaged from project activity, the contractor will repair to prevent unsafe to user.

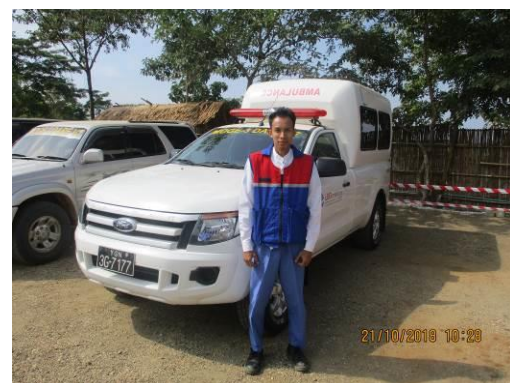
Figure 2-21 Ambulance and medical personnel were provided in emergency case.

4.1.1.13 Referral system with external medical facilities for serious injuries or emergencies	✓	Emergency respond procedure, ambulance, medical personnel and training were provided to respond in emergency case. Moreover, the contractor cooperated with nearby hospital (eg. Thayet Township Hospital) to support in serious injuries or emergencies case.	Figure 2-21, Appendix E-1, E-2 and E-4

Emergency respond procedure, ambulance, medical personnel and training were provided to respond in emergency case. Moreover, the contractor cooperated with nearby hospital to support in serious injuries or emergencies case.

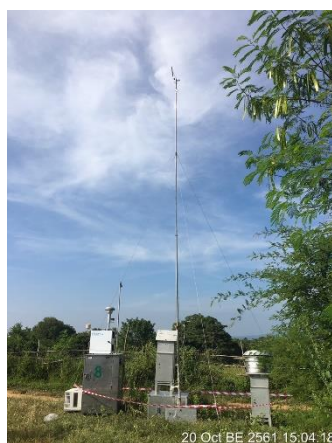
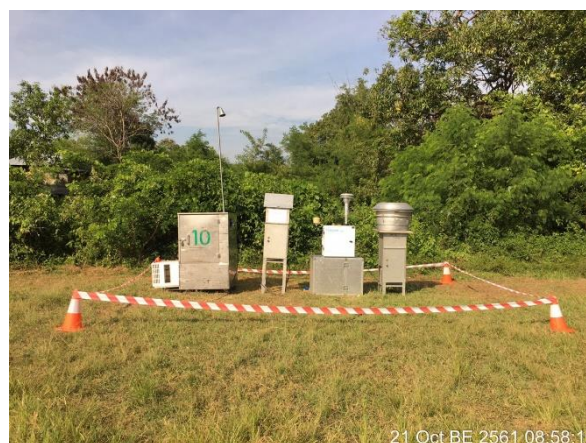
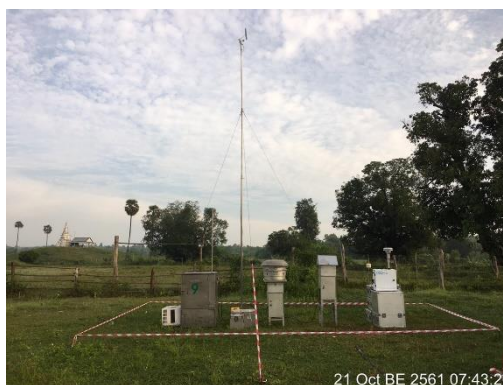
Figure 3-2 Air Quality Monitoring in construction and installation phase 2018

Air quality monitoring in 2018, for construction and installation phase of Padaukpin (PDP), Sakangyi (SKG) and Moenatkone(MNK) well site were conducted during October 20-21, 2018 and Ngabatkyia (NBK) well site was conducted during October 21-22, 2018 as shown in Figure 3-2.

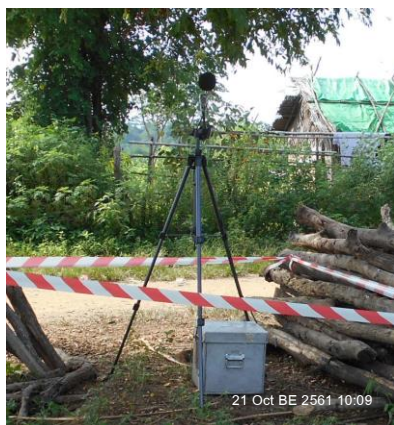
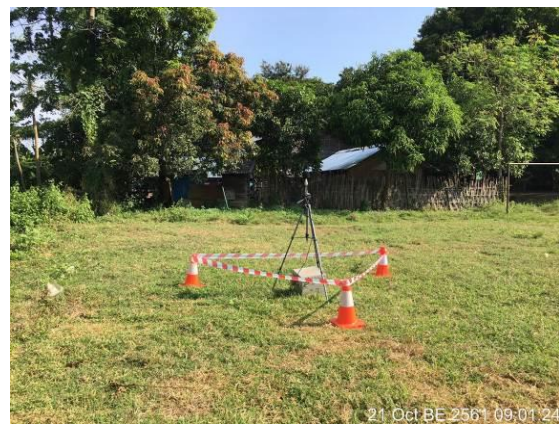
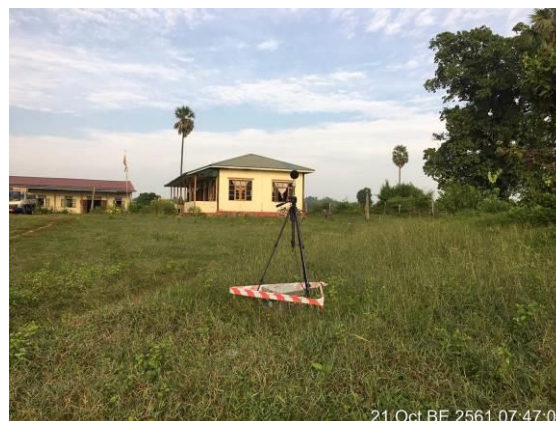
Figure 3-4 Noise Level Monitoring in construction and installation phase 2018

Noise level monitoring in 2018, for construction and installation phase of Padaukpin (PDP), Sakangyi (SKG) and Moenatkone (MNK) well site were conducted during October 20-21, 2018 and Ngabatkyia (NBK) well site was conducted during October 21-22, 2018 as shown in Figure 3-4.

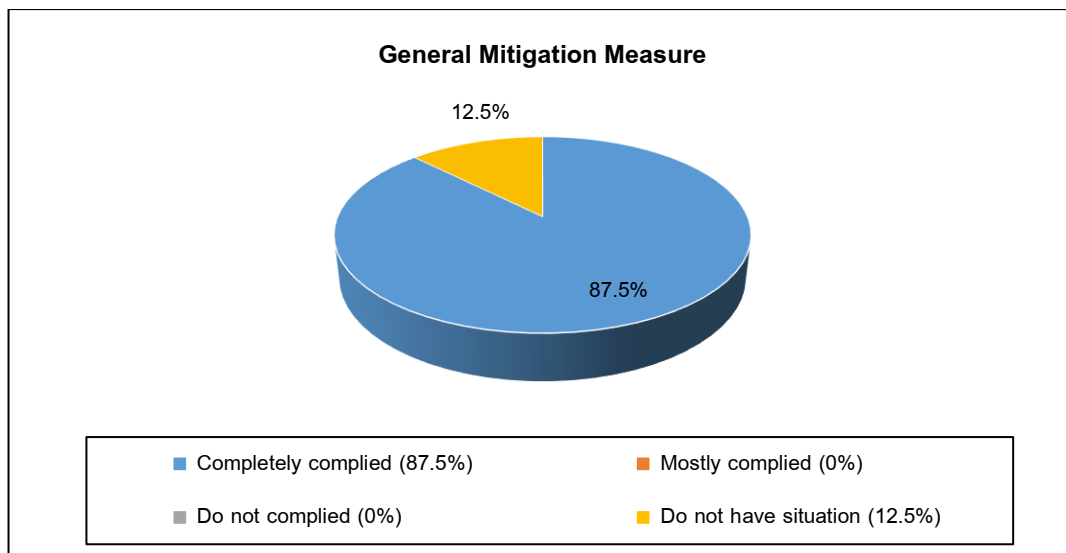
Figure 4-1 The Results of General Mitigation Measures Implementation Compliance

The results determined that the project completely complied on the general mitigation Measures for finished and on-going work while some mitigation measure (12.5% of total mitigation measure) were specified as NA due to there were no activity (Do not have situation) during the audit. The results are shown in Figure 4-1.

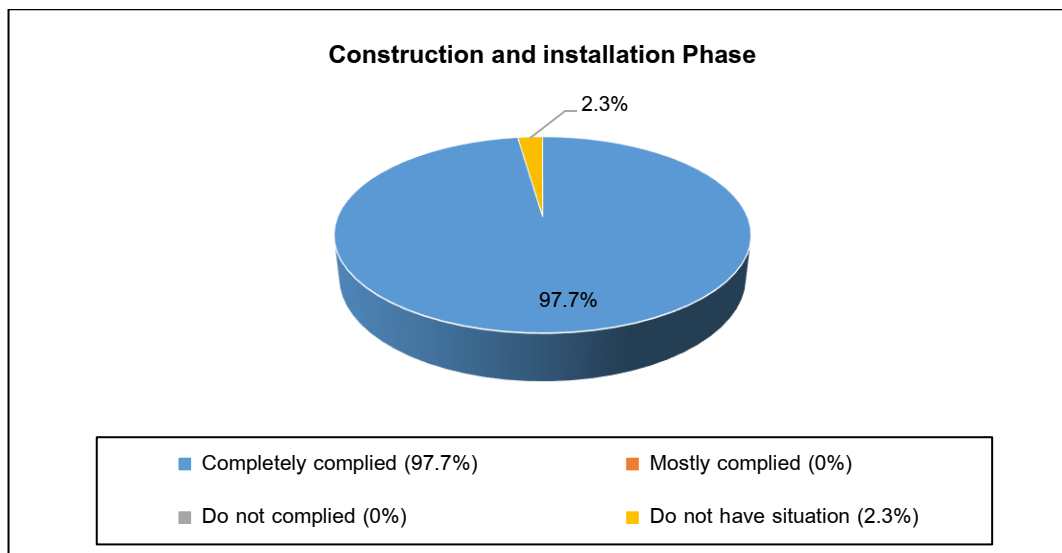
Figure 4-2 The Results of Environmental Mitigation Measures Implementation Compliance in Construction and Installation Phase

The results determined that the project completely complied on the environmental mitigation measures implementation for Construction and Installation Phase. Some mitigation measures (2.3% of all mitigation measures) do not have the operation during the audit period. Detail are shown in Figure 4-2.

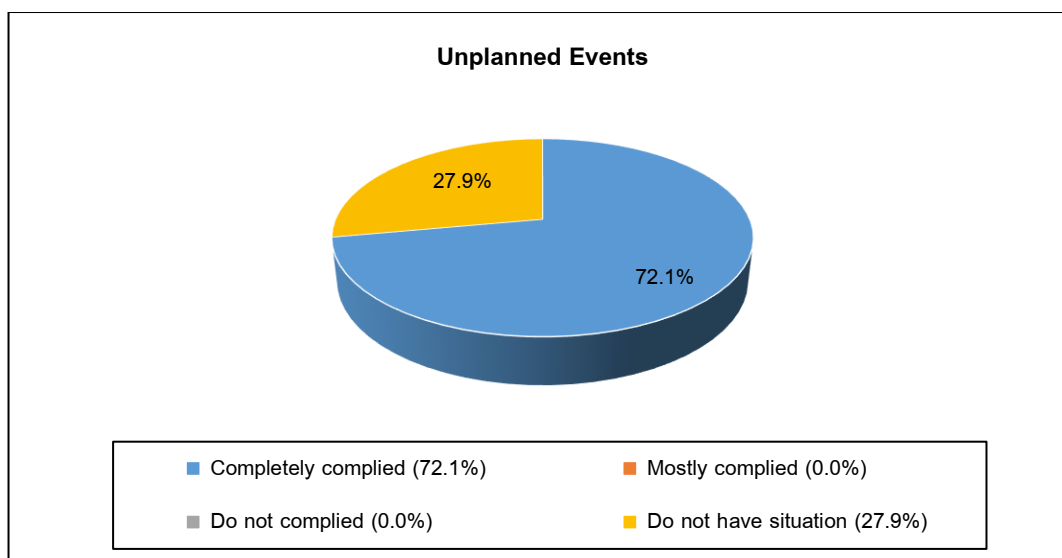
Figure 4-3 The Results of Environmental Mitigation Measures Implementation Compliance in Unplanned Events

The results determined that the project completely complied on the environmental mitigation measures implementation for unplanned event. However, some identified unplanned events (27.9%) do not have situation follows the Mitigation Measures (NA). The results are shown in Figure 4-3.

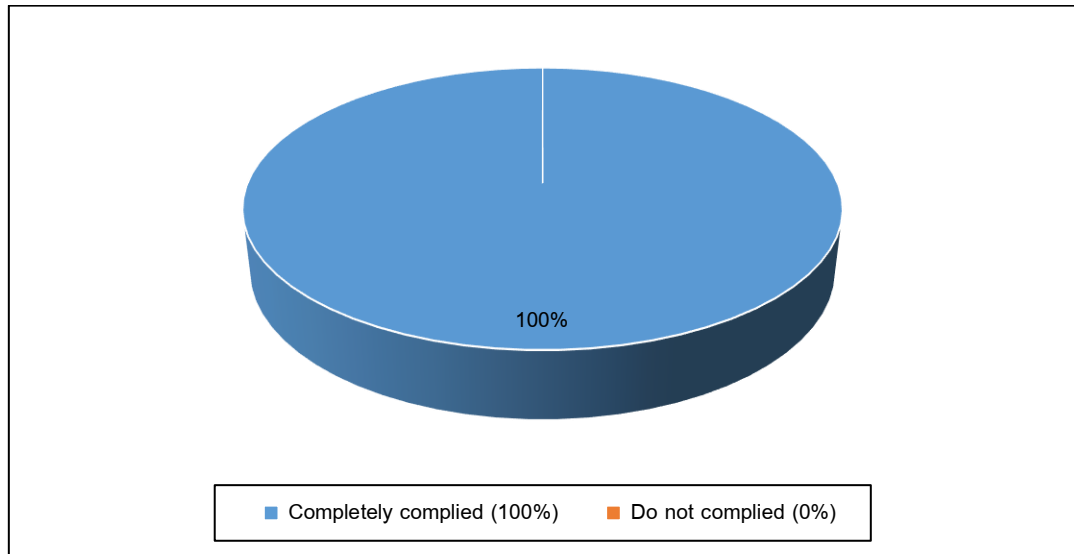
Figure 4-4 Summary of Monitoring Measure Implementation Results

The results of Environmental Monitoring determined that the project completely complied with 100% as shown in Figure 4-4.
