Monitoring Report of PTTEPI's Yangon Office Building (Construction Phase) during January – June 2020

PTTEP International Limited (PTTEPI)

Project Title	PTTEPI's Yangon New Office Building
Project Location (Address)	No. (2), Sei-Myaung Yeiktha Street, 8 ½ Mile, Mayangone Township, Yangon.
ECC number	Letter No. Forest 3(2)/ 6(D) (3423/2017) dated on 25 th October 2017

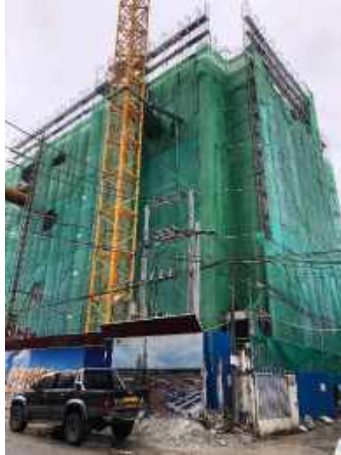
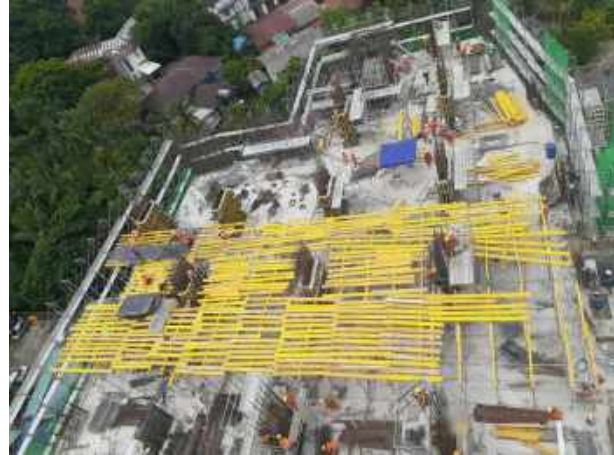
Figure 1-3 PTTEPI's Yangon Office Building in construction phase during January – June 2020

Once the demolition of old building finished, PTTEPI started the construction of new office building since January 2018 and expected to complete in January 2021 . The main activity during January – June 2020 was structural work. The example for construction activity as shown in Figure 1-3.

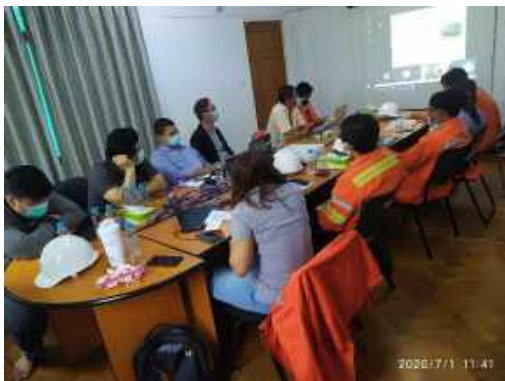
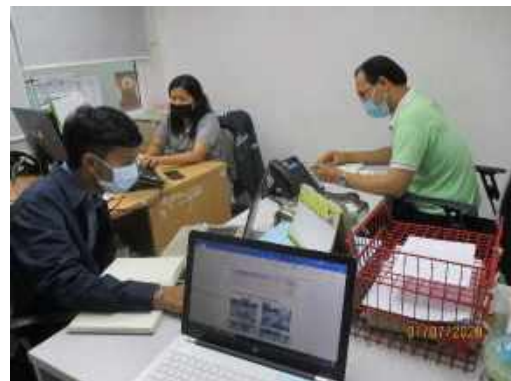
Figure 2-1 Mitigation Measures Compliance Audit (Desktop Audit)

As the Covid-19 pandemic, Audit of construction phase was performed as desktop audit at PTTEPI's Yangon Office Building on July 1, 2020 (Figure 2-1) and document checking by setting 4 levels of evaluation as follows;

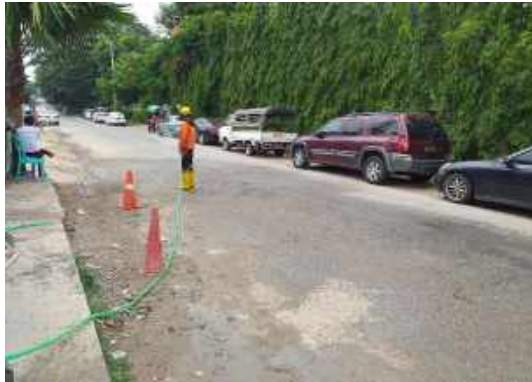
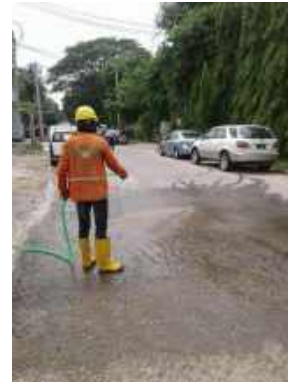
Figure 2-2 Water Spray

- **Air Pollution** - The project complied with the environmental mitigation measures strictly such as assigned staff to spray water around construction area at least three time a day or more in dry season or depending on the atmospheric conditions and the existing road was in a good condition. The project provided PVC mesh sheets around the construction areas in order to prevent dust dispersion and reduced effected to the communities nearby the construction site and along the transportation route. The project has finished piling and foundation work, the main activity during January – June 2020 was structural work, concrete work which transported by concrete truck. However, in case of the project has activity about construction materials transportation, the truck was covered during transport material to the construction area as specified in measure. Moreover, the contractor provided dust masks for workers and controlled all worker wear dust mask during working.

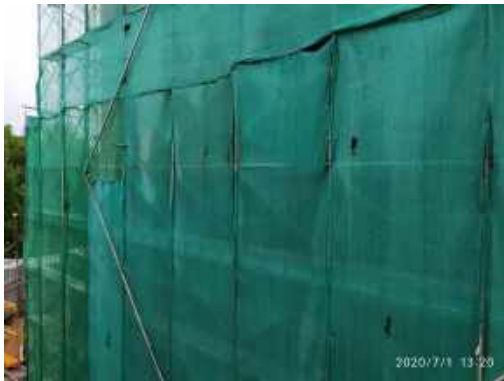
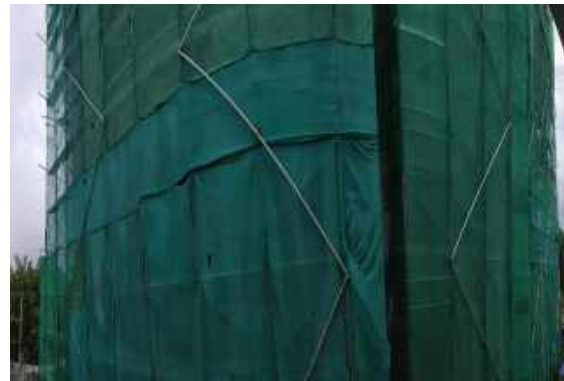
Figure 2-3 PVC Mesh Sheet

Aspects	Potential Impacts	Mitigation Measures	Location	Period/ Frequency	Status	Details	Remarks/ Reference
Environmental Mitigation Measures							
Air Pollution	<ul style="list-style-type: none"> Impacts on air quality from dust dispersion resulting from foundation and structural work cause adverse effected to the communities nearby the construction site and along the transportation route. 	<ul style="list-style-type: none"> Water spraying twice a day at and around the construction areas 	Project Site	Construction Phase	✓	The project has assigned staff to spray water around construction area at least twice a day or more in dry season or depending on the atmospheric conditions.	Figure 2-2 and Appendix J
		<ul style="list-style-type: none"> Polyester/ PVC mesh sheet should be covered around the construction areas 			✓	The project provided PVC mesh sheets around the construction areas in order to prevent dust dispersion and reduced effected to the communities nearby the construction site and along the transportation route.	Figure 2-3

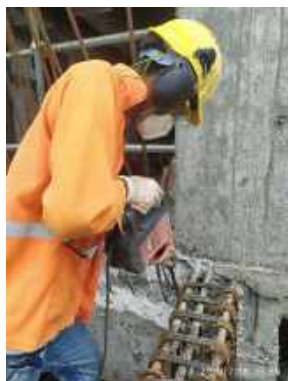
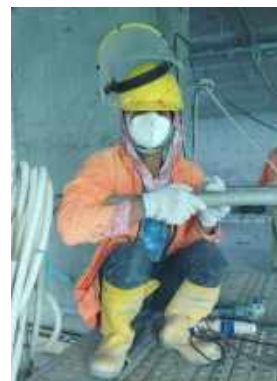
Figure 2-4 Personal Protective Equipment (PPE)

Aspects	Potential Impacts	Mitigation Measures	Location	Period/ Frequency	Status	Details	Remarks/ Reference
		<ul style="list-style-type: none"> Dust masks should be provided (where applicable) to specified construction workers. 			✓	The contractor provided dust masks for workers and controlled all worker wear dust mask during working.	Figure 2-4
Excessive Noise and Vibration	<ul style="list-style-type: none"> Impacts on excessive noise and vibration from foundation and structural work to disturb the nearby communities. 	<ul style="list-style-type: none"> Provide noise protection equipment such as ear muff, ear plugs to the construction workers working in the area 	Project Site	Construction Phase	✓	The contractor provided ear muffs for workers and controlled to use during working in high noise area.	Figure 2-4
		<ul style="list-style-type: none"> Try to carry out construction activities with high noise and vibration level at day time, some activities need to be carried out in the nighttime. 			✓	The project has finished piling and foundation work, the main activity during January – June 2020 was structural work which generally concrete work. The contractor emphasized all workers in daily toolbox talk before working to carried out the construction activities with high noise and vibration level at daytime in order to reduce noise and vibration impact to nearby communities. However, there was no any complaints during January – June 2020.	Appendix J

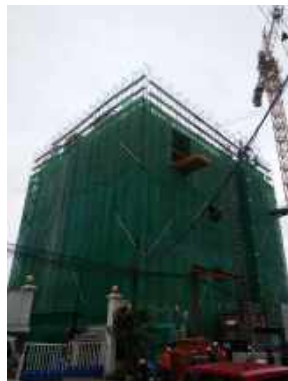
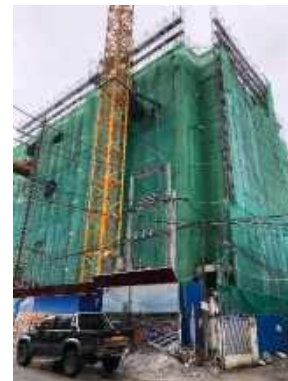
Figure 2-5 Structural Work

The project has finished piling and foundation work, the main activity during January – June 2020 was structural work, concrete work.

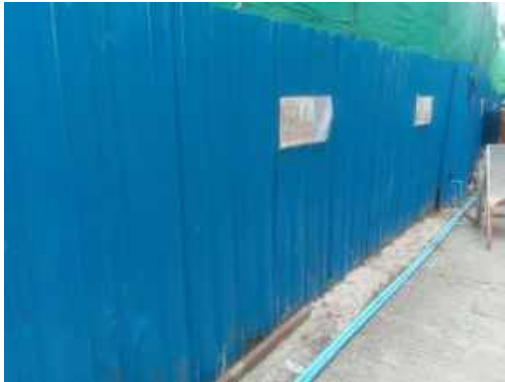
Figure 2-6 Noise Barrier

<ul style="list-style-type: none"> Install metal sheet as temporary noise barrier at construction site to reduce noise impact nearby communities 			✓	Noise barrier (metal sheet) was installed around the construction site to reduce noise impact to nearby communities.	Figure 2-6

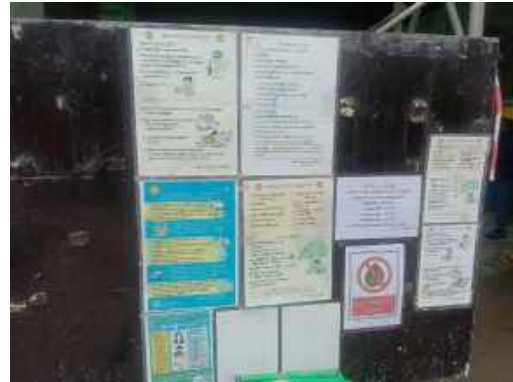
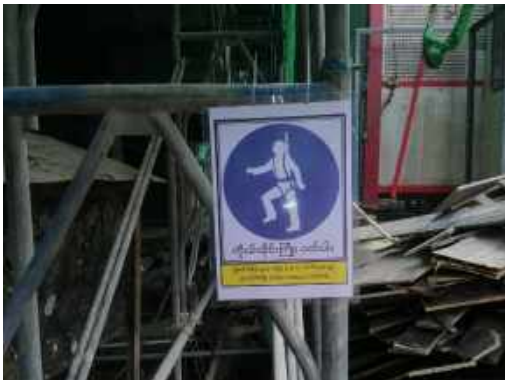
Figure 2-7 Warning Sign

Aspects	Potential Impacts	Mitigation Measures	Location	Period/ Frequency	Status	Details	Remarks/ Reference
		<ul style="list-style-type: none"> Install warning signs that can be clearly seen to show the access road and construction area. 			✓	Warning signs were installed and can be clearly seen at the public road (in front of the construction area) and within construction area.	Figure 2-7
		<ul style="list-style-type: none"> Avoiding/ lessening mobilization of material and equipment at day time. 			✓	The contractor informed about construction plan and transportation route for construction materials and heavy vehicles to local people. Moreover, avoiding transportation of materials and equipment at day time.	Appendix D-2
		<ul style="list-style-type: none"> Prepare security guard and signal man at guard house close to access road to give the sign in and out of vehicle from project area. 			✓	Security guard are stationed at guardhouse in front of construction area for 24 hr. (2 shift) and the project also provided signal man while transportation of construction materials to give the sign in and out of vehicle/truck from project area.	Figure 2-8 and Appendix J

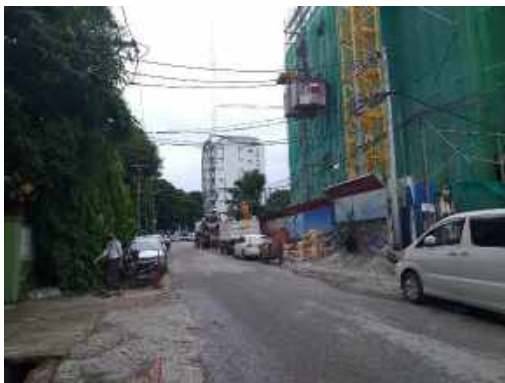
**Figure 2-9 Public Road
(In front of the construction area)**

prevent road deterioration. Moreover, the public road (in front of the construction area) was in good condition and there was no complaint from nearby communities.

<ul style="list-style-type: none"> Carry out regular, routine check and maintenance of vehicles following safety instruction. 			✓	Routine inspection and preventive maintenance for all vehicles as per inspection plan.	Appendix E-4
		<ul style="list-style-type: none"> Strictly control on over loading of heavy truck to prevent damage on road surface. 			✓	The contractor has strictly controlled of overloaded heavy vehicles to prevent road deterioration. Moreover, the public road (in front of the construction area) was in good condition and there was no complaint from nearby communities.	Figure 2-9

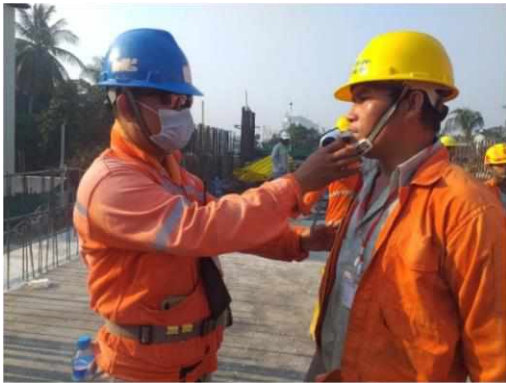
Figure 2-11 Alcohol Test

<ul style="list-style-type: none"> Test alcohol and drug on drivers before transportation. 			✓	The contractor prepared drug and alcohol abuse policy and enforced all workers to follow. Alcohol testing was conducted before working every day. The worker will immediately stop working if alcohol is found more than 0%. For drug testing, workers were random tested (3 times/month, the worker who found to be positive in drug testing shall be required to undergo rehabilitation and counseling in government accredited center. However, during January-June 2020 there were no workers found positive in drug test	Figure 2-11 Appendix H-1 and Appendix H-2

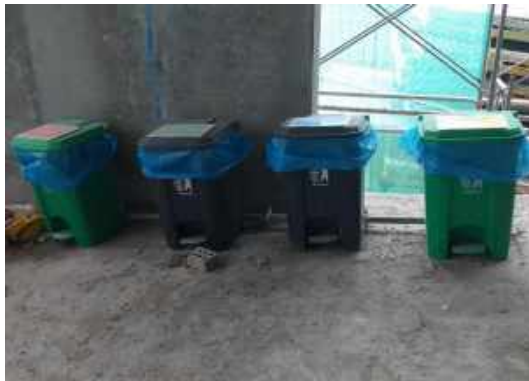
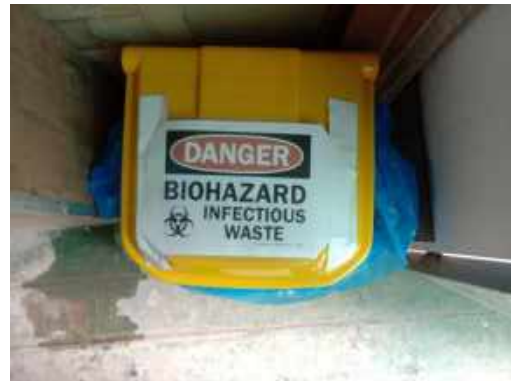
Figure 2-13 Waste Containers

- Non-Hazardous Waste - The contractor provided temporary storage area for construction materials. separate waste containers with cover are provided for 5 types; general waste (blue), recycle waste (yellow), hazardous waste (red), organic waste (green) and biohazard infectious waste. The quantity of waste was recorded by contractor. The contractor cooperated with YCDC to collect and dispose of waste in order to prevent residual waste in construction area. Moreover, the constructor enforced all workers not to burn any wastes in the construction area.
- Hazardous Waste - Hazardous waste container (red) was provided at the construction area. However, there are no hazardous waste during construction phase in January – June 2020. If there are occurred, the contractor will cooperate with licensed contractor or authorities to collect and dispose.

Aspects	Potential Impacts	Mitigation Measures	Location	Period/ Frequency	Status	Details	Remarks/ Reference
Solid waste	<ul style="list-style-type: none"> Improper management of construction waste will cause the adverse effect to the environmental. 	Non-Hazardous Waste <ul style="list-style-type: none"> Provide storage area for construction materials. 	Project Site	Construction Phase	✓	The contractor has provided temporary storage area for construction materials.	Figure 2-12
		<ul style="list-style-type: none"> Prepare proper waste bins or containers covered with garbage bag for waste collection at the construction site. 			✓	Waste containers with cover are provided at the construction area for 5 types; general waste (blue), recycle waste (yellow), hazardous waste (red), organic waste (green) and biohazard infectious waste. Moreover, the quantity of waste was recorded by contractor.	Figure 2-13 and Appendix G-2

<ul style="list-style-type: none"> Inform concerned authorities (YCDC) to collect and dispose of waste every day. 			✓	The contractor cooperated with YCDC to collect and dispose waste to prevent residual waste in construction area.	Appendix G-1
		<ul style="list-style-type: none"> If possible, reuse construction residues such as wood scrap and steel, or inform concerned authorities to collect and dispose. 			✓	The contractor cooperated with YCDC to collect and dispose of waste to prevent residual waste in construction area.	Appendix G-1
		<ul style="list-style-type: none"> Prohibit burning waste in construction area. 			✓	The constructor enforced all workers not to burn any wastes in the construction area. Moreover, the contractor has provided separate waste containers with cover at the construction area	Figure 2-13 and Appendix G

Aspects	Potential Impacts	Mitigation Measures	Location	Period/ Frequency	Status	Details	Remarks/ Reference
		Hazardous Waste • Separate hazardous waste from solid waste and store the specific containers with clear label.			✓	The contractor has provided separate waste containers with cover for waste collection at the construction area. However, there are no hazardous waste during construction phase in January – June 2020.	Figure 2-13

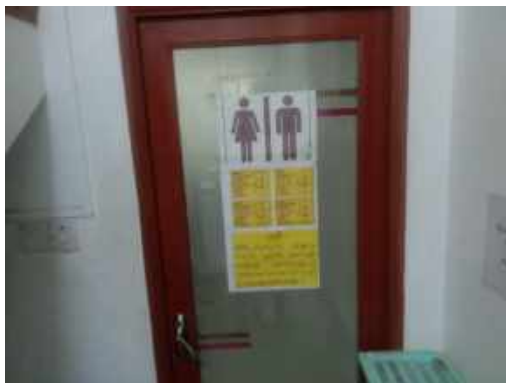
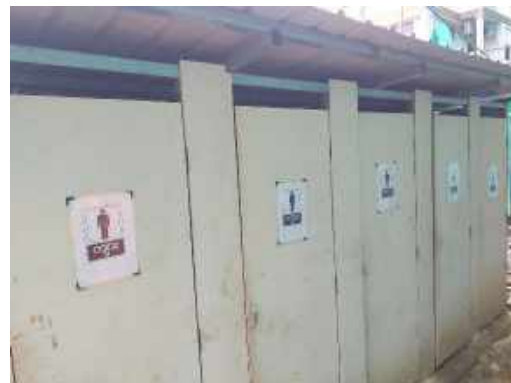
Figure 2-14 Toilets and Mobile Toilets

• Hazardous waste will be disposed by licensed contractor or authorities			✓	Hazardous waste container (red) was provided at the construction area. However, there are no hazardous waste during construction phase in January – June 2020. In case of hazardous waste generated, the project will strictly implement as specified in the measure.	Appendix G-1
Wastewater	• Improper management of sanitary system within the site will caused the adverse effect to the environmental	1) Wastewater from workers • Provide appropriate sanitary facilities in construction site and properly maintained for construction workers.	Project Site	Construction Phase	✓	The contractor has provided 6 mobile toilets within construction area 2-3 toilets at the back of construction area and 9 toilets within PTTEPI Office for 370 workers.	Figure 2-14

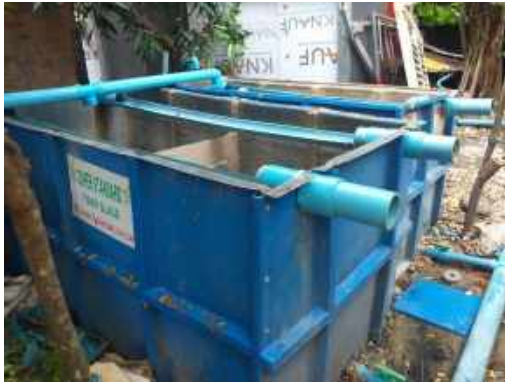
Figure 2-15 Temporary Drainage System

2) Surface runoff • Provide temporary drainage system to hold wastewater before being discharged out of the project.			✓	The contractor provided temporary drainage system in the construction area to hold wastewater before discharged out of the project.	Figure 2-15 and Appendix G-3

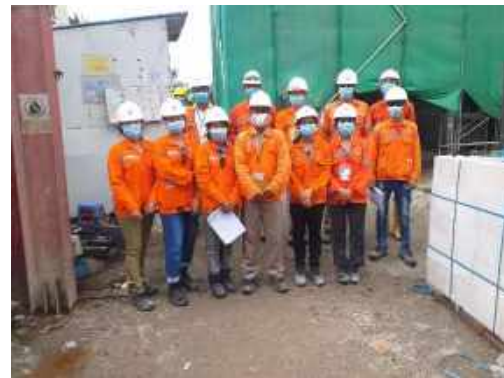
Figure 2-16 Civil Engineer and Safety Staff

<ul style="list-style-type: none"> Implement all measures to mitigate dust, excess noise, waste management and transportation. 			✓	The project strictly implemented mitigation measures as per IEE report.	Appendix B
		<ul style="list-style-type: none"> Provide skillful and experienced engineers to closely inspect construction activities and duty permanently during the entire construction period. 			✓	The contractor provided 12 civil engineer and 7 safety staff to closely inspect construction activities throughout the construction period.	Figure 2-16

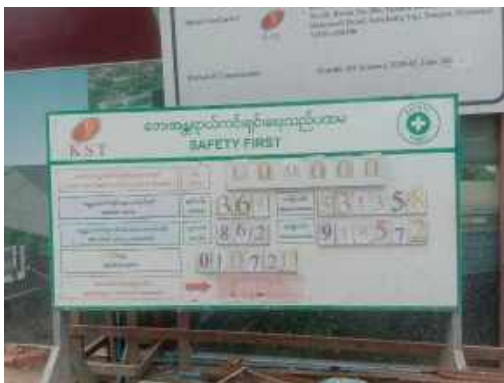
Figure 2-17 Signboard in front of the Construction Area

Aspects	Potential Impacts	Mitigation Measures	Location	Period/ Frequency	Status	Details	Remarks/ Reference
		<ul style="list-style-type: none"> Assign project staff with 24/ 7 available telephone number to handle any complaint/ issue from surrounding. In case of any damage by project activities PTTEPI will investigate and solve the problem. 			✓	PTTEPI provided grievance handling guideline to receive any complaints from the stakeholder and resolve the complaint in the immediate. Moreover, project' s signboard was installed in front of the construction area to inform the project details such as project name, owner, consultant, contractor, period of construction and emergency contact number. However, there was no any complaints during January – June 2020.	Figure 2-17 and Appendix D-1
		<ul style="list-style-type: none"> Install signboard in front of the Project site in order to inform about construction area with the name of the Project, Contractor company, permission license, PTTEP representative name and telephone number etc. 			✓	Project' s signboard was installed in front of the construction area to inform the project details such as project name, owner, consultant, contractor, period of construction and emergency contact number.	Figure 2-17

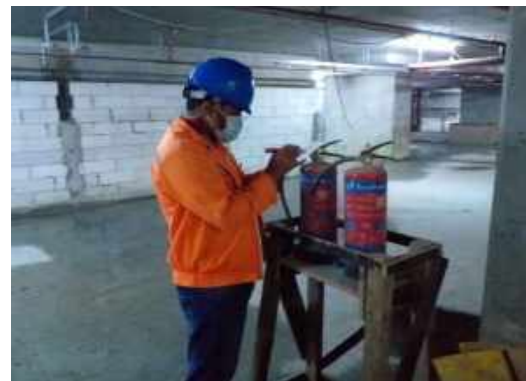
Figure 2-19 Firefighting Equipment Inspection

Aspects	Potential Impacts	Mitigation Measures	Location	Period/ Frequency	Status	Details	Remarks/ Reference
	<ul style="list-style-type: none"> Carelessness of workers may cause fire, injuries and death. 	<ul style="list-style-type: none"> Install appropriate warning signs, markings and safety signs. 			✓	The contractor has installed warning signs and safety sign in construction area to warns workers from dangers. Moreover, the contractor has provided Stop Work Policy to maintain a safe and secure work environment.	Figure 2-7 and Appendix E-2
		<ul style="list-style-type: none"> Regular checking all equipment to ensure it can be used without defect. 			✓	Routine inspection and preventive maintenance for all equipment were conducted as per inspection plan.	Appendix E-4
		<ul style="list-style-type: none"> Firefighting equipment and portable fire extinguishers shall be properly provided in construction area. 			✓	The contractor has provided firefighting equipment in the construction area and inspected monthly.	Figure 2-19

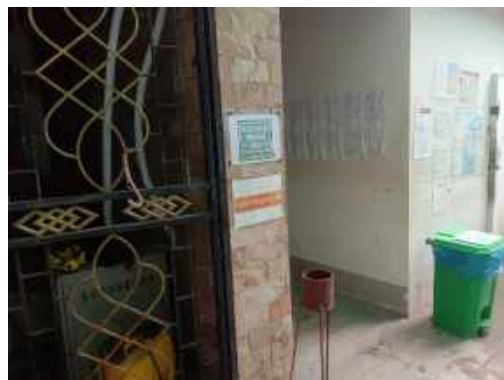
Figure 2-20 Smoking area

<ul style="list-style-type: none"> Provide smoking area in the construction zone. 			✓	The contractor has provided smoking areas in the west and in front of construction area.	Figure 2-20

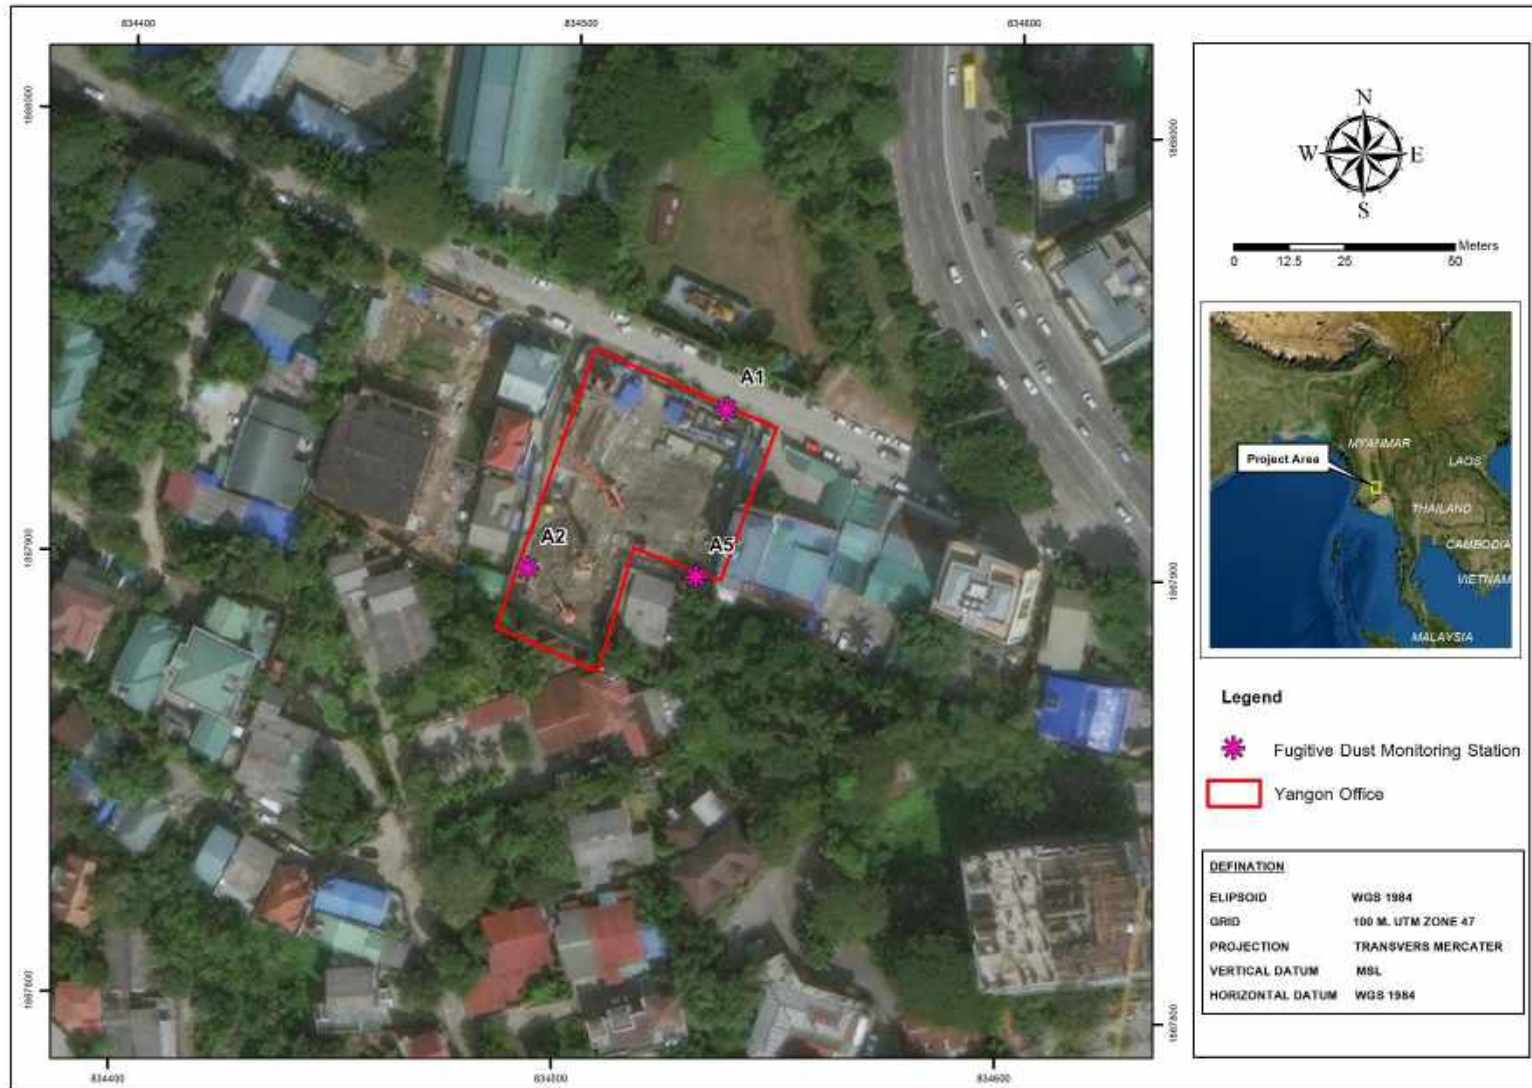
Figure 3-1 Fugitive Dust Monitoring Station

The detail and coordinate of fugitive dust monitoring station as shown in Table 3-3 and Figure 3-1.

Monitoring Station	Coordinate (UTM Datum WGS 84)		
	Zone	East (X)	North (Y)
1. Construction site : North of construction fence (A1)	47Q	195194	1867484
2. PTTEPI Building 7 : West of construction fence (A2)	47Q	195149	1867448
3. House behind PTTEPI Office : South-east of construction fence (A5)	47Q	195187	1867446

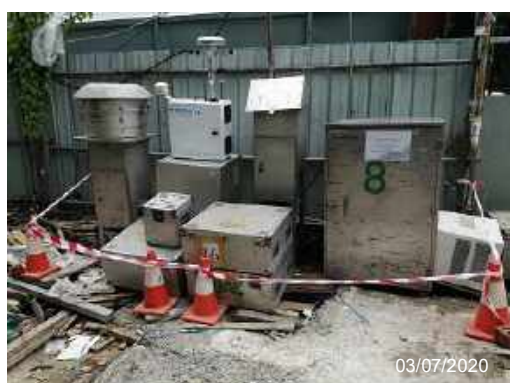
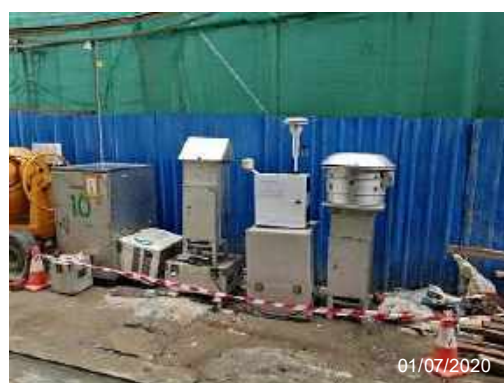
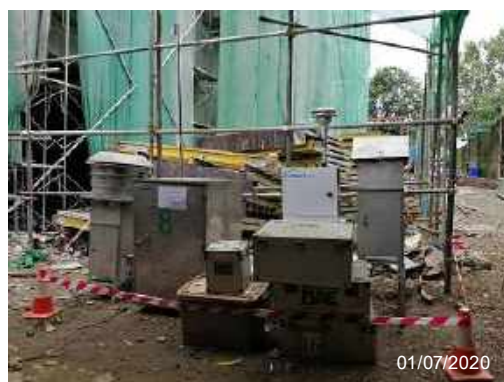
Figure 3-2 Fugitive Dust Monitoring

Fugitive dust samples were monitored at PTTEPI Building 7 and House behind PTTEPI Office during July 1-3, 2020. Construction site was monitored during July 3-5, 2020 as shown in Figure 3-2.

Fugitive dust monitoring results found that Total Suspended Particulate (TSP) of all station including Construction site : North of construction fence (A1), PTTEPI Building 7 : West of construction fence (A2) and House behind PTTEPI Office: South-east of construction fence (A5) have complied with Ambient Air Quality of WORLD BANK GROUP which determined that Average 24 hours TSP should not exceed $230 \mu\text{g}/\text{m}^3$. For the results of Particulate matter less than 10 Micron (PM-10) found that all stations have complied with National Environmental Quality (Emission) Guideline (EQEG) and the Ambient Air Quality Standard of WHO and IFC which determined that PM10 should not exceed $50 \mu\text{g}/\text{m}^3$ and $150 \mu\text{g}/\text{m}^3$, respectively.

The comparison of fugitive dust monitoring results in the construction phase in July 2020 and baseline data found that most of the results of Total Suspended Particulate (TSP) and Particulate matter less than 10 Micron (PM-10) of all stations have higher than baseline data.

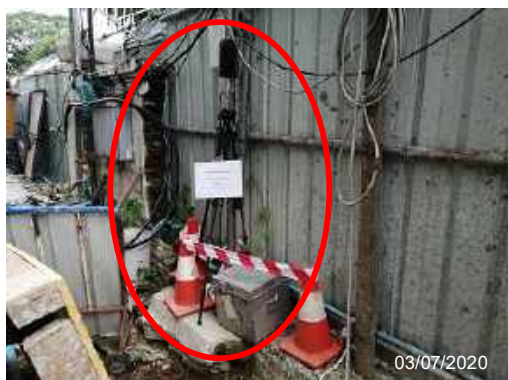
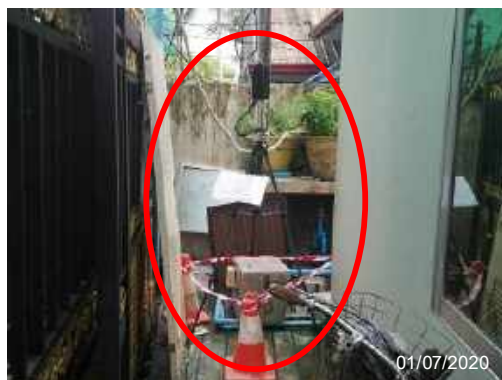
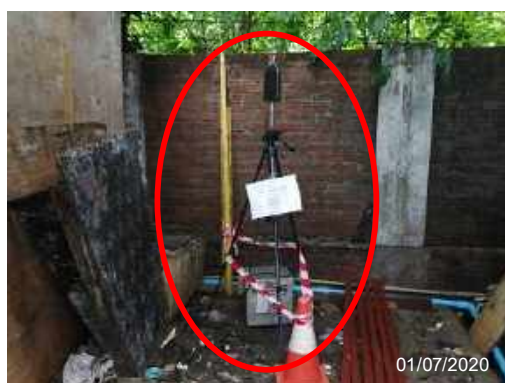
Figure 3-4 Noise Level Monitoring

Noise level monitoring of PTTEPI's Yangon Office Building were monitored at PTTEPI Building 7 and House behind PTTEPI Office during July 1-3, 2020. Construction site was monitored during July 3-5, 2020 as shown in Figure 3-4.

Noise level monitoring results found that The L_{Aeq} -1 hr daytime of Construction site : North of construction fence (N1), PTTEPI Building 7 : West of construction fence (N2) and House behind PTTEPI Office : South-east of construction fence (N5) were in ranged of 56.0-67.2, 58.6-68.4 and 57.4-62.9 dB(A), respectively. While The L_{Aeq} -1 hr night-time of N1, N2 and N5 were ranged from 59.1-64.3, 57.9-68.6 and 53.0-58.0 dB(A), respectively. All of the result of L_{Aeq} -1 hr daytime and L_{Aeq} -1 hr night-time has complied with EQEG, 2015 for Industrial/ Commercial Area which determined L_{Aeq} -1 hr daytime and night-time not more than 70 dB(A).

The comparison of noise level monitoring results in construction phase July 2020 and baseline data found that the result of L_{Aeq} -1 hr daytime and L_{Aeq} -1 hr night-time of 3 stations were slightly higher than baseline data. However, all of the result of L_{Aeq} -1 hr daytime and night-time in construction phase in July 2020 has complied with EQEG, 2015 for Industrial/ Commercial Area which determined L_{Aeq} -1 hr daytime and night-time not more than 70 dB(A). In addition, the project has continually monitoring, as specified in the measure for surveillance of environmental impact from the project construction activity.

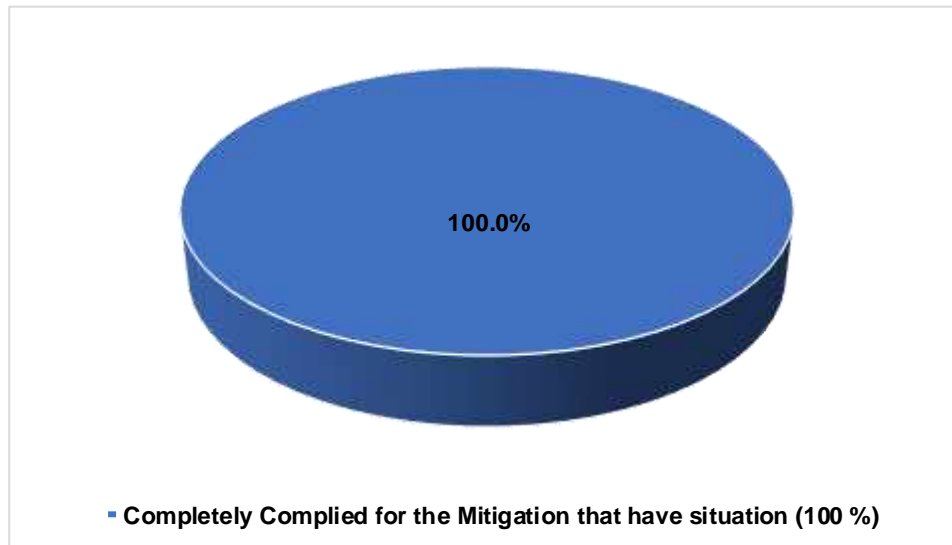
Figure 4-1 The Results of Environmental Mitigation Measures Compliance in Construction Phase during January-June 2020

The results determined that the project completely complied on the Mitigation Measures during January - June 2020 in construction phase with 100% for the mitigation that have situation. However, there are some mitigation that do not have situation during the audit period equal to 2.2% of all mitigation measure. The results are shown in Figure 4-1.

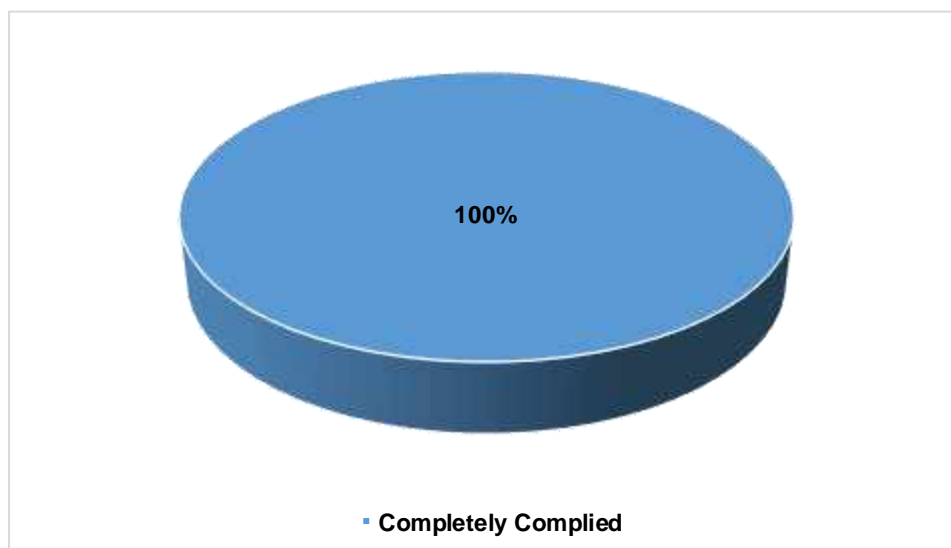
Figure 4-2 The Results of Environmental Monitoring in Construction Phase during January - June 2020

The project has completely complied the environmental monitoring as specified in IEE, including Fugitive dust monitoring, Noise level monitoring, Grievance mechanism monitoring, Public and occupational health and safety monitoring as shown in Figure 4-2.
