## Monitoring Report of PTTEPI's Yangon Office Building (Construction Phase) in 2018

PTTEP International Limited (PTTEPI)

**REM-LIAE**  
LABORATORY AND CONSULTANT  
COMPANY LIMITED

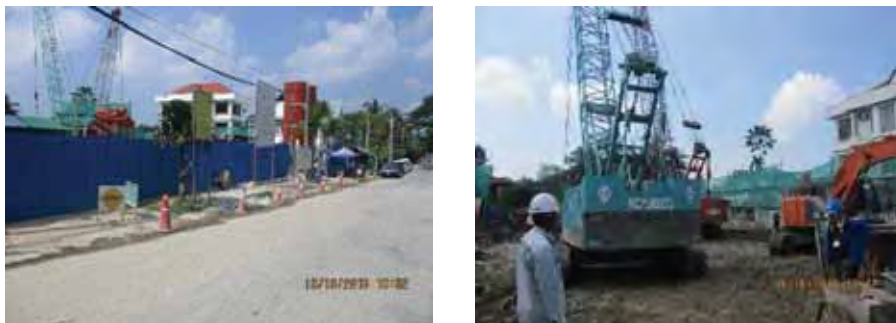
Figure 1-3 PTTEPI's Yangon Office Building in construction phase

Once the demolition of old building finished, PTTEPI started the construction of new office building since January 2018 and expected to complete in 2020. The example for construction activity as shown in Figure 1-3.

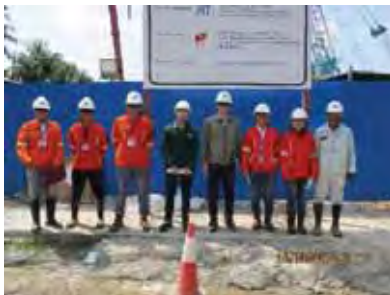
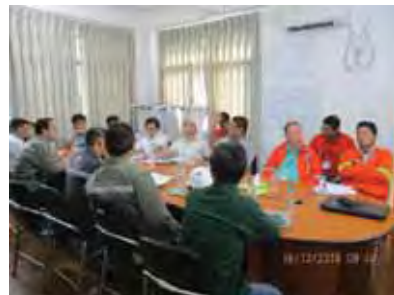
Figure 2-1 Mitigation Measures Compliance Audit

Audit of construction phase was performed at PTTEPI's Yangon Office Building on October 18, 2018 (Figure 2-1) and document checking by setting 4 levels of evaluation as follows;

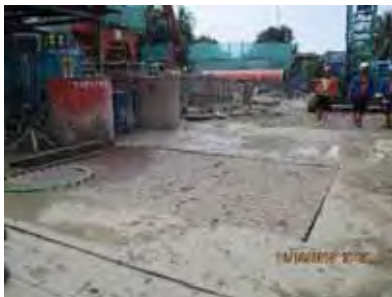
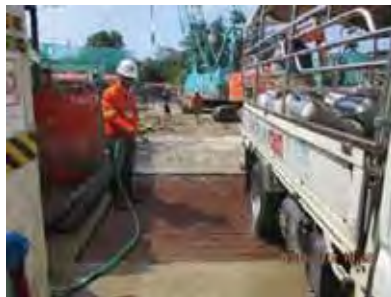
Figure 2-2 Truck's wheels cleaning

Aspects	Potential Impacts	Mitigation Measures	Location	Period/ Frequency	Status	Details	Recommendation	Remarks/ Reference
<b>Environmental Mitigation Measures</b>								
Air Pollution	<ul style="list-style-type: none"> <li>Impacts on air quality from dust dispersion resulting from foundation and structural work cause adverse effected to the communities nearby the construction site and along the transportation route.</li> </ul>	<ul style="list-style-type: none"> <li>Water spraying twice a day at and around the construction areas</li> </ul>	Project Site	Construction Phase	✓	Water spraying was provided three times per day at and around the construction areas. However, spraying had not conducted in the rainy day due to wet soil conditions made suspended particulate value was low level. The contractor always records the weather condition and cleans the truck's wheels before go out the construction area to reduce dust dispersion.	-	Figure 2-2 and Appendix J

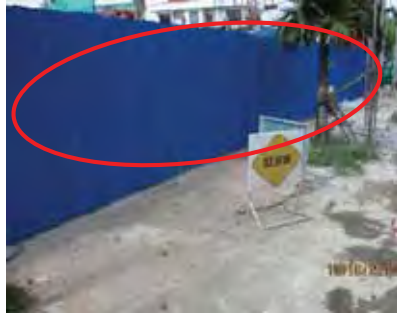
Figure 2-6 Noise barrier

<ul style="list-style-type: none"> <li>Install metal sheet as temporary noise barrier at construction site to reduce noise impact nearby communities</li> </ul>			✓	Noise barrier was installed by metal sheet around the construction site to reduce noise impact nearby communities.	-	Figure 2-6
Traffic	<ul style="list-style-type: none"> <li>The increasing number of vehicle especially heavy truck and trailer for construction materials and heavy equipment at day time might cause traffic congestion.</li> </ul>	<ul style="list-style-type: none"> <li>Inform concerned authorities and local people about the construction plan with transportation route for construction materials and heavy vehicles.</li> </ul>	Project Site	Construction Phase	✓	The contractor informed about construction plan and transportation route for construction materials and heavy vehicles to local people.	-	Appendix D-2
		<ul style="list-style-type: none"> <li>All Project drivers and transportation activities have to follow the laws related to transportation of Myanmar and follow PTTEP's driving Policy which include vehicle safety rules and journey management.</li> </ul>			✓	The contractor prepared journey management and transportation safety procedure and enjoined workers to follow regulation.	-	Appendix F-1

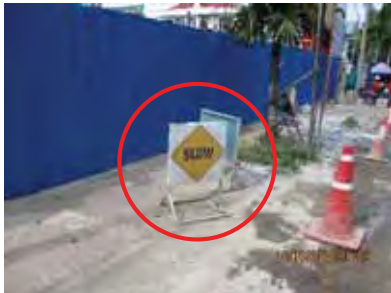
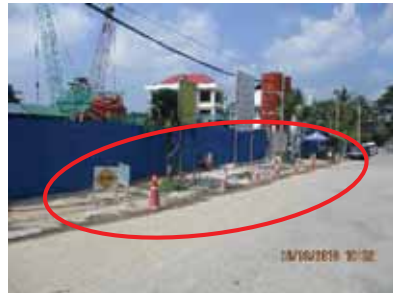
Figure 2-7 Warning sign

Aspects	Potential Impacts	Mitigation Measures	Location	Period/ Frequency	Status	Details	Recommendation	Remarks/ Reference
	<b>On Workers</b> <ul style="list-style-type: none"> <li>Increased pollution in working zone of project site such as dust diffusion, excess noise.</li> <li>Carelessness of workers may cause fire, injuries and death.</li> </ul>	<ul style="list-style-type: none"> <li>Provide sufficient first aid kits at the construction area and coordinate with nearby hospital for admission in case of accidents.</li> </ul>			✓	The medic was stand by at medic room for medical treatment included first aid kit and medical supplies. Moreover, emergency respond procedure and training were provided to respond in emergency case..	-	Figure 2-18
		<ul style="list-style-type: none"> <li>Install appropriate warning signs, markings and safety signs.</li> </ul>			✓	Warning signs were installed and can be clearly seen at the public road (in front of the construction area) and at construction area.	-	Figure 2-7

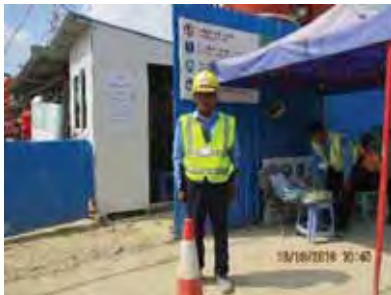
Figure 2-8 Security guard

Aspects	Potential Impacts	Mitigation Measures	Location	Period/ Frequency	Status	Details	Recommendation	Remarks/ Reference
		<ul style="list-style-type: none"> <li>Install warning signs that can be clearly seen to show the access road and construction area.</li> </ul>			✓	Warning signs were installed and can be clearly seen at the public road (in front of the construction area) and at construction area.	-	Figure 2-7
		<ul style="list-style-type: none"> <li>Avoiding/lessening mobilization of material and equipment at day time.</li> </ul>			✓	The contractor informed about construction plan and transportation route for construction materials and heavy vehicles to local people. Moreover, avoiding transportation of materials and equipment at day time.	-	Appendix D-2
		<ul style="list-style-type: none"> <li>Prepare security guard and signal man at guard house close to access road to give the sign in and out of vehicle from project area.</li> </ul>			✓	Security guard and signal man always give the sign in and out of vehicle from project area.	-	Figure 2-8 and Figure 2-9

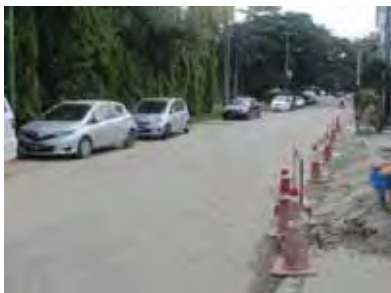
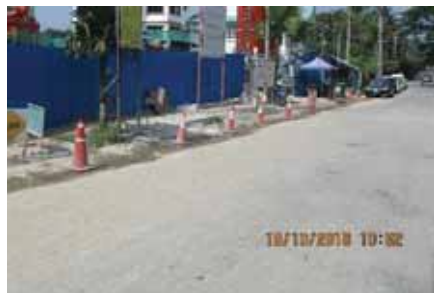
Figure 2-10 Public road (in front of the construction area)

<ul style="list-style-type: none"> <li>Carry out regular, routine check and maintenance of vehicles following safety instruction.</li> </ul>			✓	Routine inspection and preventive maintenance for all vehicles were conducted as per inspection plan.	-	Appendix E-4
		<ul style="list-style-type: none"> <li>Strictly control on over loading of heavy truck to prevent damage on road surface.</li> </ul>			✓	The contractor controlled the truck not to over loading to prevent damage on road surface. Moreover, the public road (in front of the construction area) was in good condition and there was no complaint from nearby communities.	-	Figure 2-10

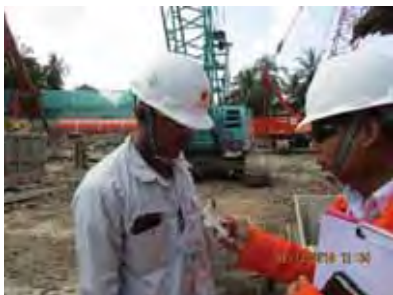
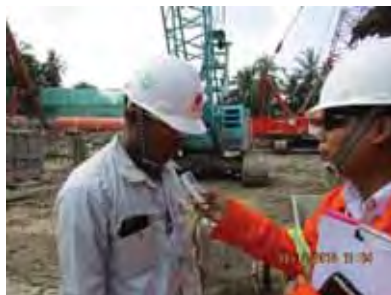
Figure 2-12 Alcohol test

Aspects	Potential Impacts	Mitigation Measures	Location	Period/ Frequency	Status	Details	Recommendation	Remarks/ Reference
		<ul style="list-style-type: none"> <li>Cover construction materials by tarpaulin during transportation to prevent falling and spreading of materials.</li> </ul>			✓	The truck was covered during transport material to the construction area.	-	Figure 2-4
		<ul style="list-style-type: none"> <li>In case of accident, the concerned sections must be promptly follow the emergency response plan.</li> </ul>			✓	The emergency response procedure was set up including incident, fire action, first aid action. Moreover, muster point is provided opposite the construction area in case of accident.	-	Figure 2-11 and Appendix E-3
		<ul style="list-style-type: none"> <li>Test alcohol and drug on drivers before transportation.</li> </ul>			✓	The contractor prepared drug and alcohol abuse policy and enforced all workers to follow. Alcohol testing was conducted before working every day. Worker will immediately stop working if alcohol is found more than 0%. For drug testing, workers were random tested at hospital.	-	Figure 2-12 and Appendix H

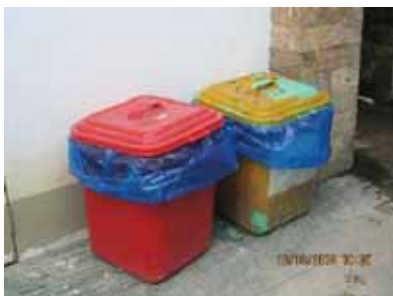
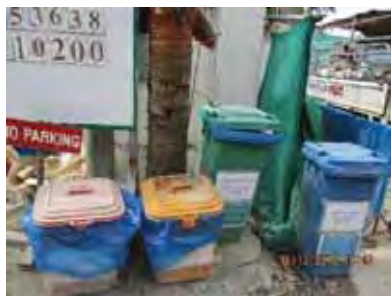
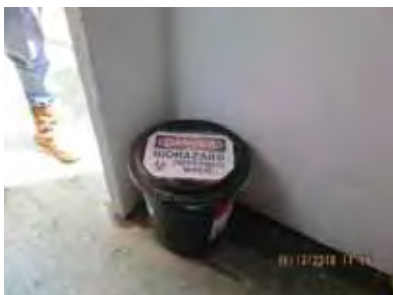
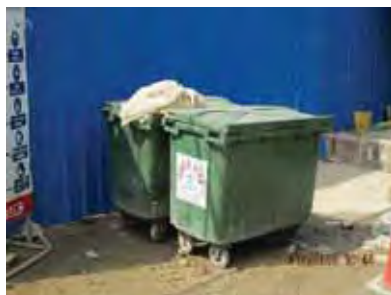
Figure 2-13 Waste containers

<b>Non-Hazardous Waste</b> <ul style="list-style-type: none"> <li>Provide storage area for construction materials.</li> </ul>	Project Site	Construction Phase	✓	The contractor provided storage area for construction materials.	-	-
Solid waste	<ul style="list-style-type: none"> <li>Improper management of construction waste will caused the adverse effect to the environmental.</li> </ul>	<ul style="list-style-type: none"> <li>Prepare proper waste bins or containers covered with garbage bag for waste collection at the construction site.</li> </ul>			✓	Waste containers with cover are provided at the construction area for 5 types; general waste (blue), recycle waste (yellow), hazardous waste (red), organic waste (green) and biohazard infectious waste. The quantity of waste was recorded by contractor.	-	Figure 2-13 and Appendix G-2

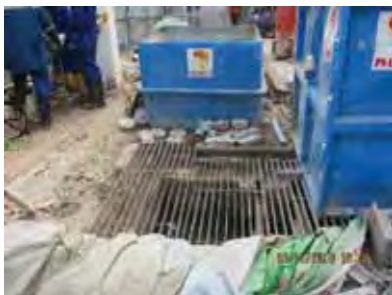
Figure 2-15 Drainage system

Aspects	Potential Impacts	Mitigation Measures	Location	Period/ Frequency	Status	Details	Recommendation	Remarks/ Reference
Wastewater	<ul style="list-style-type: none"> <li>Improper management of sanitary system within the site will caused the adverse effect to the environmental</li> </ul>	<b>1) Wastewater from workers</b> <ul style="list-style-type: none"> <li>Provide appropriate sanitary facilities in construction site and properly maintained for construction workers.</li> </ul>			✓	The toilets were provided at PTTEP's office for 4 rooms/40 workers.	-	Figure 2-14
		<b>2) Surface runoff</b> <ul style="list-style-type: none"> <li>Provide temporary drainage system to hold wastewater before being discharged out of the project.</li> </ul>				The contractor installed drainage system in the construction area to hold wastewater before discharged out of the project.		
		<ul style="list-style-type: none"> <li>Prohibit to throw and dispose of waste from demolition close to drainage system to obstruct the flow of surface runoff.</li> </ul>				The contractor prohibited all workers to throw and dispose waste demolition close to drainage system in order to prevent obstruct the water flow.

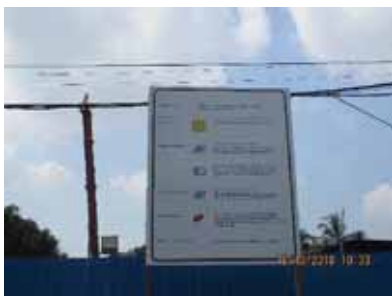
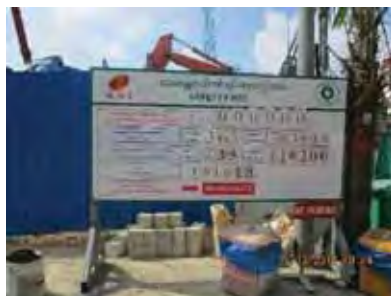
Figure 2-17 Signboard in front of the construction area

<ul style="list-style-type: none"> <li>Implement all measures to mitigate dust, excess noise, waste management and transportation.</li> </ul>			✓	The project strictly implemented mitigation measures as per IEE report.	-	Appendix B
		<ul style="list-style-type: none"> <li>Provide skillful and experienced engineers to closely inspect construction activities and duty permanently during the entire construction period.</li> </ul>			✓	The contractor provided civil engineer and safety staff to closely inspect construction activities throughout the construction period.	-	Figure 2-16
		<ul style="list-style-type: none"> <li>Assign project staff with 24/7 available telephone number to handle any complaint/ issue from surrounding. In case of any damage by project activities PTTEPI will investigate and solve the problem.</li> </ul>			✓	PTTEPI provided grievance handling guideline to receive any complaints from the stakeholder and resolve the complaint in the immediate. Moreover, project's signboard was installed in front of the construction area to inform the project details such as project name, owner, consultant, contractor, period of construction and emergency contact number.	-	Figure 2-17 and Appendix D-1

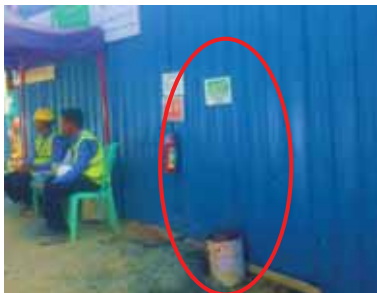
In front of the construction area

<ul style="list-style-type: none"> <li>Regular checking all equipment to ensure it can be used without defect.</li> </ul>			✓	Routine inspection and preventive maintenance for all equipment were conducted as per inspection plan.	-	Appendix E-4
		<ul style="list-style-type: none"> <li>Firefighting equipment and portable fire extinguishers shall be properly provided in construction area.</li> </ul>			✓	Firefighting equipment were provided in the construction area and inspected monthly.	-	Figure 2-19
		<ul style="list-style-type: none"> <li>Provide smoking area in the construction zone.</li> </ul>			✓	Smoking areas were provided 2 points; in front and in the west of the construction area.	-	Figure 2-20

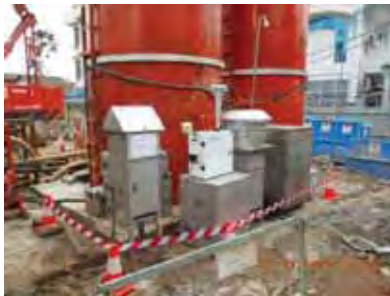
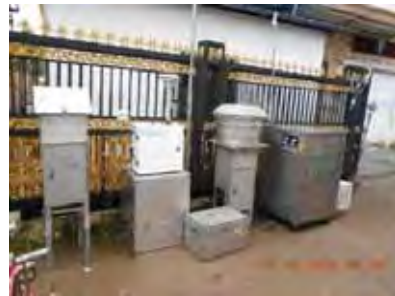
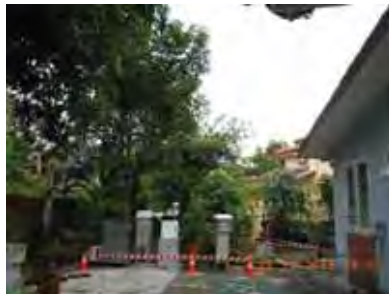
Figure 3-2 Fugitive Dust Monitoring on October 22-24, 2018

Fugitive dust samples were monitored at construction site, PTTEPI Building 7 and House behind PTTEPI Office on October 22-24, 2018 as shown in Figure 3-2.

Construction site : North of construction fence (A1) PTTEPI Building 7 : West of construction fence (A2)

House behind PTTEPI Office : South-east of construction fence (A5)

Referring to analysis number T18AG272-0004 to T18AG272-0006, fugitive dust samples were conducted on October 22-24, 2018 during construction phase. The result found that Total Suspended Particulate (TSP) complied with Ambient Air Quality of WORLD BANK GROUP and Particulate matter less than 10 Micron (PM-10) complied with National Environmental Quality (Emission) Guideline (NEQG) and, Ambient Air Quality Standard of WHO and IFC at all stations. Fugitive dust monitoring results are shown in Table 3-5.

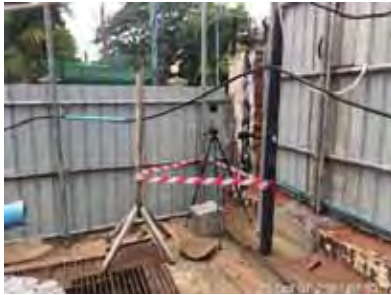
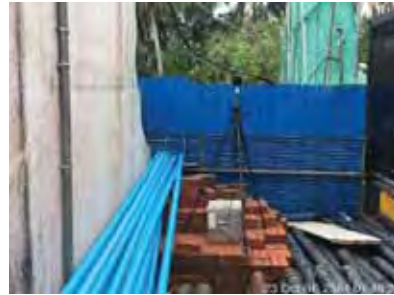
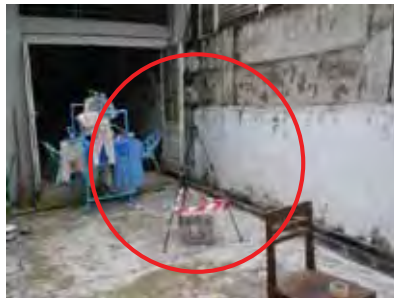
Figure 3-4 Noise Level Monitoring on October 22-24, 2018

Noise level monitoring of PTTEPI's Yangon Office Building was conducted at construction site, PTTEPI Building 7 and House behind PTTEPI Office on October 22-24, 2018 as shown in Figure 3-4.

Construction site : North of construction fence (N1) PTTEPI Building 7 : West of construction fence (N2)

House behind PTTEPI Office : South-east of construction fence (N5)

The  $L_{Aeq}$ -1 hr daytime and nighttime ranged from 64.2-75.5 and 57.1-73.6 dB(A) exceeding the limit set by NEQG, 2015 for Industrial/Commercial Area of 70 and 70 dB(A) for  $L_{Aeq}$ -1 hr daytime and nighttime, respectively. These might be caused by the traffic vehicle on the nearby road which located about 10 m. away from the monitoring station. PTTEPI will also keep continue the monitoring to check the noise level as bi-annually basis.

The  $L_{Aeq}$ -1 hr daytime ranged from 57.8-70.3 dB(A) exceeding the limit set by NEQG, 2015 for Industrial/Commercial Area of 70 dB(A) for  $L_{Aeq}$ -1 hr daytime. These might be caused by the traffic vehicle on the nearby road which located about 40 m. away from the monitoring station.

The  $L_{Aeq}$ -1 hr daytime and nighttime ranged from 60.7-74.0 and 50.1-68.5 dB(A) exceeding the limit set by NEQG, 2015 for Residential/ Institutional/ Educational Area of 55 and 45 dB(A) for  $L_{Aeq}$ -1 hr daytime and nighttime, respectively. These might be caused by the traffic vehicle on the nearby road which located about 55 m. away from the monitoring station. PTTEPI will also keep continue the monitoring to check the noise level as bi-annually basis.

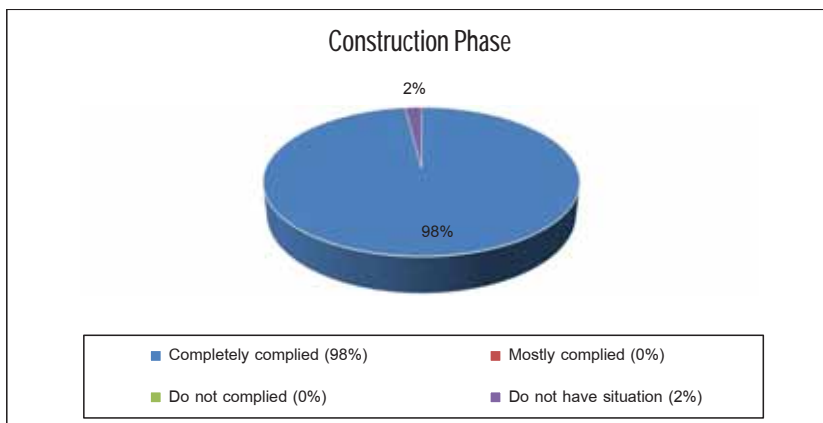
Figure 4-1 The Results of Environmental Mitigation Measures Compliance during Construction Phase

The results determined that the project completely complied on the Mitigation Measures during construction phase with 98% and do not have situation with 2%. The results are shown in Figure 4-1.

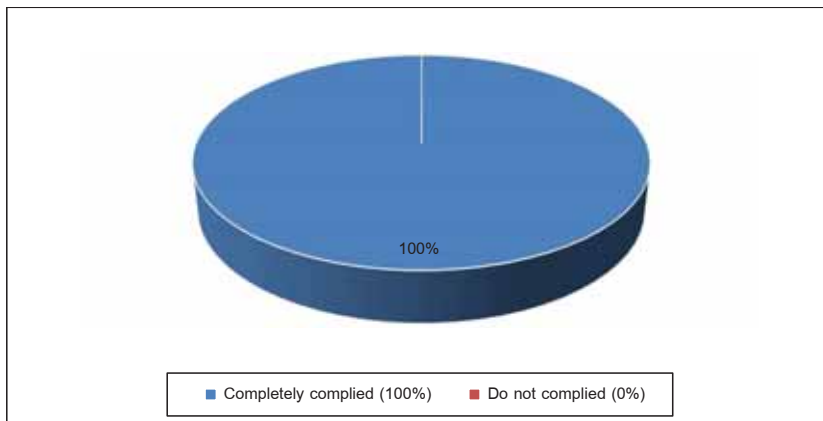
Figure 4-2 The Results of Environmental Monitoring

The results of Environmental Impact Monitoring determined that the project completely complied with 100% as shown in Figure 4-2.
