PTTEP International Limited (Yangon Branch), Yadana Asset

Six Monthly Environmental Monitoring Report (2023)

Yadana Asset, Block M5 M6

Environmental Monitoring Report for Yadana Asset Facilities

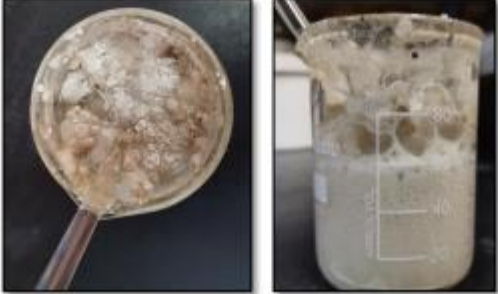
Figure 1: Produced Sand Laboratory Result

<p>In HCl solution at RT</p>

<p>A lot of bubbles were observed.</p>

Conclusion: Based on the visual inspection there is no sand indication from fine particle results. Further detail analysis can't be carried out in PP Lab due to the limitation of facilities.

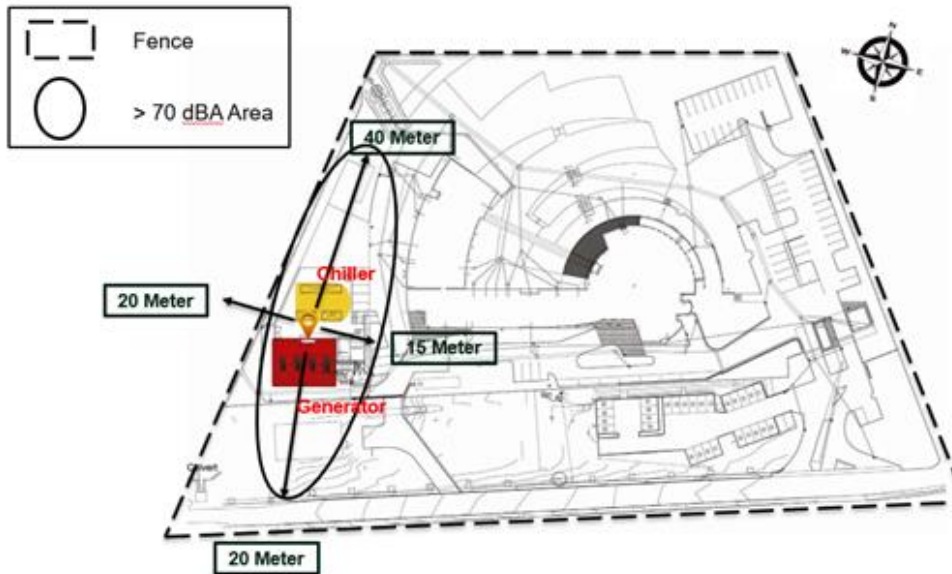
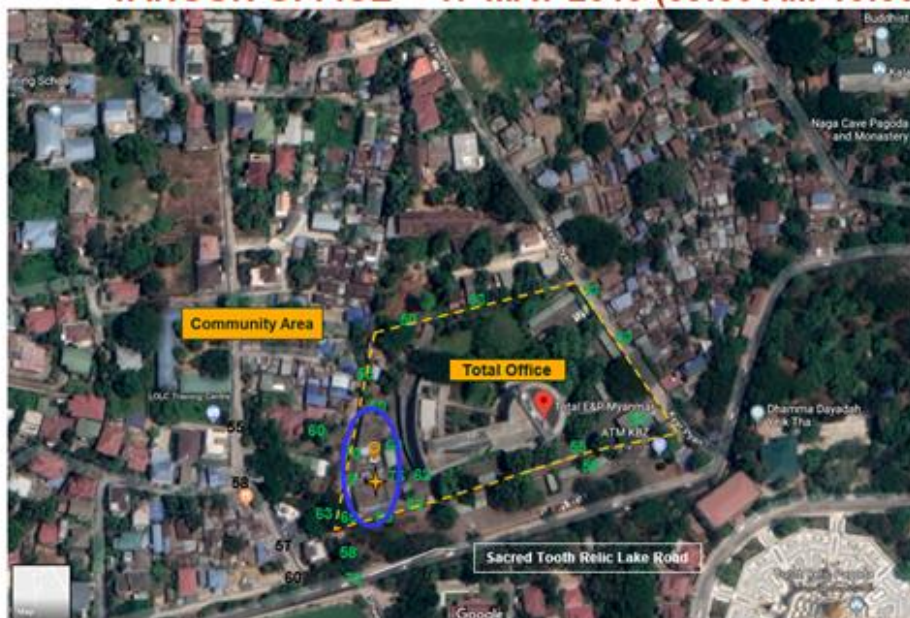
Figure 3: Noise Map of Yangon Head Office

The following figures depict the noise maps of the Yangon and Thaketa base. The generators, which is the noise source, are available in Thaketa and Yangon head office and are used for emergency purpose only. It means Thaketa and Yangon head office generators will run during the power cut-off. Due to no significant maintenance operations or new infrastructures being installed during six-month, the previous noise map is attached as follows, and the monitoring frequency is five yearly. No complaints have been received until now from the neighboring communities or residences..

- Measurement during Chiller & Generator running

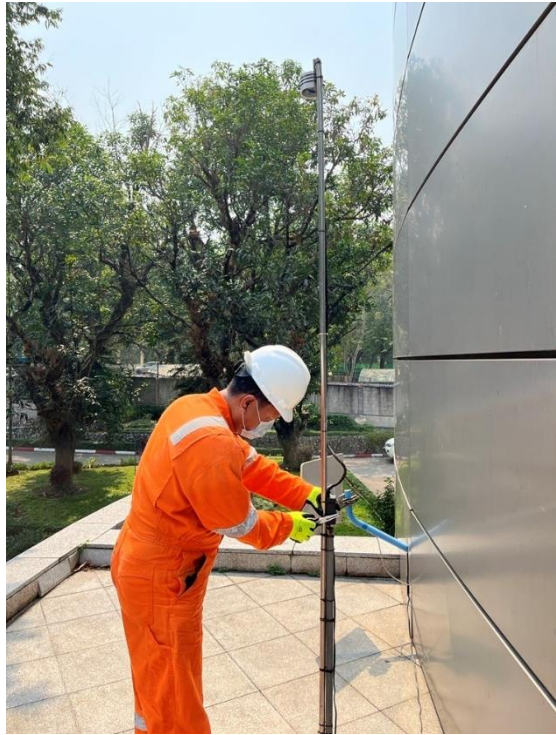
Figure 8: Ambient air quality monitoring device installed at Yangon Office

Yadana asset management has decided to install a real-time air quality monitoring device in the Yangon office so that the ambient air quality of the Yangon office and its surroundings is informed to the staff and set up the warning system if the outdoor air quality is more than air quality index (AQI) limits defined by WHO. The measurement parameter is particulate matter (PM2.5), a critical indicator of air pollution. By installing this device, the staff can avoid heavy physical activity outdoors if AQI is high and take preventive measures if necessary. The following picture portrays the installation of purple air in the Yangon office.

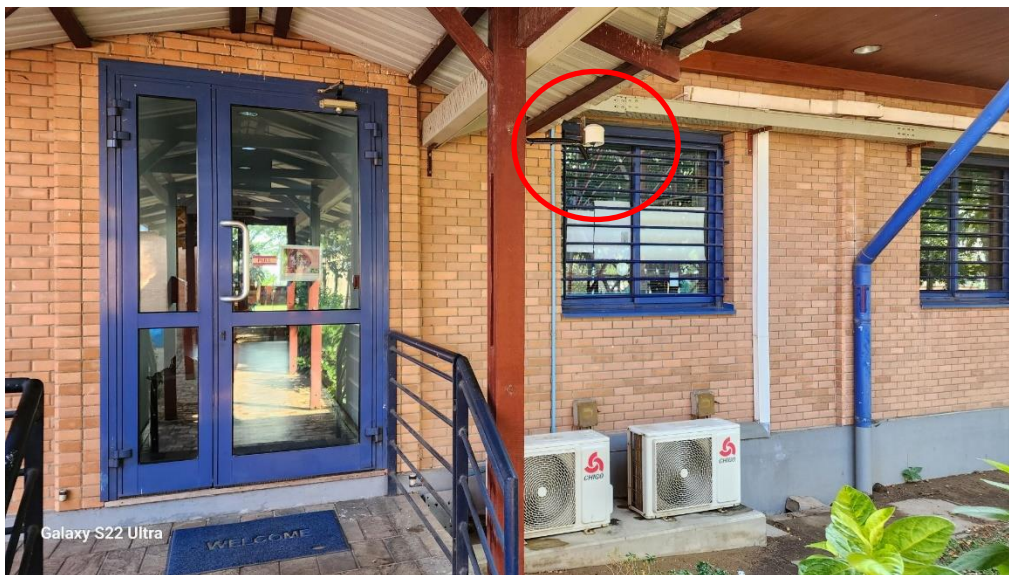
Figure 9: Ambient air quality monitoring device installed at Thaketa Logistics Base

The same air quality monitoring device is also being installed at Thaketa Logistics Base (see the below picture) so that the ambient air quality is monitored in real time and takes the necessary actions. The result of Purple Air can be checked in the following website link in real-time: <https://map.purpleair.com/1/mAQI/a10/p604800/cC0#8.17/19.451/96.569>
