PTTEP International Limited (Yangon Branch)

Monitoring Report 2019

3D Seismic Survey in Block M9, Offshore Myanmar

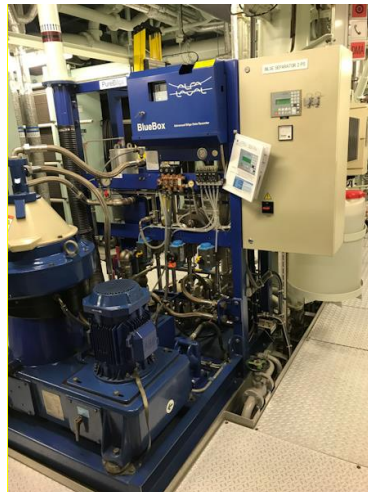
Figure 3-5 Oil/Water Separator on M/V Ramform Hyperion

2.2.2 Large operating vessels (over 400 gross tons) shall comply with the MARPOL 73/78 requirements and Regulation of Vessel Inspection (No. 34) B.E. 2551 (A.D. 2008). Oil contaminated bilge water shall be de-oiled prior to discharge into the sea. Discharge water shall contain less than 15 ppm oil content.	All project vessels.	✓	The survey, chase, and support vessels more than 400 gross tons have valid MARPOL Annex I certificates. Bilge water is deoiled through Oil/Water Separator (OWS) prior to discharge to the sea. The 15 ppm alarm has been calibrated. Discharge from OWS is recorded in Oil Record Book as per MARPOL Annex I requirement.	-	Appendix 2-2 – Relevant Certificates of Project Vessels Appendix 2-6 – Bilge System and Alarm Certificate Figure 3-5 – Oil/Water Separator on M/V Ramform Hyperion

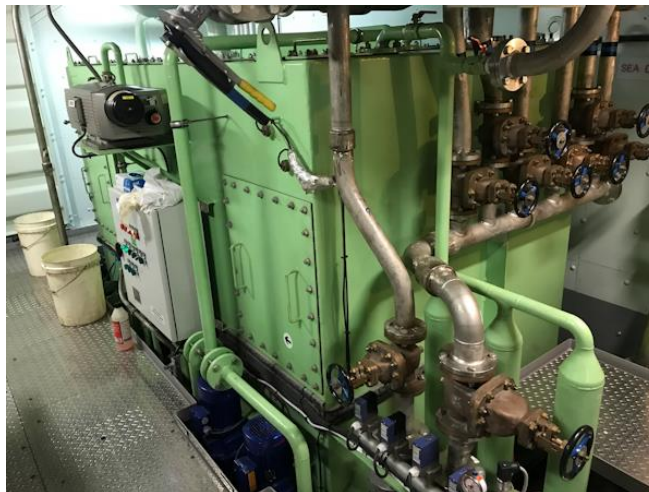
Figure 3-6 Sewage Treatment System on M/V Ramform Hyperion

2.2.6 Sewage will either be treated by sewage treatment system before discharged into the sea, or will be retained in a storage tank and will be pumped for disposal at the port/support base after the operation is completed.	All project vessels.	✓	Vessels more than 400 gross tons used in the Project are certified with MARPOL 73/78 Annex IV.	-	Appendix 2-2 – Relevant Certificates of Project Vessels Figure 3-6 – Sewage Treatment System on M/V Ramform Hyperion

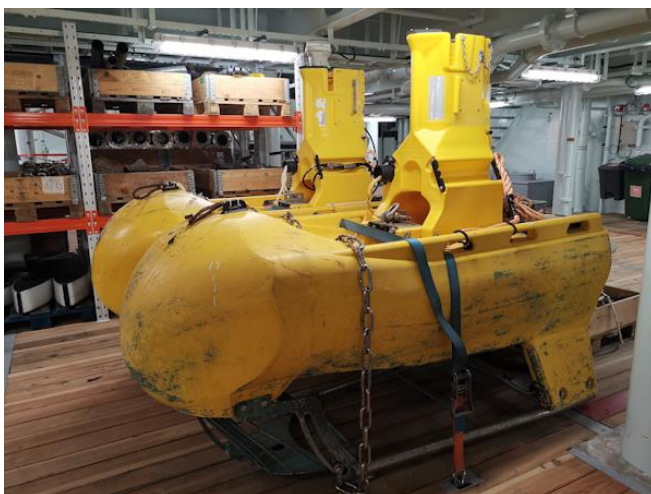
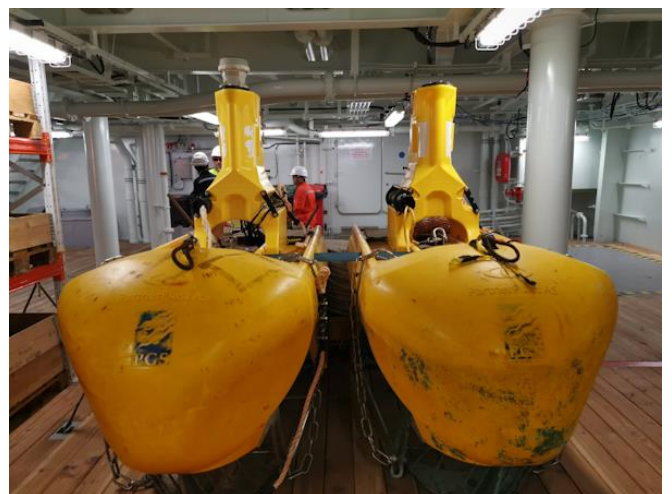
Figure 3-7 End Buoy Used at the end of Each Streamer Equipped with Signal Light

5.1.6 Warning device (i.e. Bell or Light) will be provided on the streamer tail buoy for night-time operations.	All project vessels. Entire survey area. Relevant authorities	✓	Streamer tail buoy is equipped with signal light powered by solar cell and turbine.	-	<p>Appendix 2-14 – Signal Light of Streamer</p> <p>Figure 3-7 End Buoy Used at the end of Each Streamer Equipped with Signal Light</p>
